# MOP for BBU Board Maintenance Link Failure

## Alarm Description:

This alarm is due to the maintenance link failure between the main control board and sub boards.

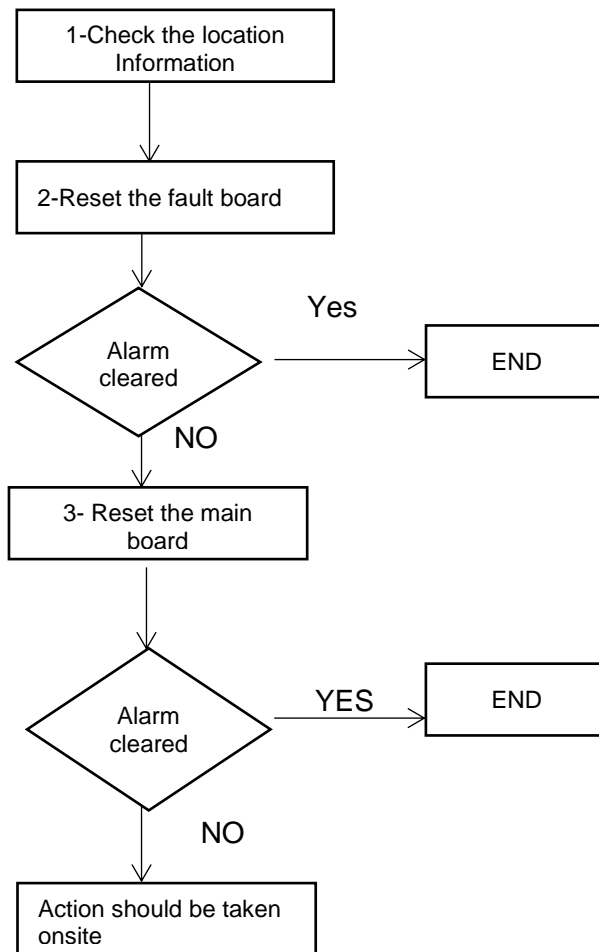
## Remote Process:

### 1-Check the location Information

### 2-Reset the fault board

### 3- Reset the main board (UMPT Board)

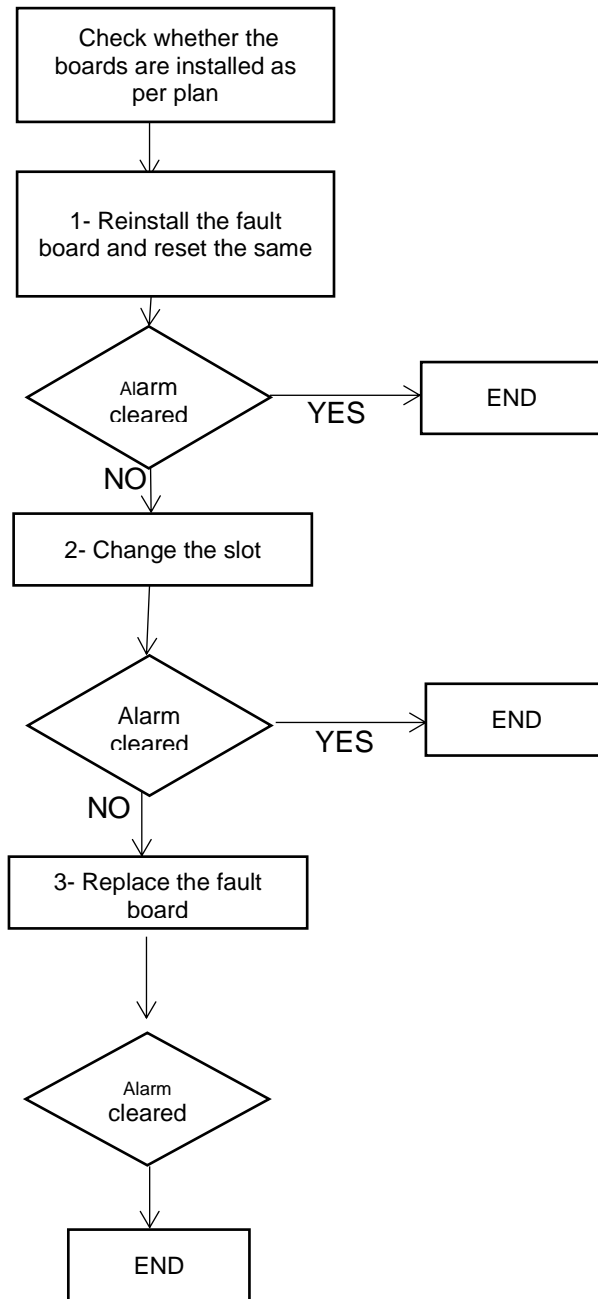
## Onsite Process:

## 1- Reinstall the fault board and reset the same

### 3- Replace the fault board
