The Note Pad, and a Workaround Wearing a Costume

UM-NATOS-022

DOCUMENT	REVISION	STATUS	CLASSIFICATION
UM-NATOS-022	1.1 · 2026-08-15	**Complete, verified on hardware**	Internal

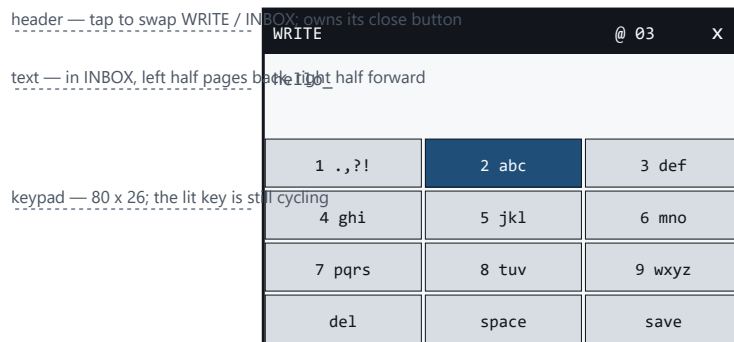
Keys are 80 px wide because the touch mapping reads about 24 px low on X. That fault is not fixed — it is absorbed. A 24 px key was destroyed by it: typing `e` produced `w`, reliably.

Figure 1. *The note pad. Key size is a consequence of a touch calibration fault the layout absorbs rather than corrects.*

The touch mapping reads systematically about **24 px low on X**.

What that paragraph got wrong. The cause is right; the characterisation is not. "Reads systematically about 24 px low on X" describes a constant offset, and the fault was a **magnification** — the narrow range is a divisor, so the error is proportional to distance from centre and changes sign across the screen (−29 px at the left edge, +12 px at the right; UM-NATOS-017 §7.4).

Twelve keys, 3×4 , each 80×26 — a third of the panel wide. An 80 px key absorbs a 24 px error. A 24 px key is destroyed by it.
