MOP of RX Path imbalance Alarm for Ericsson Site

Activity Description

This activity is for E2E troubleshooting and Clearance of RX Path imbalance alarm cell/ site.

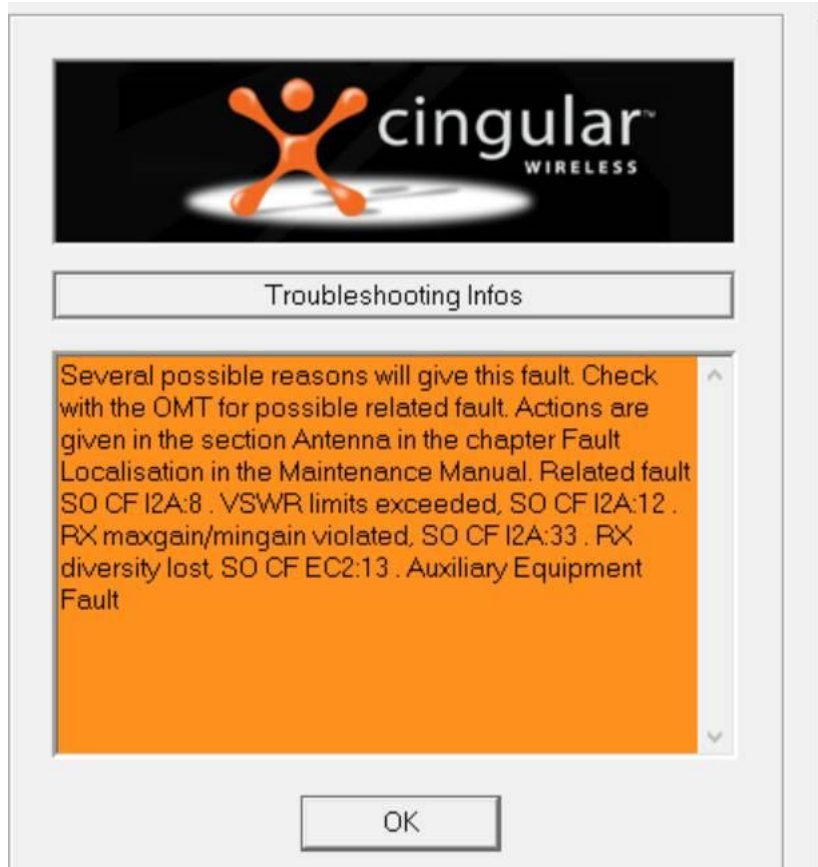
The following Steps must be taken to identify the alarm.

- > If the path between Radio and Antenna is mismatch.
- > If sector swap is there in any sector, there is a of chance of RX imbalance path alarm irrespective of VSWR value.
- > If there is no VSWR alarm, TX cables/Feeder swapping and any other loose connection also.

The following measures must be taken to clear this alarm.

- > Need to check path between Radio and Antenna, it should be same +ve and -ve of Radio and antenna resp.
- > Need to check Sector Swap and clear if found.
- > Need to check connection it should be tight.
