The Note Pad, and a Workaround Wearing a Costume

UM-NATOS-022

DOCUMENT	REVISION	STATUS	CLASSIFICATION
UM-NATOS-022	1.1 · 2026-08-15	**Complete, verified on hardware**	Internal

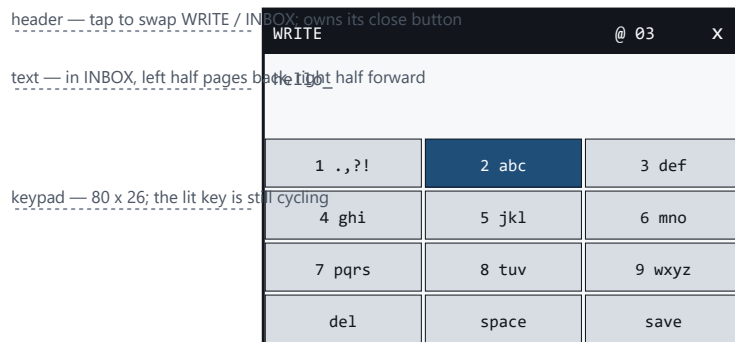
Keys are 80 px wide because the touch mapping reads about 24 px low on X. That fault is not fixed — it is absorbed. A 24 px key was destroyed by it: typing `e` produced `w`, reliably.

Figure 1. *The note pad. Key size is a consequence of a touch calibration fault the layout absorbs rather than corrects.*

The touch mapping reads systematically about **24 px low on X**.

What that paragraph got wrong. The cause is right; the characterisation is not. "Reads systematically about 24 px low on X" describes a constant offset, and the fault was a **magnification** — the narrow range is a divisor, so the error is proportional to distance from centre and changes sign across the screen (−29 px at the left edge, +12 px at the right; UM-NATOS-017 §7.4).

Twelve keys, 3×4 , each 80×26 — a third of the panel wide. An 80 px key absorbs a 24 px error. A 24 px key is destroyed by it.

The keypad is tolerant of the defect, not a correction of it. Those are different, and calling the first one a fix is how a known fault becomes folklore. Anything finer than 80 px will hit it again.
