Lifeboat Incident Survey - 2000

*Results from a Joint Industry Survey carried out
by
OCIMF, INTERTANKO AND SIGTTO*

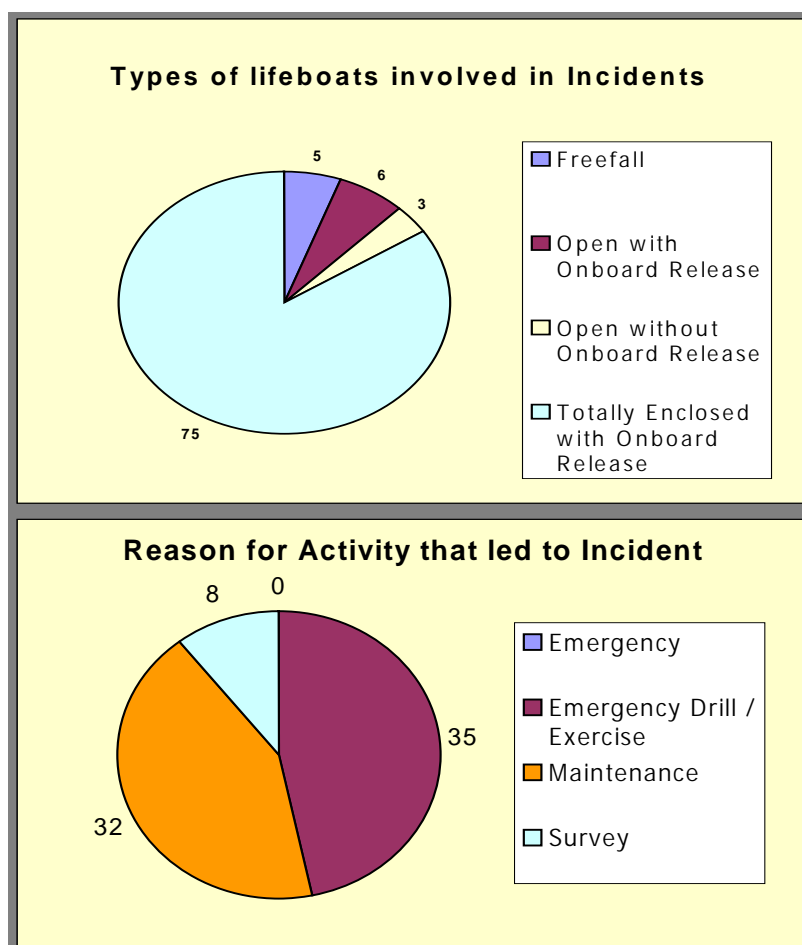
The charts below show the proportions of different lifeboat types involved in the reported incidents.

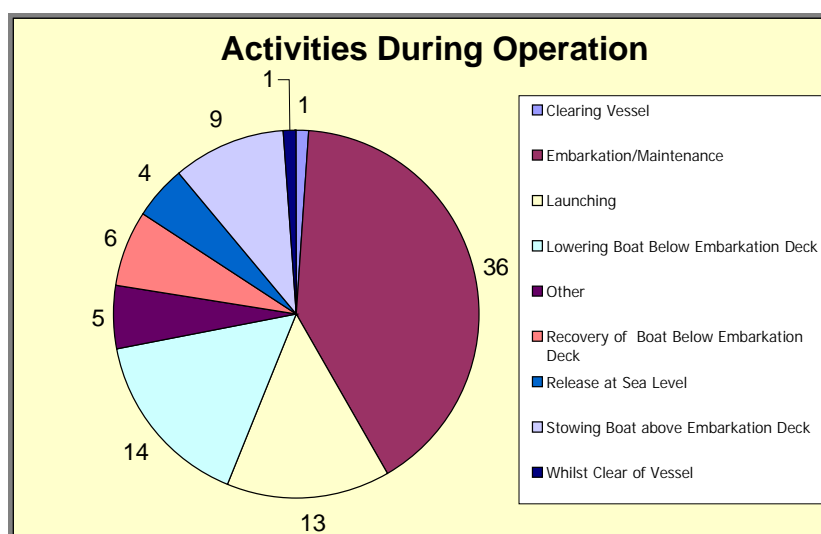
All reported incidents were associated with either testing or maintaining the boats, training exercises/drills or Surveys.

The majority of incidents involved personnel being within the boats.

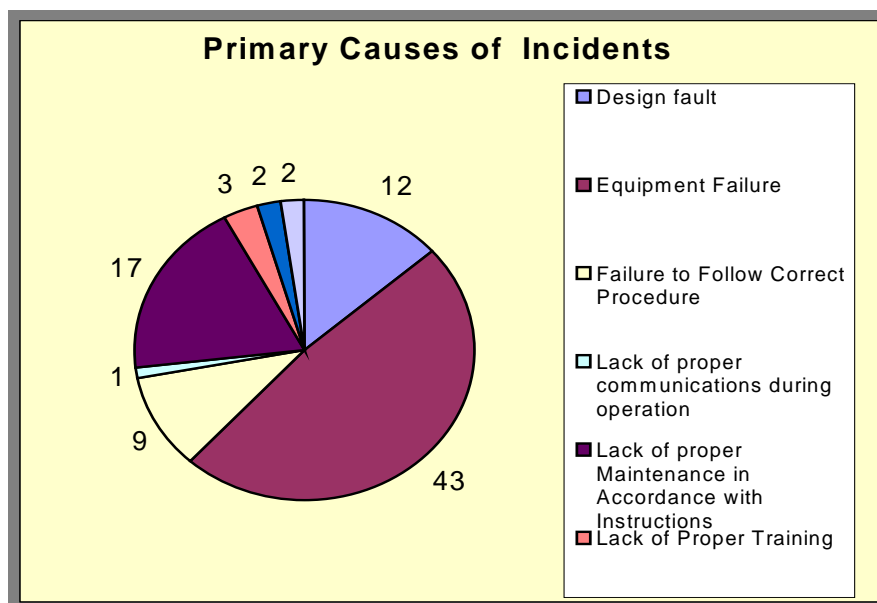
Primary Causes of Incidents

In the charts below, an attempt has been made to classify the incidents into three categories; Serious, Non-Serious and Minor.

Equipment failure is the greatest cause of incidents in all categories, followed by lack of proper maintenance, design faults and a relatively small number of Procedural faults.

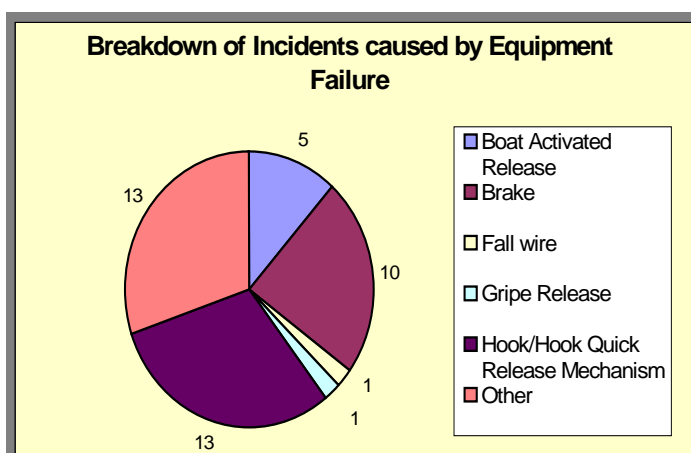
Equipment Failure

Hook/Hook Quick Release Mechanism failure is the largest group, relating to inability to engage or release hooks correctly due to cable failure or mislocated safety mechanisms.

Other major types of failure are winch brake related, caused by internal mechanism or remote controls for brake releases.

“Others” includes retrieval of free-fall lifeboats.

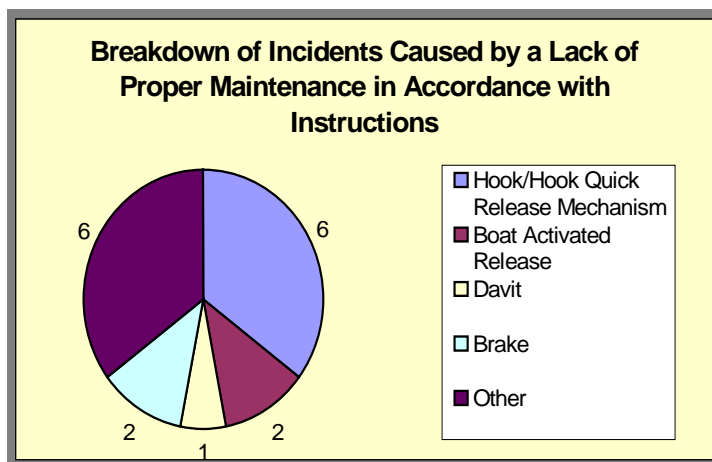
Lack of Proper Maintenance

Problems with Hook/Release Mechanism top this grouping. Usually attributable to wastage of critical parts within safety mechanisms.

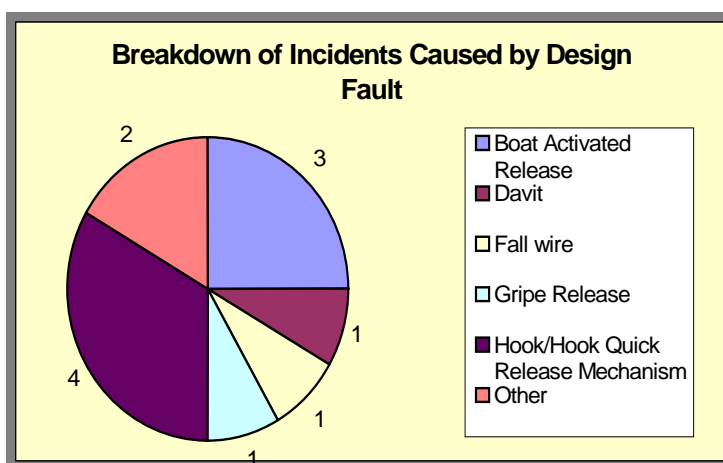
Design Faults

Again, the majority of incidents have occurred with Hook/Release Mechanisms followed closely by Boat Activated Release. The Lifesaving Role of the lifeboat may be compromised by an inability to launch it

The design faults reported may not have become apparent without regular training exercises.

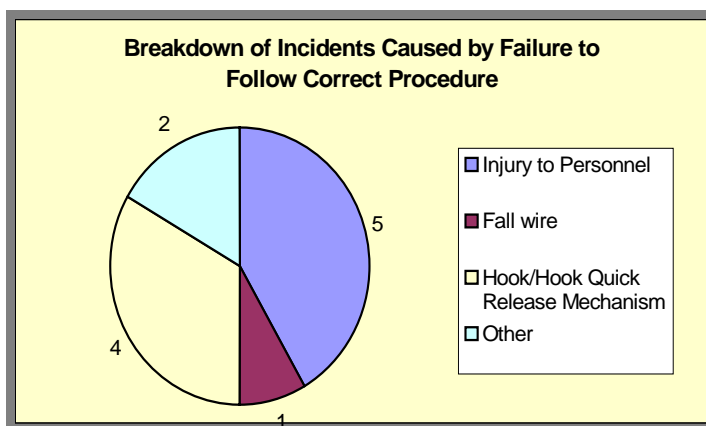
Failure to Follow the Correct Procedure

A number of incidents from failure to follow the correct procedure resulted in injury to personnel. Others resulted mainly in damage to boat or launching apparatus. Again, the Hook/Release Mechanism is a substantial contributor to this type of incident.

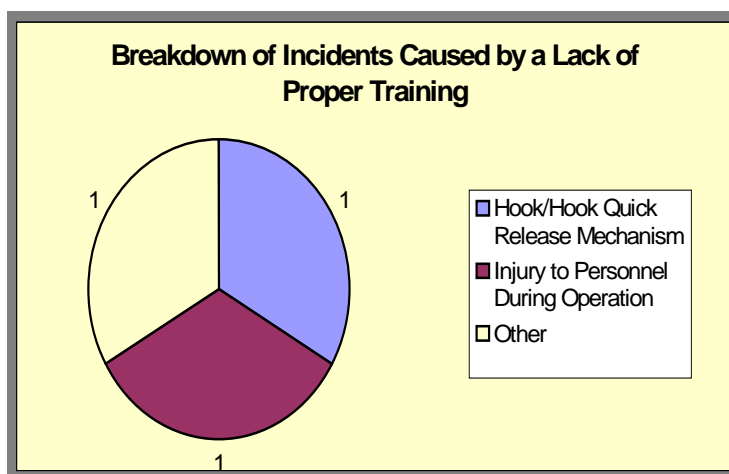
Lack of Proper Training

Few incidents can be attributed to lack of proper training and no valid conclusion can be drawn.

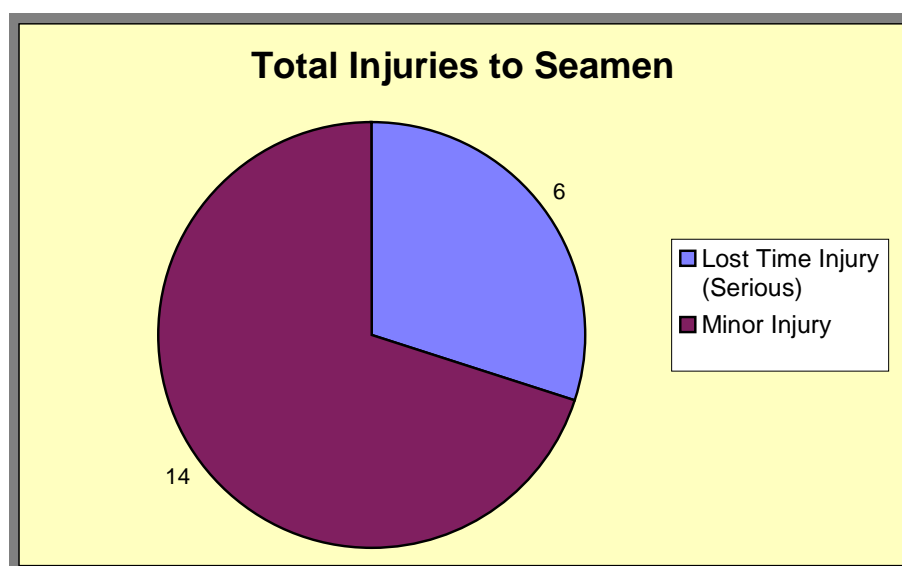
Primary Causes of Injuries

The number of injuries in comparison with the number of incidents is low. It can be assumed that a deep mistrust of lifeboats has developed on board vessels, resulting in operation of the boats in a manner that limits as much as possible any exposure to potential injury, such as a minimum number of persons in the boats when being lowered and lifted.

20 injuries were reported, 6 being serious, requiring at least several days off work and 14 were minor, requiring first aid or medical treatment before continuing work.

These 20 injuries occurred in 13 separate incidents, 4 of which accounted for the serious injuries.

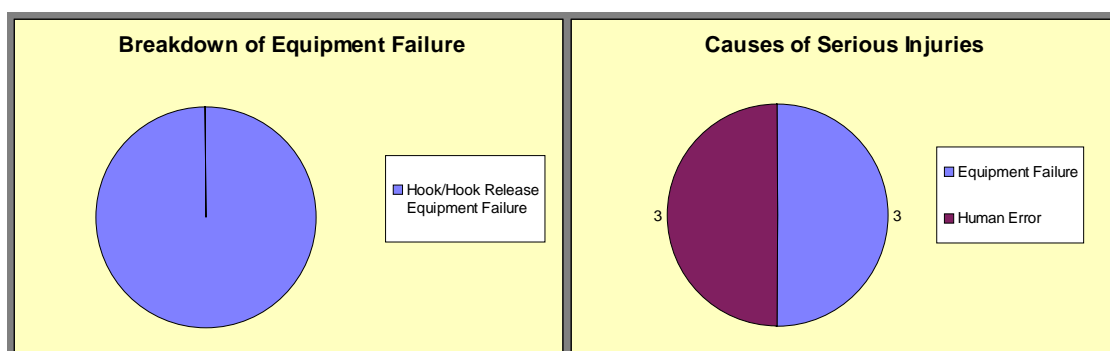
Serious Injuries

- A major incident was a lifeboat releasing itself and falling to the water from the embarkation deck level. The height above the water was relatively small at 12 metres and three members of the lifeboat crew incurred leg and/or back injuries. Had the freeboard been greater, fatalities would have been likely.
- The other incidents were all caused by human error - failure to follow correct procedure or lack of proper training. These included a thumb crushed by a closing lifeboat door and wrist fracture whilst starting a lifeboat engine.

N.B The charts in the Serious and Minor Injuries sections assume that “Equipment Failure” relates directly to a failure of the equipment and “Human Error” relates to following incorrect procedures or taking insufficient care.

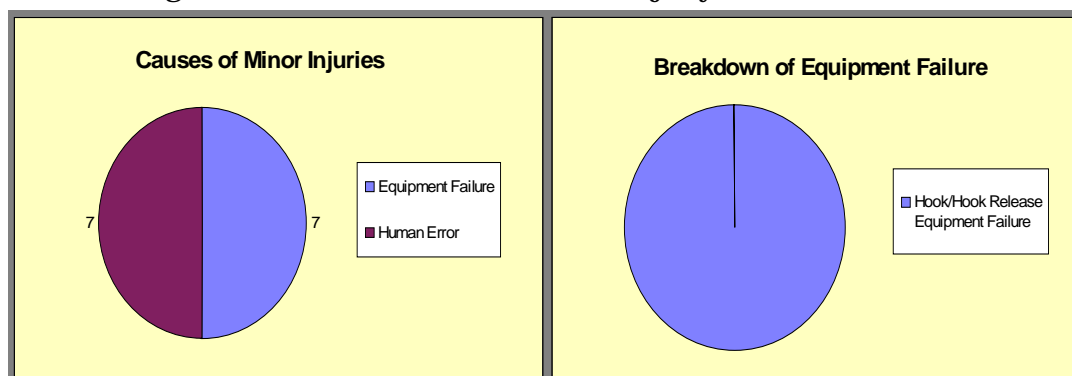
Minor Injuries

9 incidents involved minor injury. Two had potential for serious injury: -

- During a boat launch, the forward quick release hook released itself with the boat five metres above the waterline. This resulted in minor injuries to 4 seamen. The nature was not reported but the potential for more serious injury existed.
- A lifeboat was lowered to sea level but the launch aborted when one hook did not release. The other released but was reconnected and the boat recovered above embarkation deck with the crew onboard. When the boat reached the davit head the hook that failed released itself, resulting in the boat swinging from one fall. The three crew received cuts and bruises. Great potential existed for serious or fatal injuries. The one fall and davit proved sufficiently strong to hold the total weight of the boat on this occasion.

- Some incidents include injuries incurred whilst attempting to “hook on” to the falls for boat recovery. In one incident a seaman was struck by the swivel block and in the other a seaman incurred pinch cuts to his hands whilst holding the hook in place as the release system was engaged. The connection of waterborne lifeboats to falls has always proven a hazardous operation, but is exacerbated by release mechanisms which are difficult to engage correctly. A similar minor injury was incurred when trying to reconnect a quick release hook after maintenance. This resulted in cuts to fingers.

- Other incidents include gripe releases under tension where a seaman was struck heavily by the freed end of the gripe and one where a seaman caught his finger in the gripe release mechanism.

- More minor incidents include a seaman attaching his safety harness to the davit and being pulled off balance when the davit was lowered and a seaman losing balance whilst attempting to start a lifeboat engine. The seaman struck his head, rather than fracturing a wrist as noted in Serious Injury section.

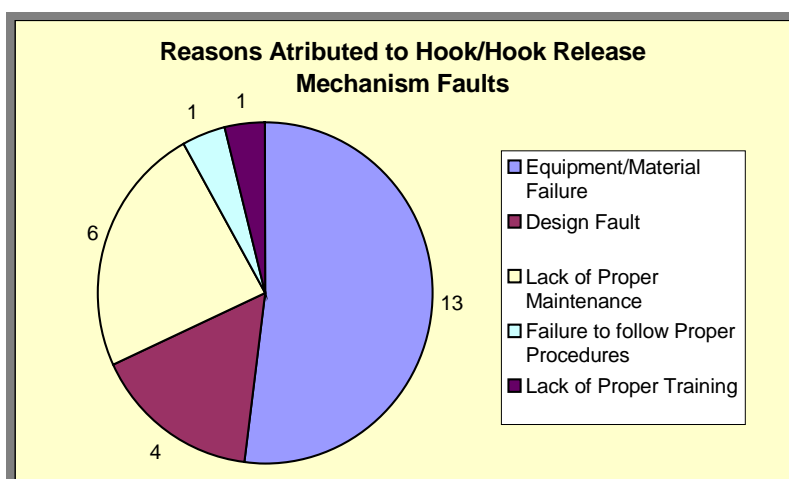
Hook/Hook Quick Release Mechanisms

As previously noted, incidents attributed to faults with the Hook/Hook release Mechanism are the greatest single group. Of these 25 incidents, over 50% are due to failure of the equipment or of the material. When

Design Fault is added some 68% of these incidents can then be grouped as a single "Design factor". If at the design stage the requirement for non-critical maintenance was addressed, the incidents categorised under Lack of Proper Maintenance may not have occurred. Therefore, all but 2 of these incidents can be attributed to poor design of the Hook/Hook Release Mechanism.
