# The Note Pad, and a Workaround Wearing a Costume

UM-NATOS-022

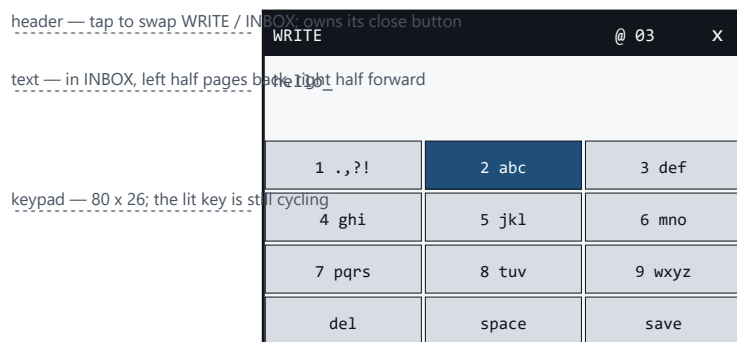
Keys are 80 px wide because the touch mapping reads about 24 px low on X. That fault is not fixed — it is absorbed. A 24 px key was destroyed by it: typing `e` produced `w`, reliably.

**Figure 1.** *The note pad. Key size is a consequence of a touch calibration fault the layout absorbs rather than corrects.*

The touch mapping reads systematically about **24 px low on X**.

**What that paragraph got wrong.** The cause is right; the characterisation is not. "Reads systematically about 24 px low on X" describes a constant offset, and the fault was a **magnification** — the narrow range is a divisor, so the error is proportional to distance from centre and changes sign across the screen (−29 px at the left edge, +12 px at the right; UM-NATOS-017 §7.4).
