Structural Health Monitoring of Wind Turbine Blade

Problem Definition

To determine the early detection of longitudinal cracks & establishing benchmarks for severity of their propagation at the trailing edge of the Wind Turbine blade

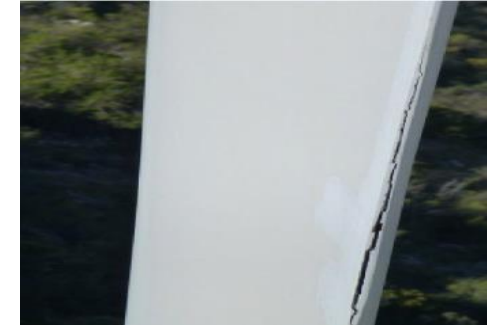
Longitudinal Cracks

- The longitudinal crack at the trailing edge of the tip is mainly due to a reduction in the thickness of the shell, resulting in a crack formation due to change in stiffness of the blade.

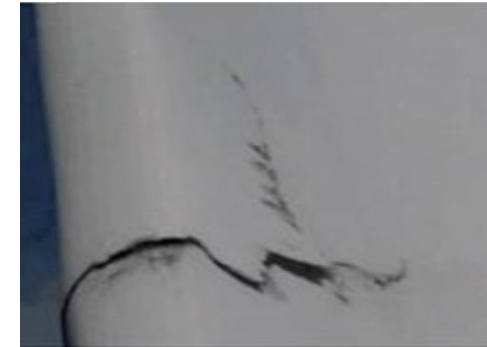
Transverse Cracks

- It occurs mainly when one side of the blade needs to be polished in order to eliminate the asymmetry between the two shells of the blade during the manufacturing process, which leads to a reduction in glass fiber on one side, and this kind of crack occurs under the high load or stall of the blade.
