CALSPEC
HOME INSPECTORS, LLC
"Inspected Once, Inspected Right"

Re: 1801 Via Estudillo

Summary of Deficiencies

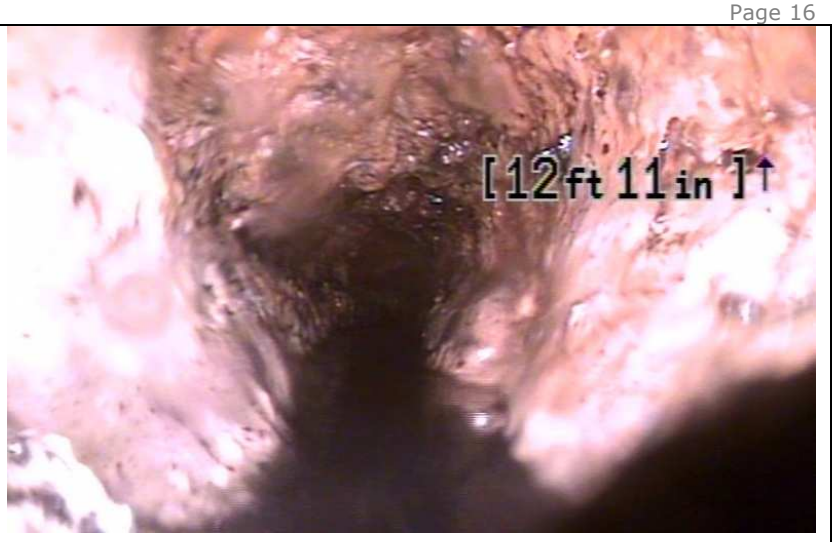
1. Rust stains were noted under several plumbing cleanouts around the home. These stains indicate that sewage/water has backed up and out of the cleanouts. I noted an excessive amount of debris buildup in the cast iron waste/sewer lines. I highly recommend having a licensed plumber snake and/or jet the sewer line to ensure good drainage.

Root intrusion was noted in several sections of the clay pipe. The first area of root intrusion was noted in the middle of the front yard. The root intrusion was located at the top portion of the pipe at this location. Larger roots were evident inside the main sewer line just inches before the city sewer lateral connection. I recommend having a licensed sewer line specialist evaluate and clean/service the line as needed.
