GENERAL SERVICE REPORT

Subject: Line 2 Film Breaking and Flat pack issues.

Equipment Type:	Serial Number:	Customer Line # (if applicable):
Trave 590VGXL-S	A21A-12629	Line 2

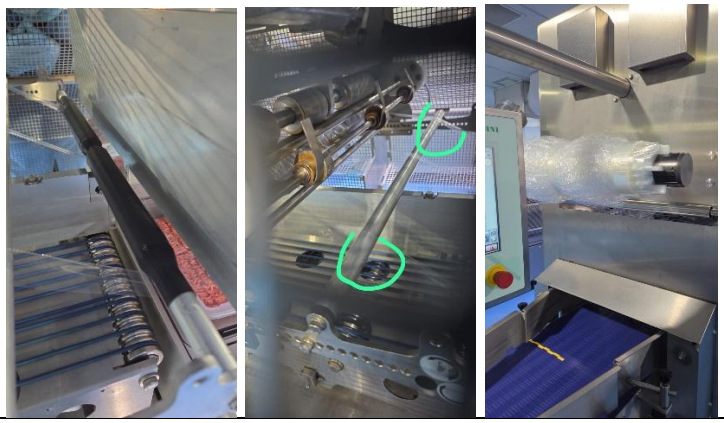
- Travel to site, sign in.
- Inspect machine operations, film breakage and flat pack reported in first pack non operator side.
- On monitoring operation, we found film slightly loose in the machine made some changes to the recipe, film unwinding infeed, film unwinding, deceleration, acceleration and waste rewind to keep tension on the film, also centralised the film to the tool. These adjustments helped the film breaking, however the waste cone directly after the tool were found to have stripped threads and unable to be adjusted correctly as they were moving and not tracking the waste film correctly. There is an upgrade from urethane to aluminium which will be quoted.

- Some minor adjustments were made to the vacuum settings the aid with the flat pack, and we were able to improve the issue, vacuum leaks were detected in the tool and will be addressed in the next uptime service, and the gummed rollers also require attention.

- The film waste was rewinding tightly and in a more uniform roll.
- Clean area and pack up.

RECOMMENDATIONS
Comments: Luminium Cones requiredsc
