GENERAL SERVICE REPORT

Subject: Gas Mixer Callout

Equipment Type:	Serial Number:	Customer Line # (if applicable):
Trave 590	A/21/A-12629	2

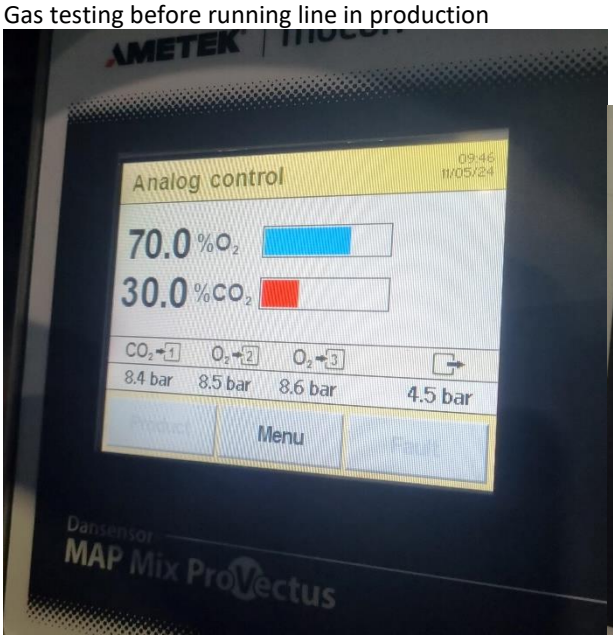
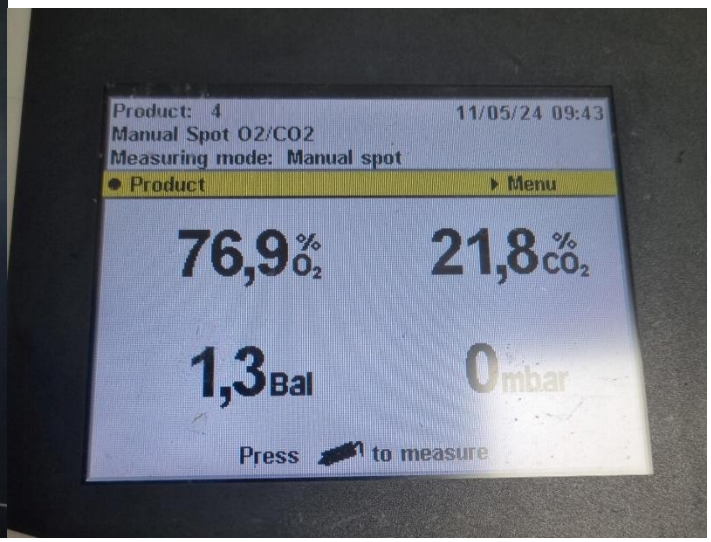
Gas testing before running line in production
