Duo Labs Report

Examining Personal Protection Devices

Hardware & Firmware Research
Methodology in Action

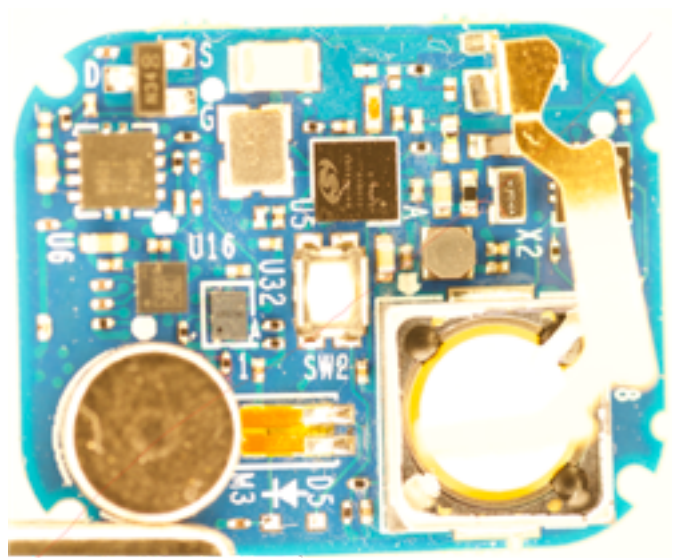
My analysis of Denver-based Revolar's Instinct device began with a teardown of the hardware and photographing the printed circuit board (PCB) to identify components and connections. The images below show the two sides of the board. On the left, the upper side of the board shows the components comprising the device. On the right, the lower side reveals a number of test points that can be used to measure and interact with the various components.

The upper and lower side of the Revolar Instinct PCB

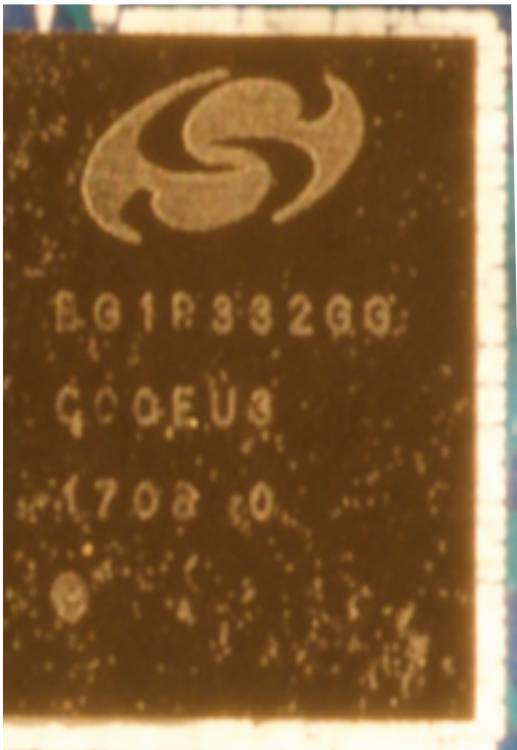
As shown in the image below, the markings on the Revolar microcontroller start with the string **BG1P332GG**, while the logo at the top indicates the part is manufactured by Silicon Labs.

Chip markings reveal the Silicon Labs BG1P332GG

Searching for the part number shows the Revolar is based on a Silicon Labs Blue Gecko line¹ of Bluetooth system-on-chip (SoC) devices. These devices are ARM Cortex M4 devices with 256k of flash program memory and 32k of RAM. I located the Silicon Labs datasheet for the product, and translated the chip markings into a specific part number. Finding a datasheet for a target device gives the researcher necessary information for proceeding with a hardware audit. Using the part number allows the researcher to determine the features present in a particular chip model.

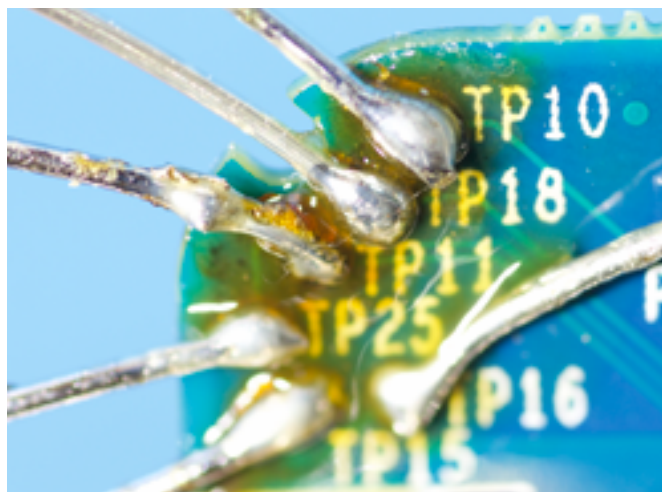
Leads connected to PCB test pads

I identified the debugging pins by connecting lead wires to the possible test points identified above. Don't judge my soldering skills too harshly. As the following image shows, connecting leads even to well-marked test points can be difficult with a shaky hand.

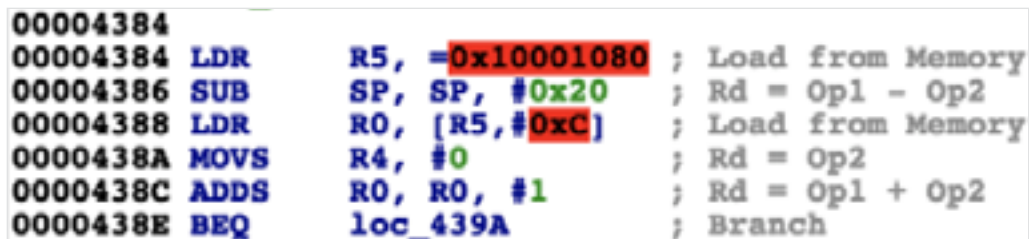
I searched the firmware image for any instruction that set the registers as shown above. Good fortune smiled on me that day, because I found only a single instruction in the firmware that set the R5 register.

```
00004384
00004384 LDR      R5, =0x10001080 ; Load from Memory
00004386 SUB      SP, SP, #0x20   ; Rd = Op1 - Op2
00004388 LDR      R0, [R5, #0xC]   ; Load from Memory
0000438A MOVS     R4, #0          ; Rd = Op2
0000438C ADDS     R0, R0, #1      ; Rd = Op1 + Op2
0000438E BEQ      loc_439A       ; Branch
```

IDA Pro showing an instruction setting R5=0x10001080. The only such instruction in the firmware.
