GENERAL SERVICE REPORT

Subject: PLC Fault and Pusher arm fault

Equipment Type:	Serial Number:	Customer Line # (if applicable):
Trave 340	A/14/A-00912	Skin Line

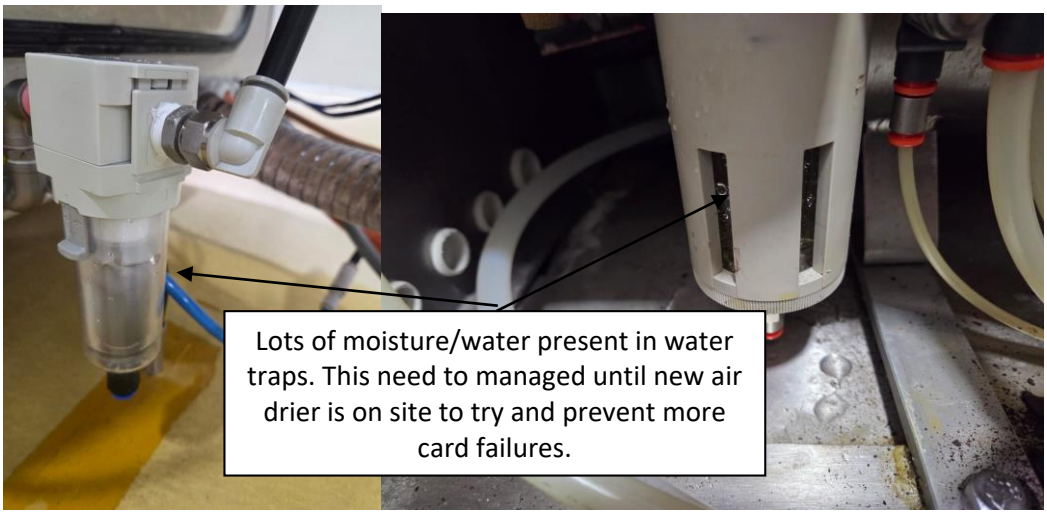
Pressing and tapping on the Power supply card would bring up the PLC error. Replaced connection card and power supply card with one from the spare machine. Contacts and pins looked good the bus.

Replaced first card I6 on the valve was not getting the 24vdc on the relevant bus contact to feed power to the pusher arm card K8. Card also had a lot of corrosion on it.

Lots of moisture/water present in water traps. This need to managed until new air drier is on site to try and prevent more card failures.
