TITLE: LogBoard

AUTHOR: Renan R. Duarte

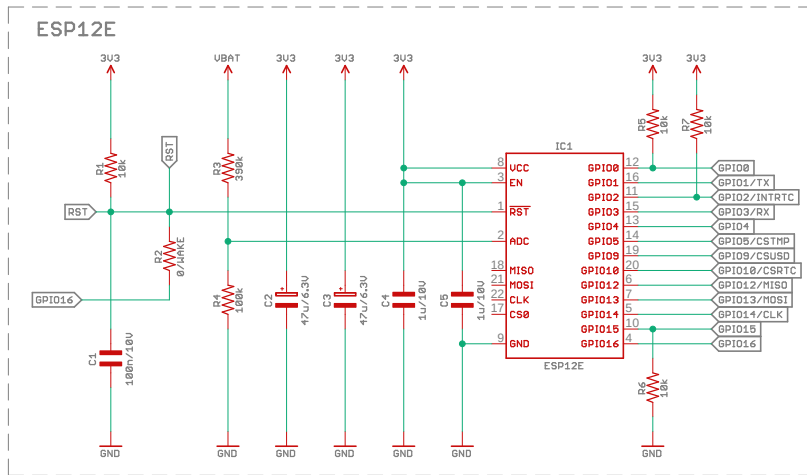
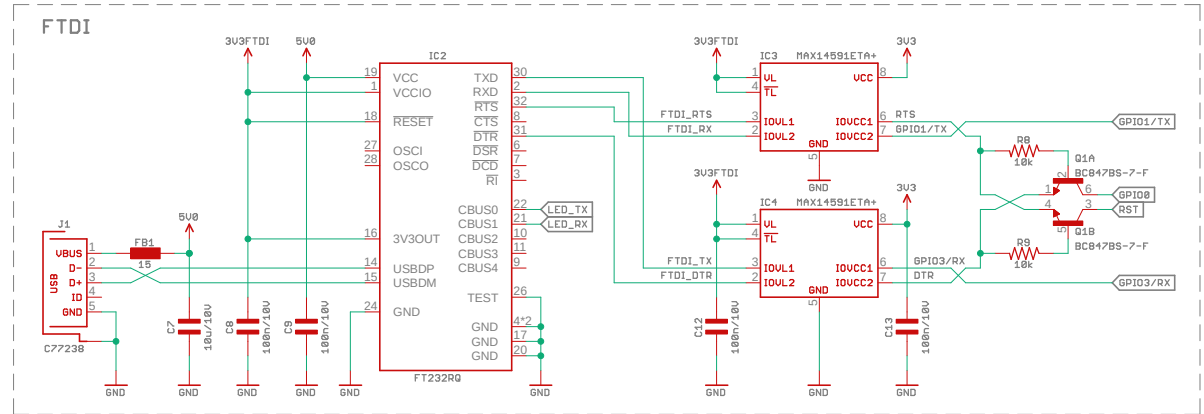
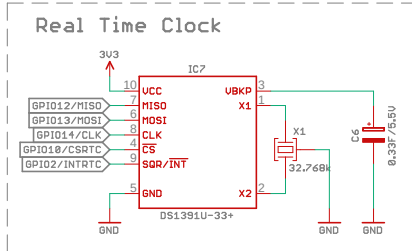
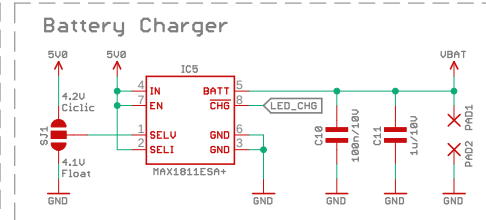
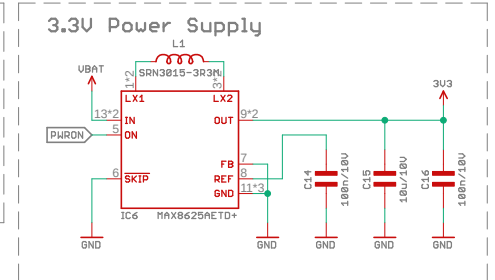
MISTAKES OF v1:
 - USD CD was not connected
 - RTC RST (DS1391) causes ESP not to boot.
 Disconnect this signal or use DS1390
 - S2 footprint is wrong

IC1 (ESP12E) must be configured in DIO SPI mode. To do this, desolder the metal shield, lift pins 3 and 7 of the SPI flash memory chip and connect these pins to pin 8 (3V3).
