Figure 63-4. Damage limits — engine-to-transmission (main)driveshaft (sheet 1 of 4)

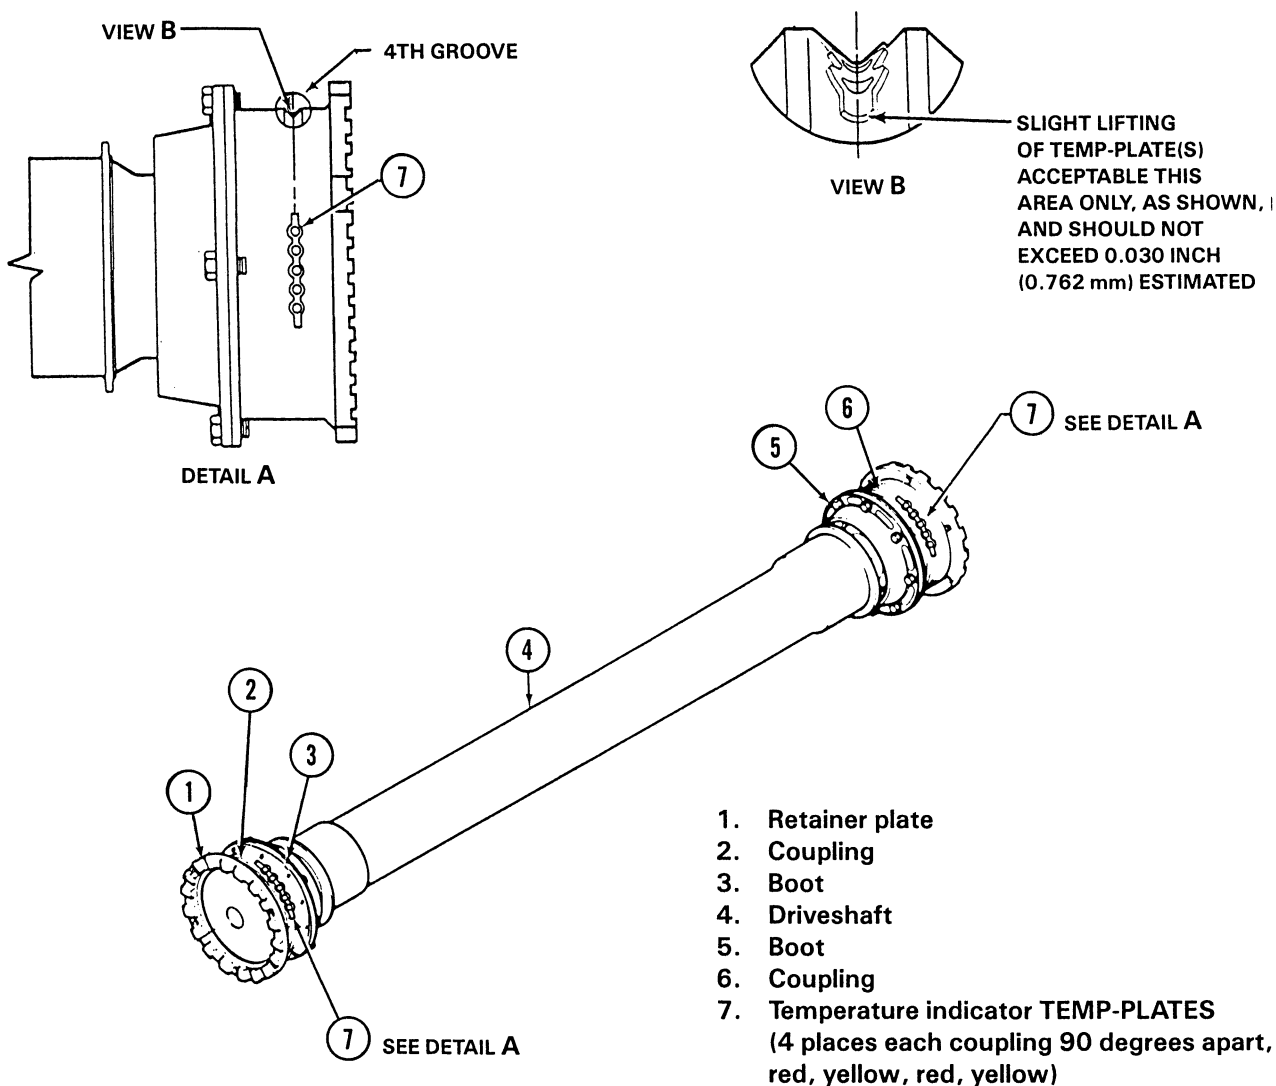
212-M-63-4-1

1. Evidence of lubricant leakage at couplings (2) or (6) is cause for overhaul evaluation of driveshaft. Refer to BHT-212-CR&O manual.
2. Mechanical and/or corrosion damage on plate (1) in coupling (2) or similar plate in coupling (6) that could result in lubricant leakage is not acceptable.
3. Mechanical and/or corrosion damage on boots (3 and 5) that could result in lubricant leakage is not acceptable.
4. Superficial mechanical damage on couplings (2 and 6) is acceptable without repair. Mechanical damage in excess of superficial and/or corrosion damage is cause for overhaul evaluation of driveshaft. Refer to BHT-212-CR&O.

5. Mechanical and corrosion damage limits on shaft (4) are defined as follows:
 - a. Nicks and scratches running parallel to, or within 15 degrees of parallel of shaft axis.

Not exceeding 0.004 inch (0.101 mm) in depth are acceptable without repair.

Not exceeding 0.008 inch (0.203 mm) in depth or 1.5 inch (38 mm) in length are acceptable if polished out, provided total polished area does not exceed 10 percent of circumference at any point.
 - b. Nicks and scratches not running within 15 degrees of shaft axis.

Not exceeding 0.004 inch (0.101 mm) in depth are acceptable on up to 100 percent of the circumference of shaft if polished out.

Not exceeding 0.008 inch (0.203 mm) in depth or 1.5 inches (38 mm) in length are acceptable provided the total polished area does not exceed 10 percent of the circumference at any point.
 - c. Corrosion pitting.

Not exceeding 0.008 inch (0.203 mm) in depth is acceptable provided it is polished out. Maximum length of rework at any point must not exceed 1.5 inches (38 mm) nor cover more than 10 percent of the circumference at any point. The maximum acceptable total reworked area is 4.0 square inches (2580 square mm).

6. Overtemperature indicator DOTS on TEMP-PLATES (7) are a white or light gray color and turn black when exposed to an overtemperature condition. Chemical contamination can also cause indicating DOTS to turn black.

7. Temperature indicator TEMP-PLATES must not show evidence of overtemperature, deterioration, debonding, or discoloration of the epoxy coating that prevents interpretation of the indicating DOTS. If any of these conditions exist, proceed to note 8.

8. If only one TEMP-PLATE of a given color is missing, and no DOT on any other TEMP-PLATE (on the same coupling) is discolored or shows mechanical damage or degradation of the epoxy overcoating, the aircraft may be returned to service.

9. The discrepant TEMP-PLATE (in step 8) should be replaced as soon as practical. If any indicator DOT on either the red or yellow-bordered TEMP-PLATE has changed color to black, see sheets 3 and 4 for probable cause and required corrective action.
