# VOLVO PENTA SPEED RELAY

A Guide to Testing & Repair

This document provides general information about the Volvo Penta KAD series marine diesel engine. The words and other content provided in this document, and in any linked materials, are not intended and should not be construed as technical advice.

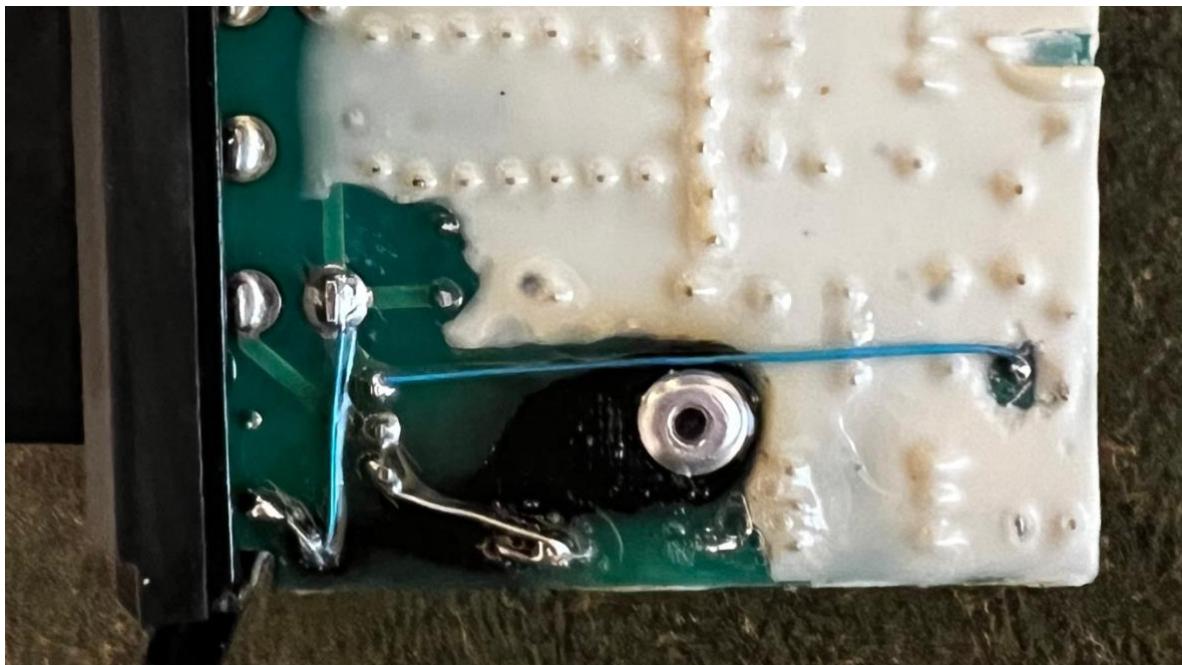
### Example of a damaged board

Whilst the board has suffered from heat damage which has also damaged some of the tracks and the pads it is still repairable, although the repair will be obvious.

The damage destroyed about 5 tracks and 2 through holes. The heat also damaged 2 other components on the board.

The board has been repaired and a new transistor has been riveted in.

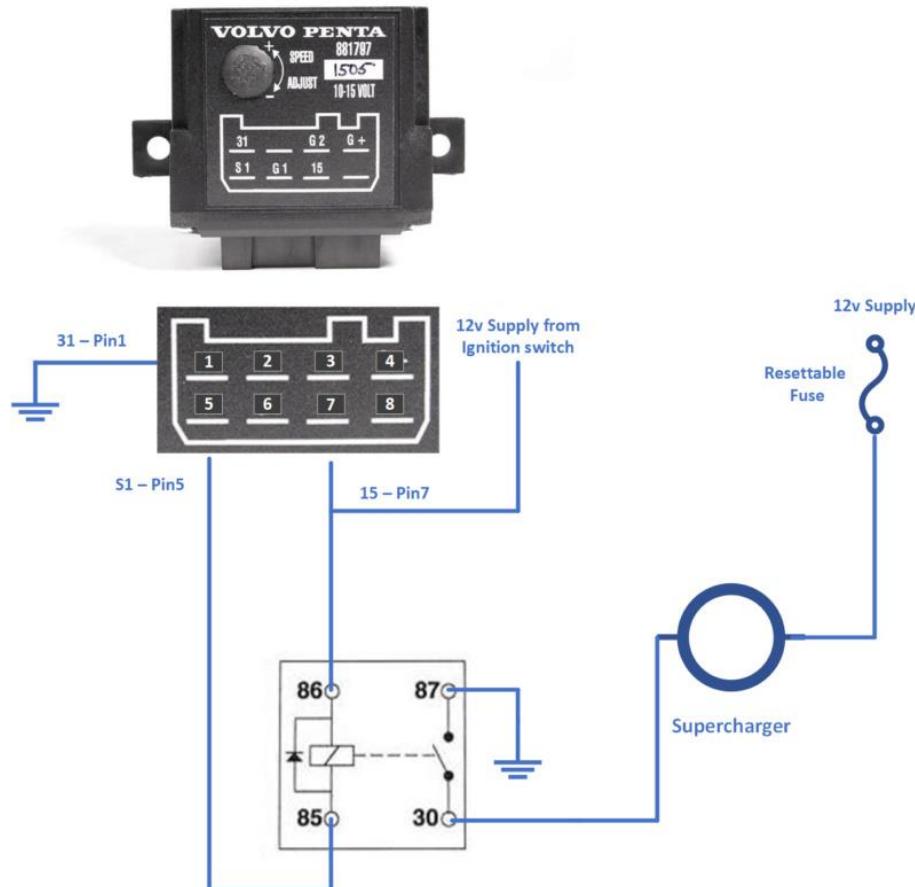
Consider fitting a relay in between the supercharger and the Volvo speed relay. This will protect the speed relay from damage when the clutch coil fails.

Ensure the relay has a suppression diode.

Relay with diode across coil for spike suppression

The diode should be installed in the relay with the stripe on the diode body facing towards terminal 86 (reverse biased) and it is important that +12V is connected this terminal.

Diodes are usually installed with the band (Cathode/Negative) of the diode facing to terminal 86 (if positive reverse biased) & is critical that 12v be connected here and not to 85 to prevent diode damage and relay box damage.

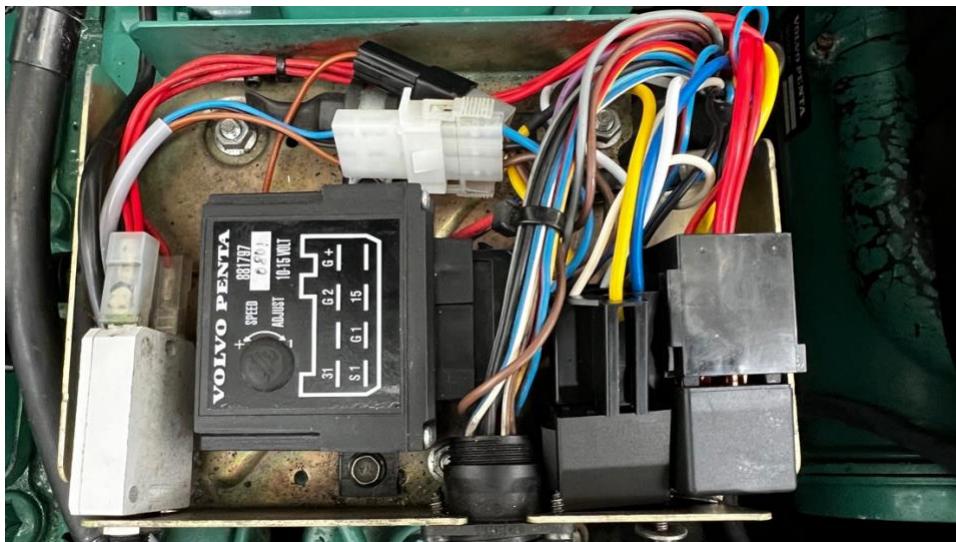
Protection relay installed next to starter relay

Locate cable S1 / Pin 5 on the Volvo connector block. Do not cut this cable. Remove the connector from the connector housing using a [connector pin removal tool](#).

On the new relay socket remove the existing cable for Pin 30\*\* using a pin removal tool and insert the cable removed from S1/Pin 5 into the new relay socket at Pin 30.

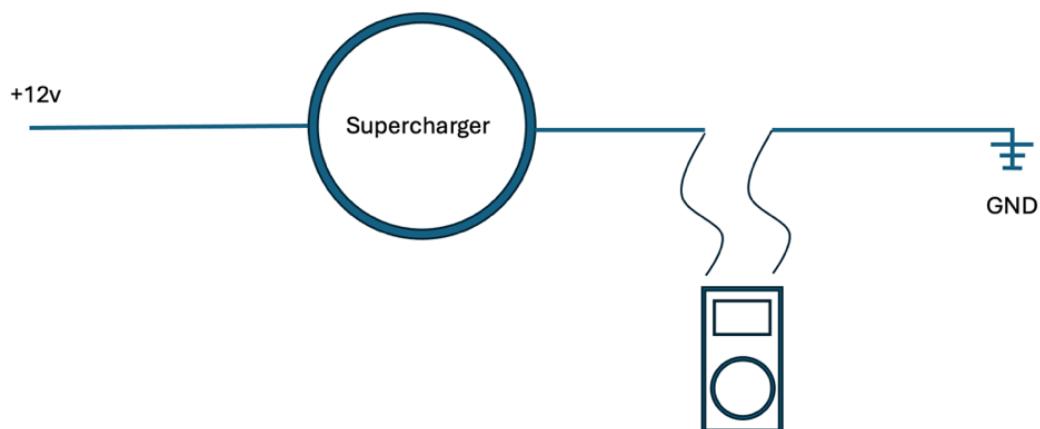
The clutch coil is the primary reason the speed control relay gets damaged.

The clutch coil can be tested in situ to measure the voltage and current.

Using a multimeter set to DC volts measure the voltage between pin 1 and pin 5 on the connector (31 & S1). The reading should be at least 12v.

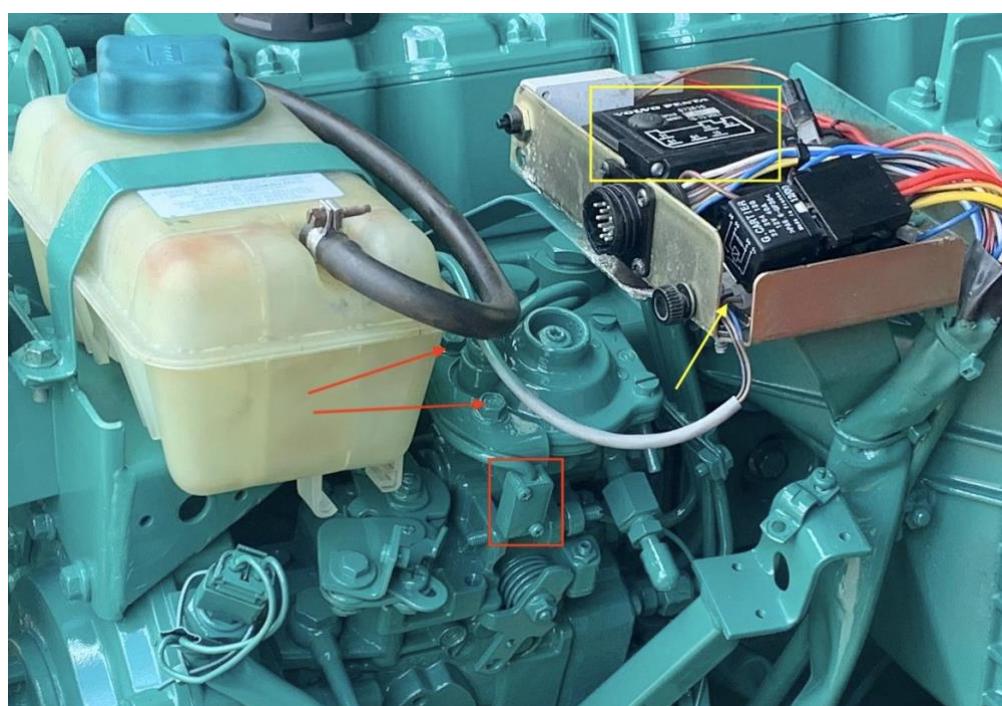
A faulty or bad connection on throttle position sensor can cause the supercharger to run when the engine is at idle. Temporarily disconnecting the speed sensor (Part number: 862251) and restarting the engine will confirm if this is the case. With no signal being received the clutch will not be engaged at idle.

Proximity sensor connections to the relay box: Brown – P4, Black – P3, Blue – GND

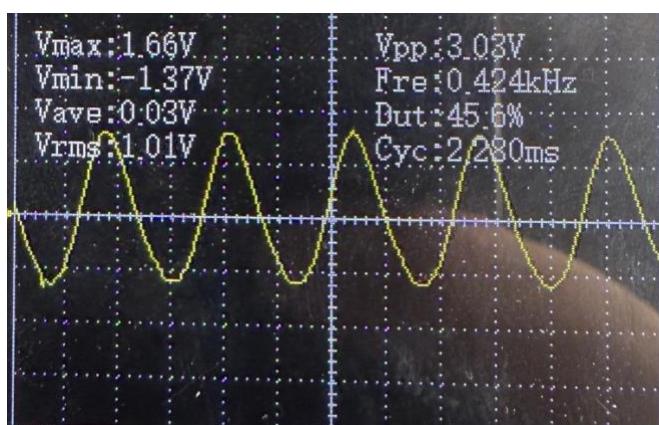
Inductive sensor (cog counter). Internal resistance  $1050\ \Omega \pm 100\ \Omega$ .

With the connector removed measure the resistance with a multimeter set to Ohms.  
Expected reading  $1050\ \Omega \pm 100\ \Omega$

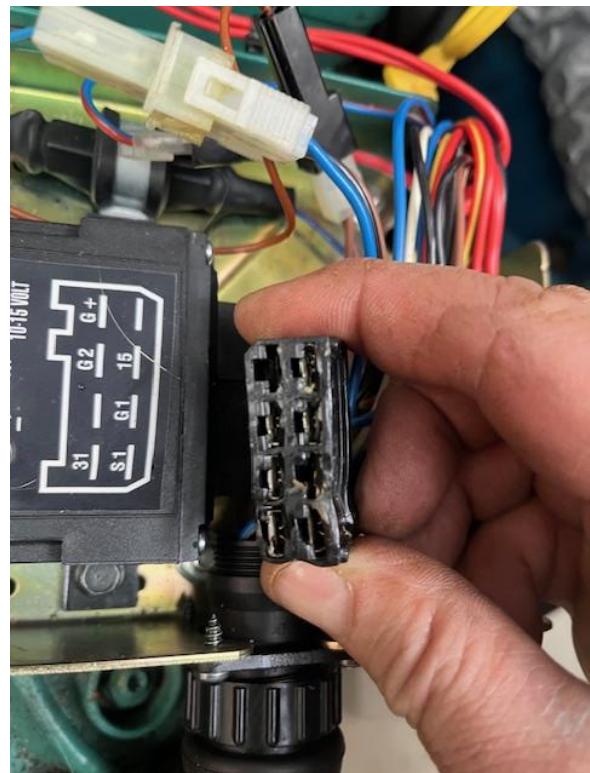
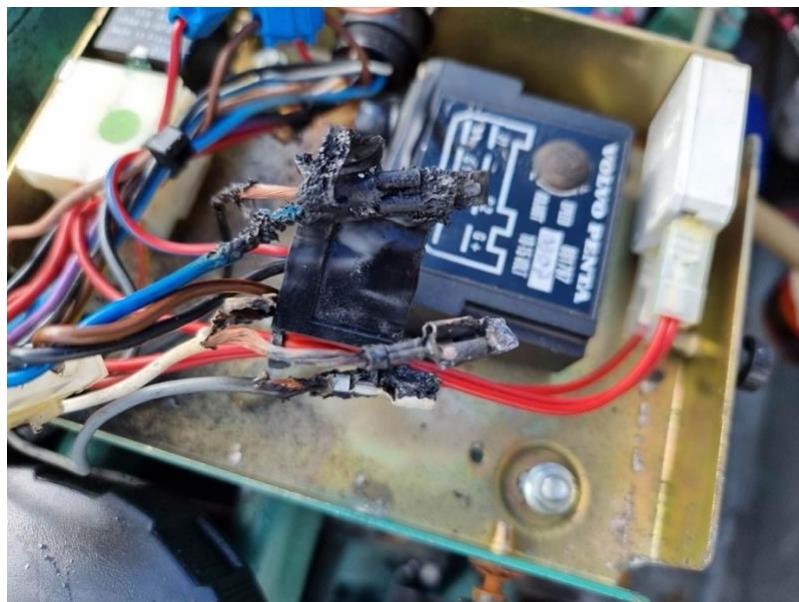
Picture below shows a wiring loom damaged by a faulty clutch coil.  
This caused considerable damage.

Treat any burning smell seriously and isolate power immediately.

Replacement wiring harness from Volvo: Part No: 3581477. £404.40

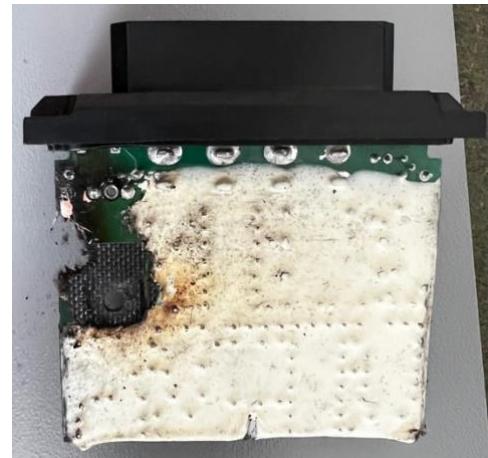
Unfortunately for this owner the speed relay was beyond repair. The heat had damaged 6 components, and the main board had started to disintegrate.

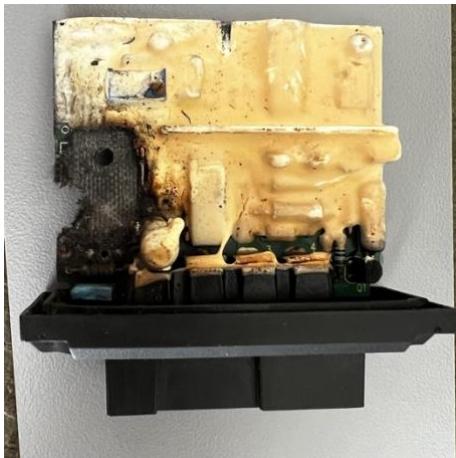
A different board and a successful repair.

This board had heat damage, but no track damage. Whilst cosmetically it does not look perfect, it is a good repair with a new transistor riveted in place.

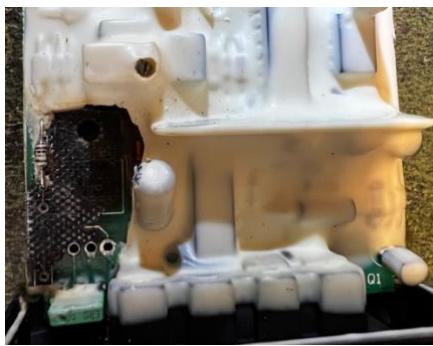
Another board with track and component damage.

Successfully repaired with the repair covered in a conformal coating to protect it from moisture and corrosion.
