Grid Relay Fault

FAQ\Hybrid INV

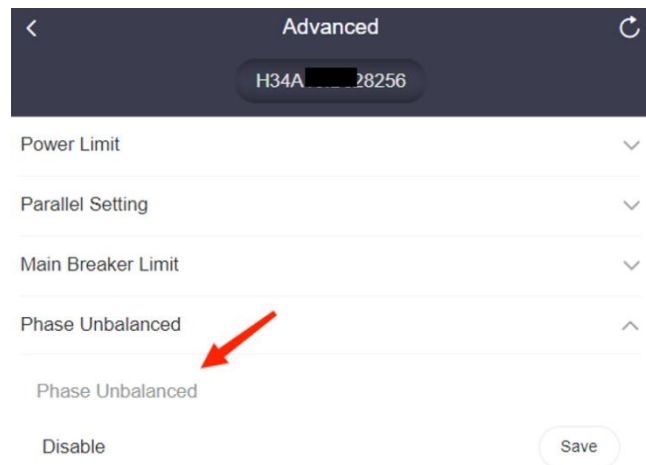
Step 1: Disable the three-phase unbalance function and restart the inverter.

Settings path: *Setting→Advanced Setting→Phase Unbalanced*

If the error disappears after disabling the function, check whether the neutral line is conductive with the grid.

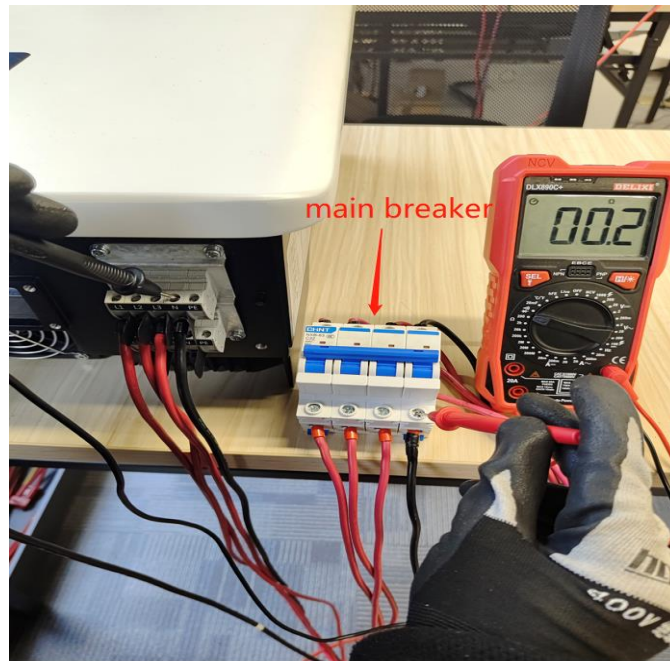
Step 2: Check whether the neutral line is correctly connected. Set the multimeter to resistance mode and measure the resistance of the neutral line from the circuit breaker to the inverter grid port.

- If the measured result is close to 0, it indicates that the neutral line between the inverter and the grid is conductive.
- If the measured value exceeds the range, carefully check whether the neutral line is properly connected.

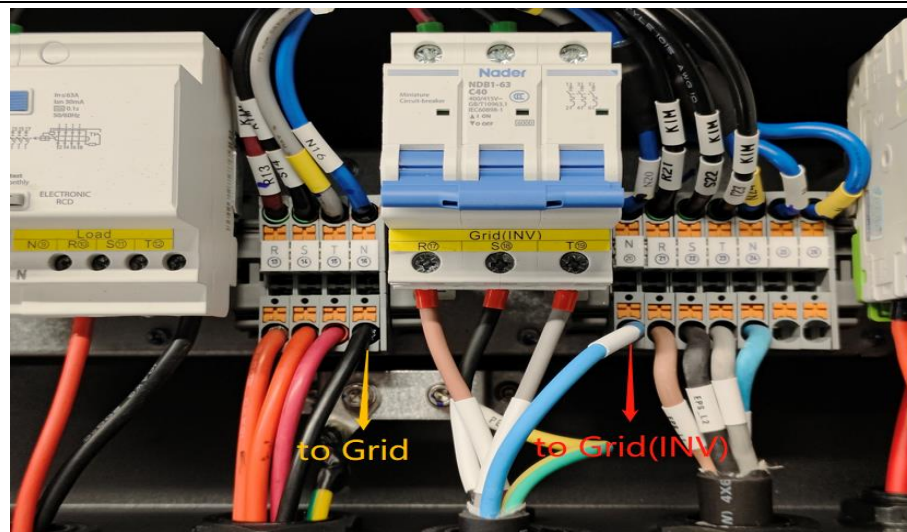
Matebox
basic

Step 3: If the MateBox is used, check whether the neutral line is connected correctly.

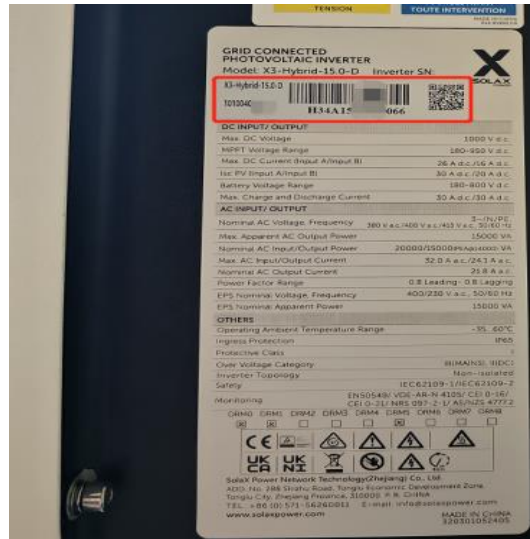
1. [Photo]SN numbers of the inverter.

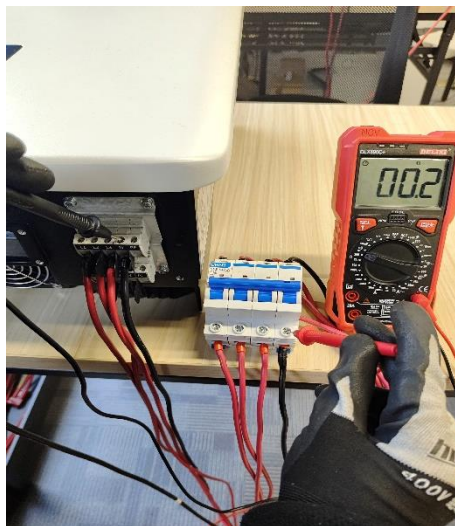
2.[Photo] The measurement result of whether the neutral line is conductive.
