Failed to connect to the network using the 4G V3.0 dongle

FAQ\Network Communication

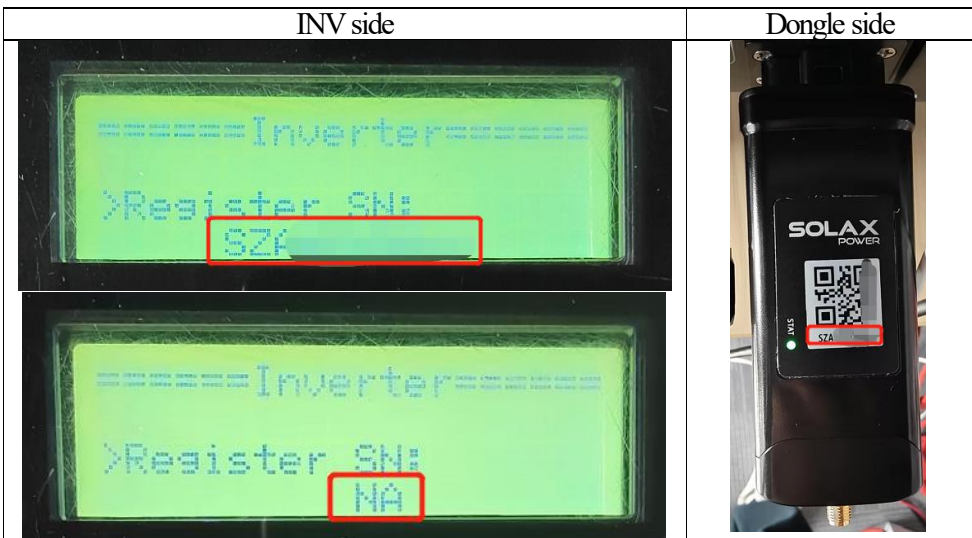
[Photo]SN number of the inverter and pocket.

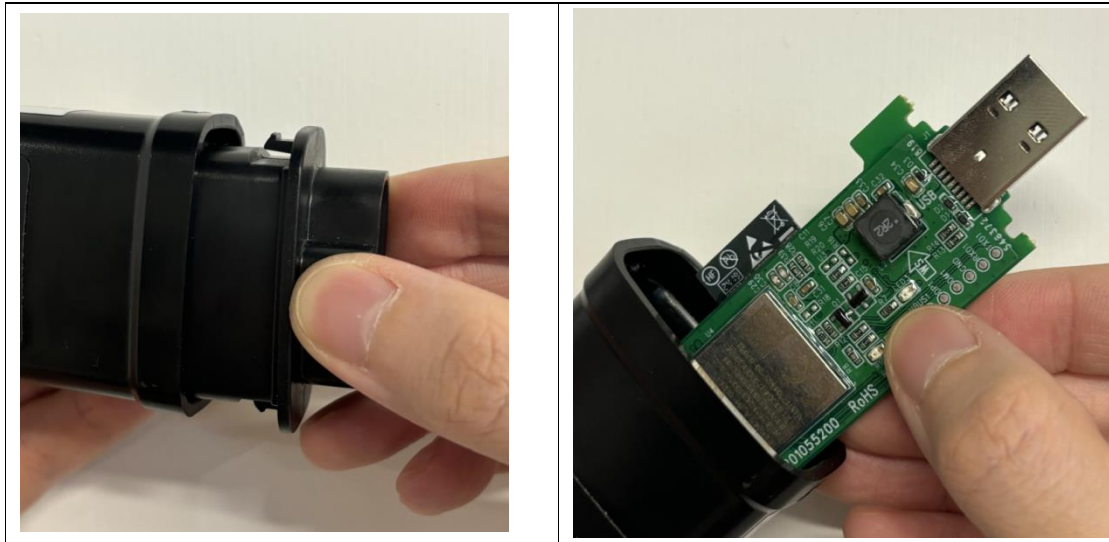
If “NA” is still displayed, Remove the internal components of the pocket and verify whether the pocket is damaged. First, locate the recessed clips on both sides of the pocket.

Use a flat-head screwdriver to find a downward-slanting angle, insert it into the slot, and gently pry downward.

Continue until the screwdriver is positioned as shown in the image, perpendicular to the side of the pocket.

Do the same on the other side, then remove the front cover and take out the internal components.
(There may be communication cables adhered inside; as shown in the image, removing half of them is sufficient.)

Reinsert the inverter and check if it successfully connects to the network. If not, replace the pocket. If the connection is successful, return to Step 1 and reinsert the pocket to ensure it is securely connected. When restoring the pocket, make sure the USB is inserted into the position shown in the image, and the side of the top cover with the hole should face the same direction as the side with the QR code.

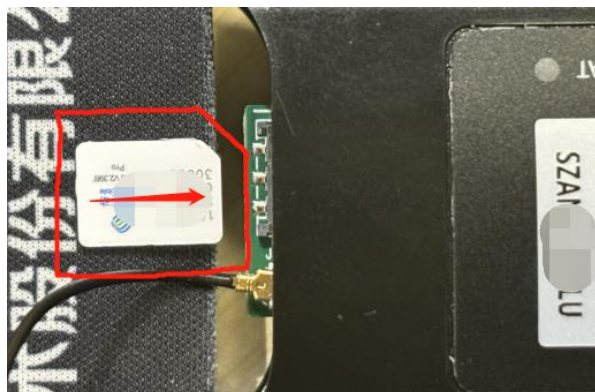
Step2: Use a Phillips screwdriver to unscrew the screws at the bottom and open the back cover.

Reinsert the IoT SIM card. When the dongle's QR code is facing up, the notch on the card should be at the top right of the card slot.
