## STM32H745xI/G, STM32H755xI, STM32H747xI/G, STM32H757xI device errata

This document applies to the part numbers of STM32H745xI/G, STM32H755xI, STM32H747xI/G, STM32H757xI devices and the device variants as stated in this page.

It gives a summary and a description of the device errata, with respect to the device datasheet and reference manual RM0399.

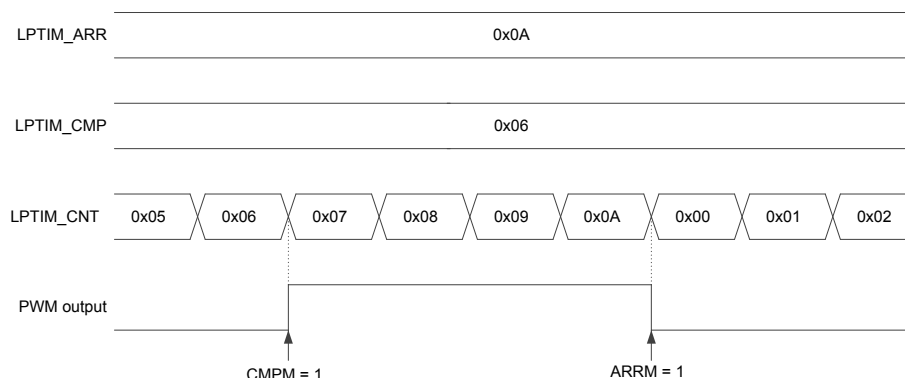
Figure 1. Example of PWM output mode

The following waveform gives the example of PWM output mode and the effect of the delay:

Set the compare value to the desired value minus 1. For instance in order to generate a compare match when LPTM\_CNT = 0x08, set the compare value to 0x07.
