TECHNICAL BULLETIN

JTB00389NAS1
04 DEC 2014

'Squeal' Noise From Rear Brakes - 380mm Brake Discs

F-TYPE (X152)

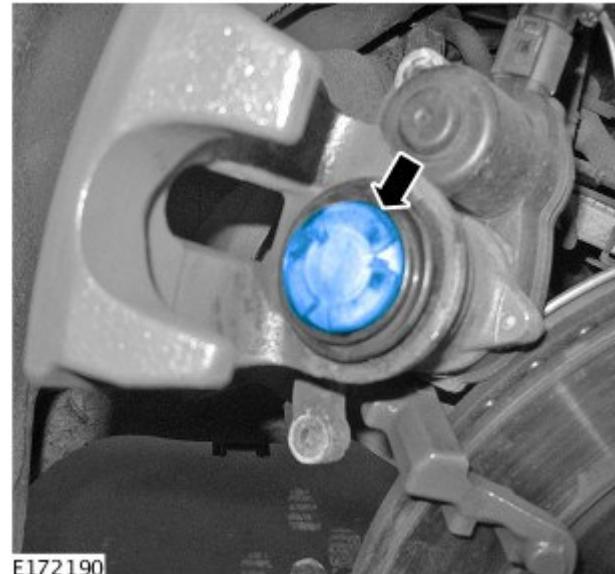
E172184

Situation: A 'squeal' noise from the rear brakes may be evident at slow speed as the vehicle is coming to a stop.

Cause: This may be caused by noise generated from the contact points of the brake caliper and pads.

NOTE: Do not apply excessive amounts of grease to the areas shown.

Using a suitable brake cleaner, clean the rear surface of the brake pads and apply the supplied grease to the areas shown.

3. Using a suitable brake cleaner, clean the brake caliper piston and apply the supplied grease in the area shown.

4. Using a suitable brake cleaner, clean the brake caliper carrier and apply the supplied grease to the areas shown.
