INFORMATION AND ENTERTAINMENT SYSTEM - GENERAL INFORMATION

INCONTROL TOUCH SOFTWARE UPDATE (G2003319)

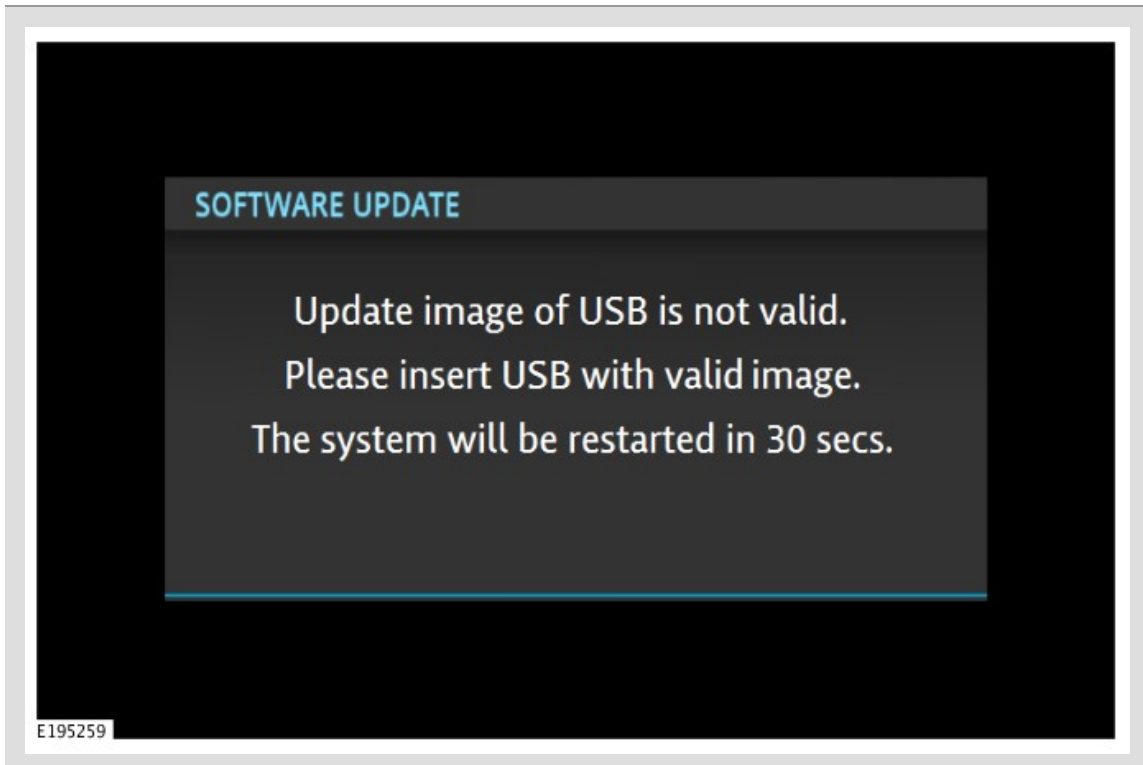
3.

Update image of USB flash drive is not valid. Please insert USB flash drive with valid image. The system will be restarted in 30 seconds.

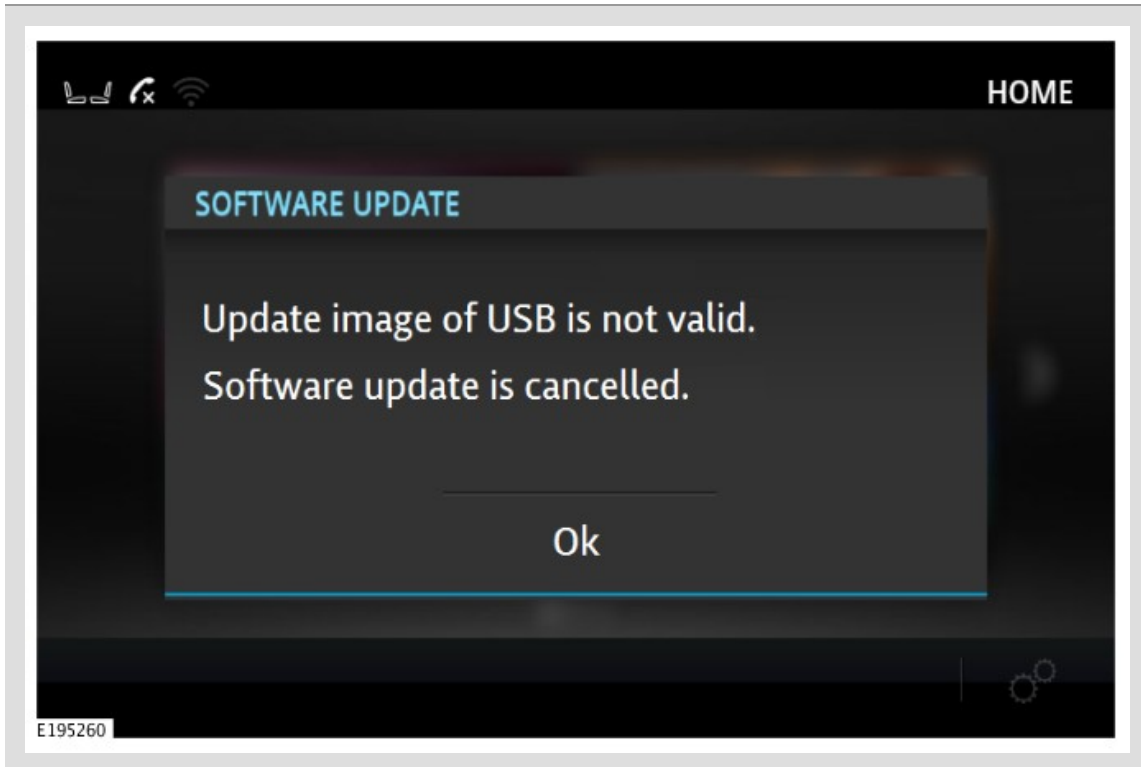
4.

Update image of USB flash drive is not valid. Software update is cancelled.

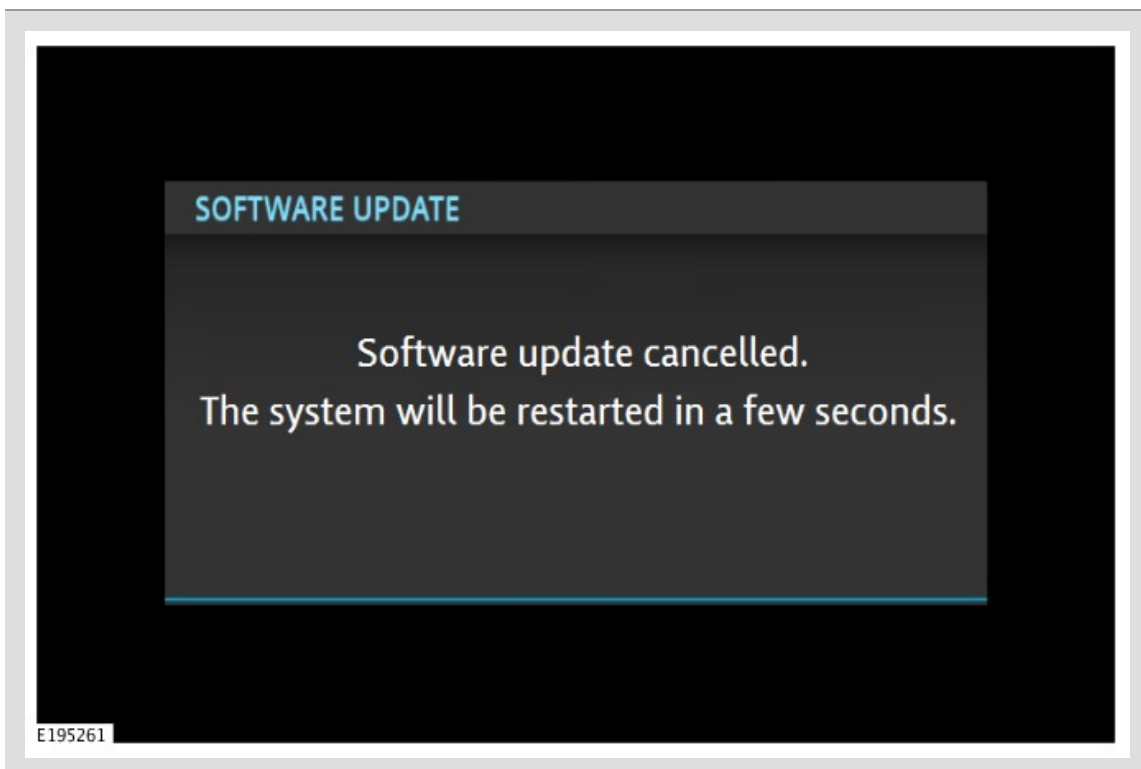
5.

Software update cancelled. The system will be restarted in a few seconds.

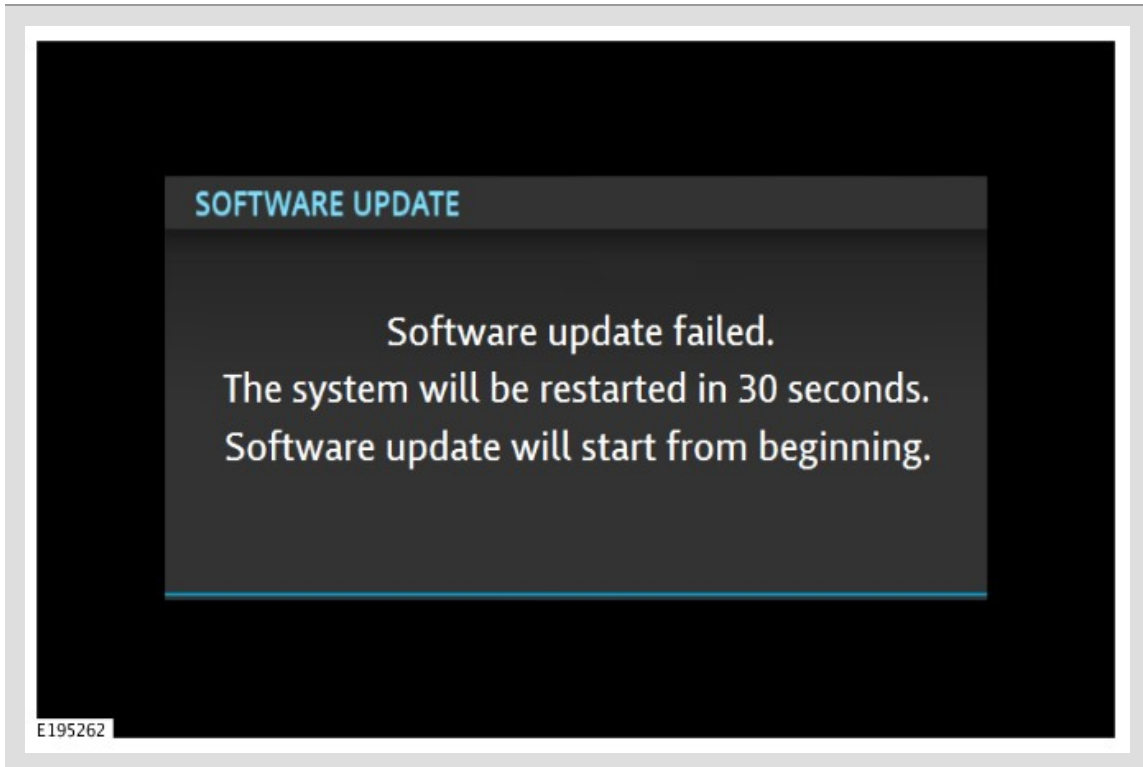
6.

Software update failed. The system will be restarted in 30 seconds. Software update will start from the beginning.
