# MRT AU9-AIS / AU10 RTCM 11901.1:2012 Test Report

## Annex E - AIS Type MSLD System E.8 Link layer tests

Product:	MRT AU9-AIS / AU10 dual-band personal Man Overboard (MOB) Alerting Unit (AU)
Manufacturer:	Marine Rescue Technology Marshall House Zarya Court, Grovehill Road Beverley, East Yorkshire HU17 0JG
Serial Number(s):	972418880, 972412430
Date tested:	21 February 2014
Standards Tested to:	RTCM Standard 11901.1:2012 "For Maritime Survivor Locating Devices (MSLD)" – Annex E : "AIS Type MSLD System"
Summary:	The sample tested met the requirements after software modification.
Tested by:	M.Swale
Report Author:	T.P.Jarvis

Project: MT251-RP2

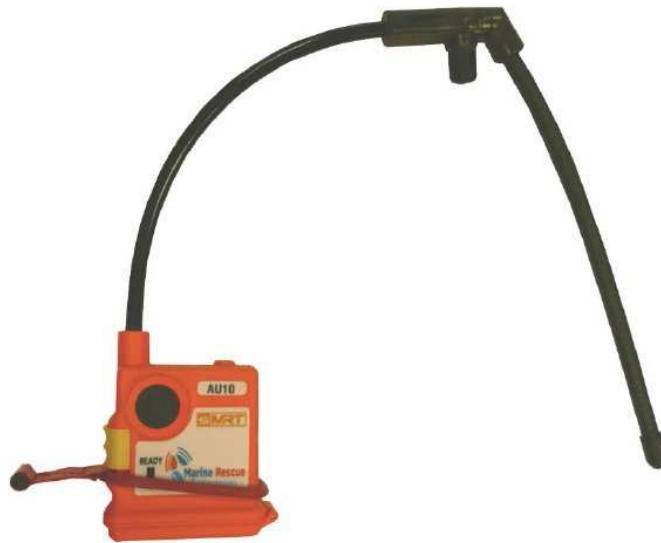
### **MRT AU9-AIS / AU10**

The AU10 (formerly known as the AU9-AIS) is a dual-operation personal MOB Alerting Unit (AU) transmitting on 121.5 MHz SAR frequency, whilst simultaneously sending GPS position information on maritime AIS channels AIS1 & AIS2.

- (i) Ports: (1) Antenna cable (260+260mm).
- (ii) EUT Software version: V2.10-RTCM
