Effects of Atmospheric Ozone on Microarray Data Quality

A data anomaly was observed that affected the uniformity and reproducibility of fluorescent signal across DNA microarrays. Results from experimental sets designed to identify potential causes (from microarray production to array scanning) indicated that the anomaly was linked to a batch process; further work allowed us to localize the effect to the posthybridization array stringency washes. Ozone levels were monitored and highly correlated with the batch effect. Controlled exposures of microarrays to ozone confirmed this factor as the root cause, and we present data that show susceptibility of a class of cyanine dyes (e.g., Cy5, Alexa 647) to ozone levels as low as 5-10ppb for periods as short as 10-30 s. Other cyanine dyes (e.g., Cy3, Alexa 555) were not significantly affected until higher ozone levels (>100 ppb). To address this environmental effect, laboratory ozone levels should be kept below 2 ppb (e.g., with filters in HVAC) to achieve high quality microarray data.

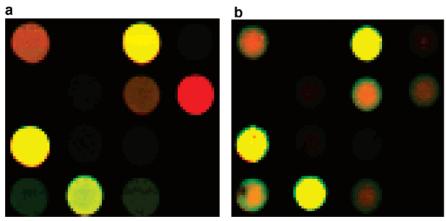
Reports in the literature have noted seasonal effects on microarray data quality. The intermittent nature of these effects makes tracking down the root cause difficult and time-consuming. During a series of experiments, we observed that fluorescent signal intensity decreased and a ratio reproducibility parameter (defined in Methods Section below) consistently failed its passing threshold value. Closer examination of the arrays showed two effects: First, there was an array-wide gradient for signal intensity and ratios. Second, individual features had reduced Cy5 signal intensity relative to Cy3 intensity with a spatial intensity profile characteristic of the anomaly (see comparison in Figure 1 of spots with expected morphology versus spots that display the anomaly, namely, a green ring and inscribed red circle).

Figure 1. (a) Image of a microarray section displaying high-quality features and (b) the same section of a different microarray with the intraspot anomaly that occurs with the ratio reproducibility failure.

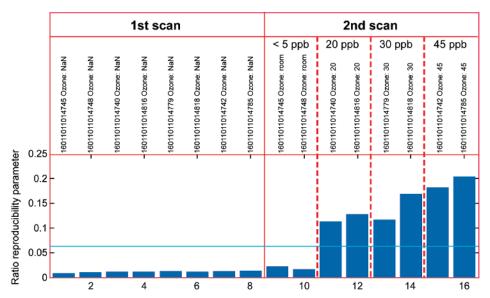
Exposure of Artifact-Free Microarrays to Ozone during the Washing and Drying Steps. Ratio reproducibility data for exposure of eight arrays to ozone that had previously passed the ratio reproducibility metric are shown in Figure 2. Data in the left panel (first scan) show that these arrays passed the metric immediately prior to exposure (within the hour). Arrays were then washed in the ozone chamber, two at a time, then dried in the chamber. Different array sets were exposed to a range of ozone concentrations for \sim 60 s. In the right panel, we show that the ratio reproducibility metric increases on array pairs after exposure and the metric worsens at higher ozone exposure level. At a 20 ppb exposure for 1 min, the arrays have already crossed the metric failing threshold (indicated by the blue line in the plot). Rewash controls run at very low ozone (<5ppb) show that simply rewashing the slides does not significantly contribute to the observed effect (see arrays 9 and 10 in Figure 2).

Figure 2. Results from array ozone exposure during wash steps. A larger value in the Y axis indicates worse ratio reproducibility. Total time of ozone exposure for a given pair was 1 min. Data in the left panel are for arrays that had previously passed and were rescanned just prior to exposure; the right panel shows results from the same arrays after exposure to indicated ozone levels (note barcodes). The horizontal blue line is the pass/fail quality threshold.

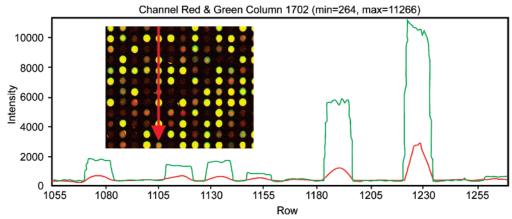
In addition, this ozone exposure induced the intraspot anomaly characteristic of this effect (see Figure 3, taken from slide 16011011014779 in Figure 2). The inset image (Agilent Technologies, Image Analysis Version A.4.0.34, Palo Alto, CA) shows a section of an ozone-exposed array containing the anomaly. We show a plot of Cy5 (red) and Cy3 (green) signal intensity traced through the spots designated by the red arrow. We noted that a given spot has relatively uniform green intensity, whereas the overall red intensity has decreased (relative to its initial value),

Figure 3. Image (inset) and fluorescence intensity trace through spots (slide 16011011014779 in Figure 2) designated by red arrow shows the induced ozone effect is identical to the data anomaly in failed arrays.

with a peak in the center of the spot, and symmetrically tails off toward the spot edge. The combination of uniform green intensity with the profile of the red intensity creates the characteristic appearance for the defect.

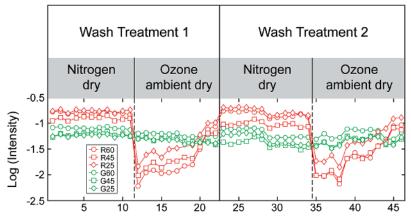
Modification of Wash Procedure to Assess Effect of Ozone during Drying. In Figure 4, we show results from tests to determine whether ozone induces this effect either during washing or during drying. In this experiment, 48 arrays were all hybridized simultaneously, then split into two groups of 24, each group to be washed by two separate treatments. Within each group, onehalf of the arrays were immediately set in the nitrogen purge box after being removed from the second wash buffer, while the remaining arrays were left open to dry in the environment. In wash treatment 1, 24 arrays were transferred between hybridization and wash buffers under water but in an overpressure of 12.5 (\pm 2.5) ppb ozone, then dried under either nitrogen or 12.5 (\pm 2.5) ppb ozone. In wash treatment 2, 24 arrays were transferred between hybridization and wash buffers through the 12.5 (± 2.5) ppb ozone overpressure, then dried under either nitrogen or 12.5 (± 2.5) ppb ozone. As can be seen in the figure, the condition that

induced the effect was the drying condition. Hence, we can discount ozone absorbed into the wash solutions and ozone exposure during transfer to wash as contributing to the effect; furthermore, we speculate that as long as water could provide a diffusion barrier to ozone during the drying step, the dyes would be protected.

Figure 4. Comparison of the log intensity of two wash treatments (see text for details) under two drying conditions: dry nitrogen and 10–15 ppb ozone. For the two drying conditions on the left, arrays were transferred under buffers throughout processing to avoid ozone exposure. For the two drying conditions on the right, arrays were washed with normal (air) transfer from hybridization buffer to wash buffer 1 to wash buffer 2. Arrays in the figure are presented in order of processing (within treatment). Total time of exposure from first to last array within treatment was ~30 min; note that the lowest intensities are observed for those arrays that have been exposed to ozone the longest. R60, R45, and R25 are defined as the Cy5 intensity of the 60-mer, 45-mer, and 25-mer probes.

To reduce effects of ozone on microarray data, we recommend several effective actions: first, when possible, microarray work should be performed in a laboratory with an HVAC system outfitted with filters that significantly reduce ozone (≤2 ppb) and second, arrays should be stored in a positive-pressure nitrogen box after washing. By implementing both of these changes, we were able to completely eliminate the occurrence of the ozone effects on our microarray data. Alternatively, a dye-protecting solution available from Agilent Technologies has been demonstrated to prevent both the Cy5 signal degradation and the associated loss of data quality at elevated ozone concentrations.⁷ We were able to rule out other contributors to ozone generation, such as internal instruments and the HVAC system itself; however, electrical motors can create substantial ozone within a confined area and should be kept out of microarray laboratories. Further investigation into environmental effects during processing with other microarray platforms is recommended.
