Test Report	Document No.	TA0016
	Issue	01.00
Approved:	Date Last Amended	7/11/18
	Last Amended by	David Sheekey
Document Title	DSC Channel management to IEC62287-2

Test of the DSC channel management in accordance with Annex A of IEC 62287-2:2017.

Product: **ATB1**

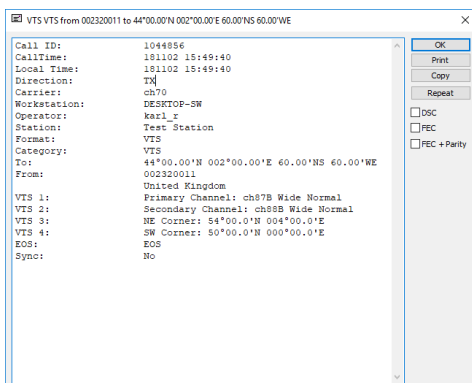
Table 1 ICS DSC Test Message 2

Cell ID: 1044856
CallTime: 181102 15:49:40
Local Time: 181102 15:49:40
Direction: TX
Carrier: ch70
Workstation: DESKTOP-SW
Operator: karl_r
Station: Test Station
Format: VTS
Category: VTS
To: 44°00.00'N 002°00.00'E 60.00'NS 60.00'WE
From: 002320011
United Kingdom
VTS 1: Primary Channel: ch87B Wide Normal
VTS 2: Secondary Channel: ch88B Wide Normal
VTS 3: NE Corner: 54°00.0'N 004°00.0'E
VTS 4: SW Corner: 50°00.0'N 000°00.0'E
EOS: EOS
Sync: No

The ICS DSC test station was configured to send test messages 2,3 and 4. Messages 2,3 and 4 were configured as follows receptivity:-

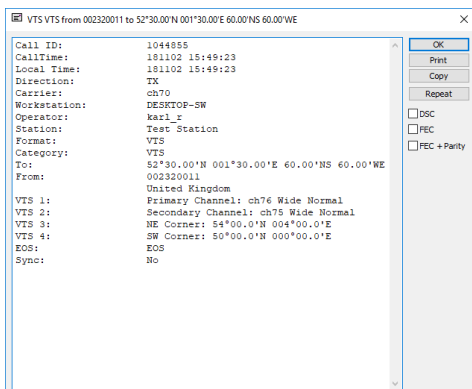
Table 2 ICS DSC Test Message 3

Cell ID: 1044855
CallTime: 181102 15:49:23
Local Time: 181102 15:49:23
Direction: TX
Carrier: ch70
Workstation: DESKTOP-SW
Operator: karl_r
Station: Test Station
Format: VTS
Category: VTS
To: 52°30.00'N 001°30.00'E 60.00'NS 60.00'WE
From: 002320011
United Kingdom
VTS 1: Primary Channel: ch76 Wide Normal
VTS 2: Secondary Channel: ch75 Wide Normal
VTS 3: NE Corner: 54°00.0'N 004°00.0'E
VTS 4: SW Corner: 50°00.0'N 000°00.0'E
EOS: EOS
Sync: No

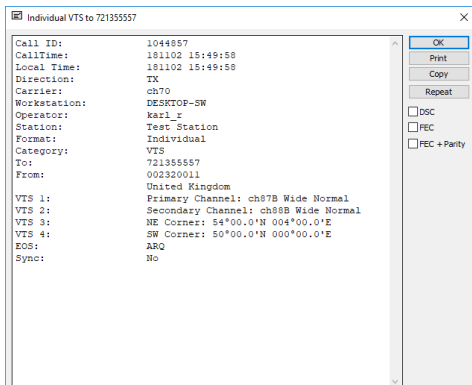
Table 3 ICS DSC Test Message 4

Cell ID: 1044857
CallTime: 181102 15:49:58
Local Time: 181102 15:49:58
Direction: TX
Carrier: ch70
Workstation: DESKTOP-SW
Operator: karl_r
Station: Test Station
Format: Individual
Category: VTS
To: 721355557
From: 002320011
United Kingdom
VTS 1: Primary Channel: ch87B Wide Normal
VTS 2: Secondary Channel: ch88B Wide Normal
VTS 3: NE Corner: 54°00.0'N 004°00.0'E
VTS 4: SW Corner: 50°00.0'N 000°00.0'E
EOS: ARQ
Sync: No
