## Flashing WG827

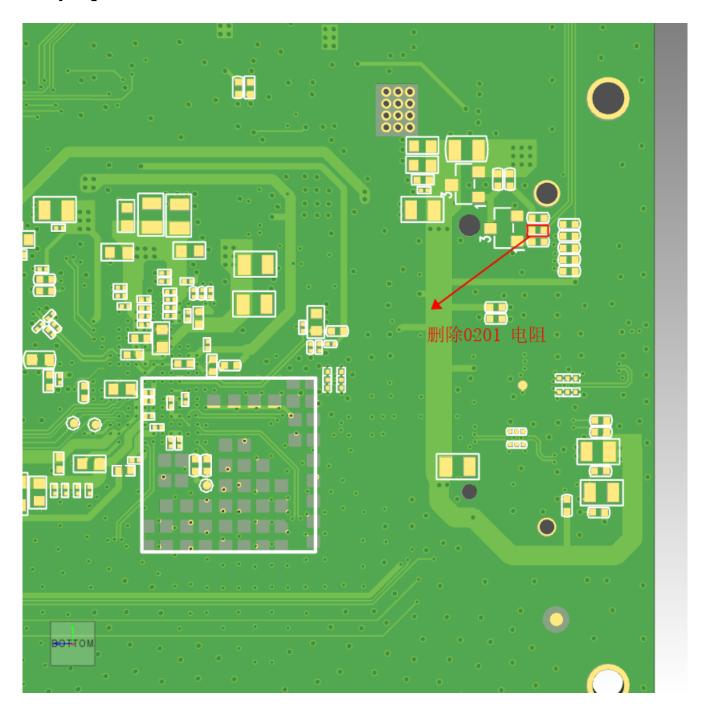
One jumper is on the top of the board and the other on the bottom.

The jumper to be added is on top of the board right bethind the power plug.

The power plug is in the lower right corner. Just bridge the 2 pads with solder.
