## COCKPIT WINDSHIELD - INSPECTION/CHECK

TASK 56-10-01-200-801-A

## 2. COCKPIT WINDSHIELD - INSPECTION/CHECK

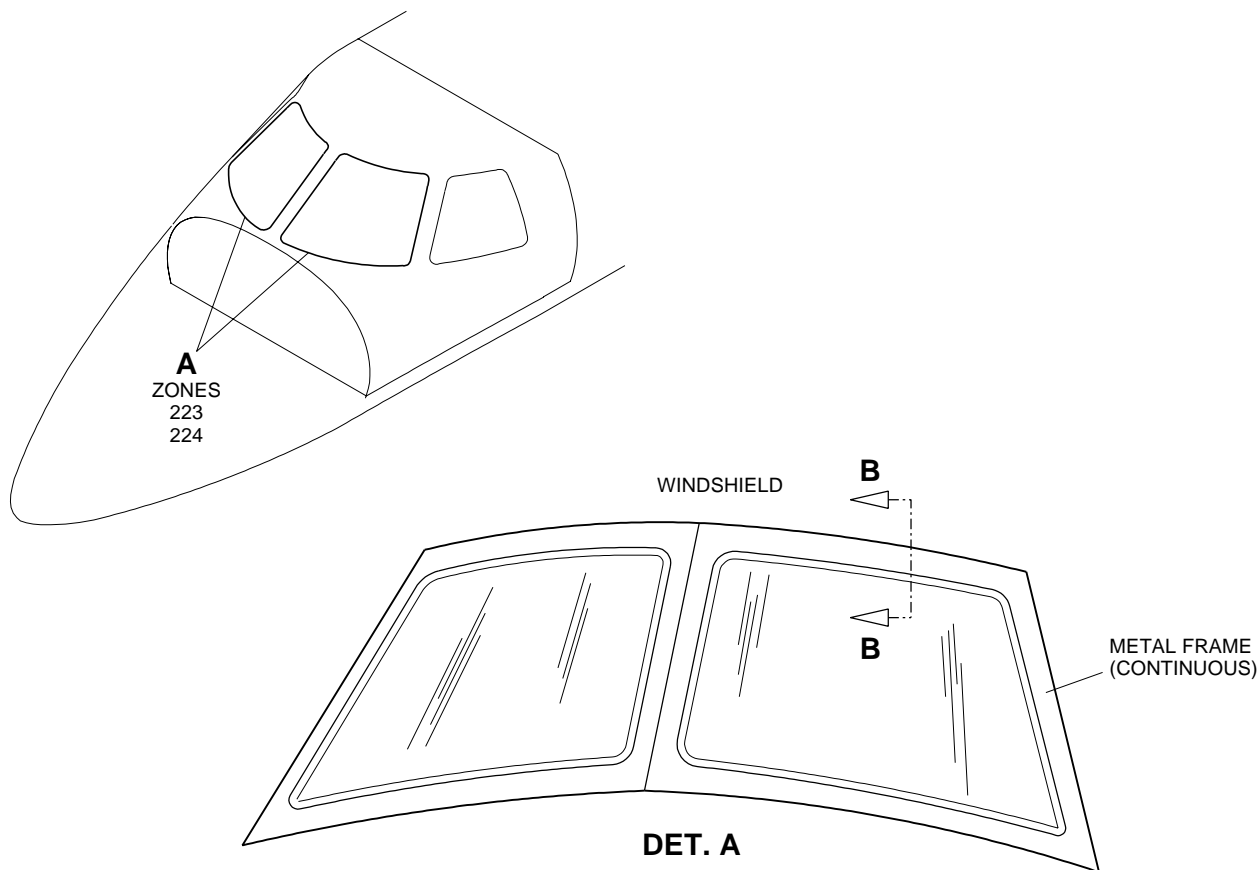
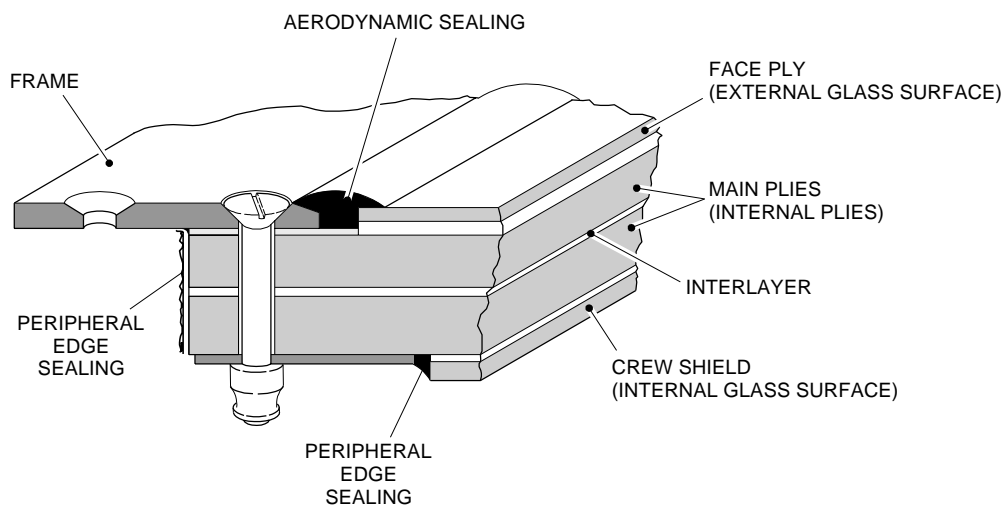
Figure 601

Cockpit Windshield - Inspection/Check

**SECTION B-B**

J. Inspection/Check ([Figure 601](#))

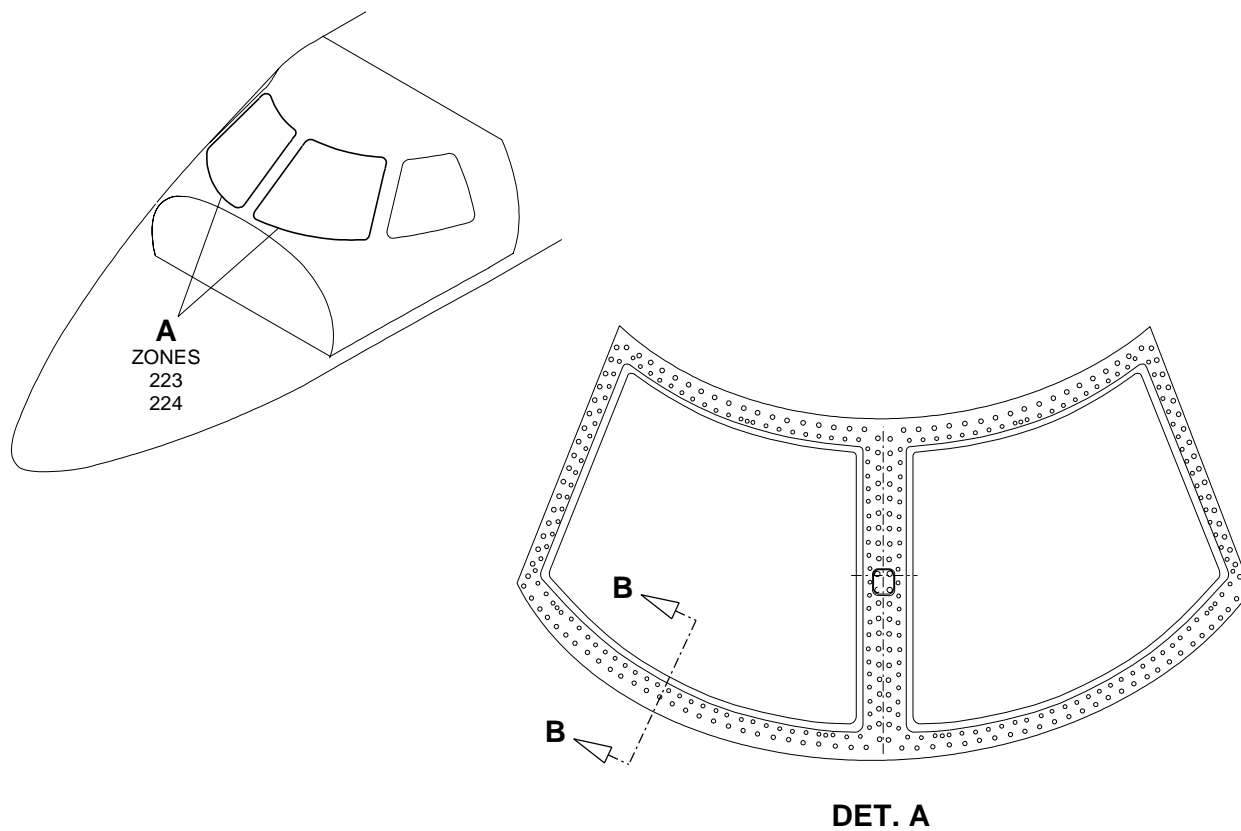
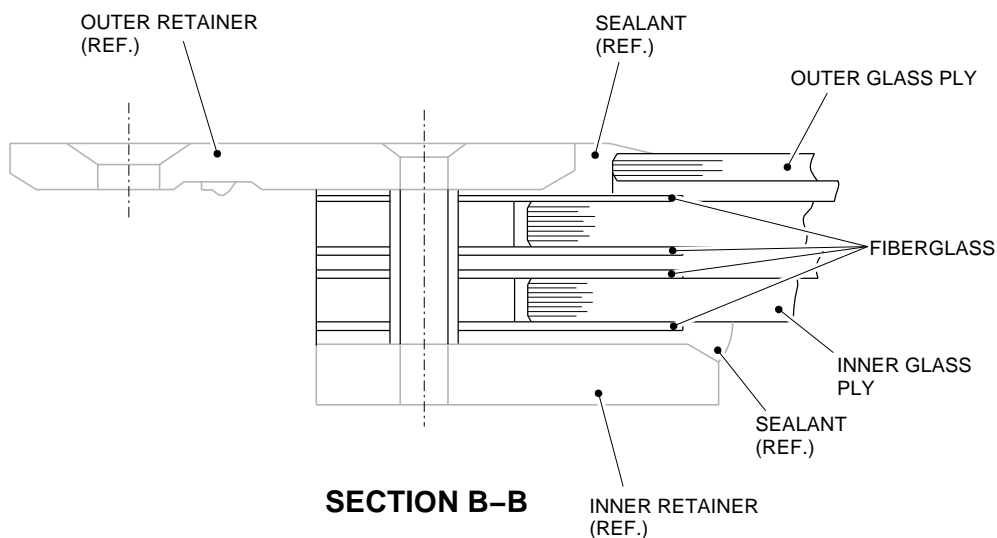
Figure 602

EFFECTIVITY: AIRCRAFT WITH PPG - MADE WINDSHIELD

Cockpit Windshield - Inspection/Check

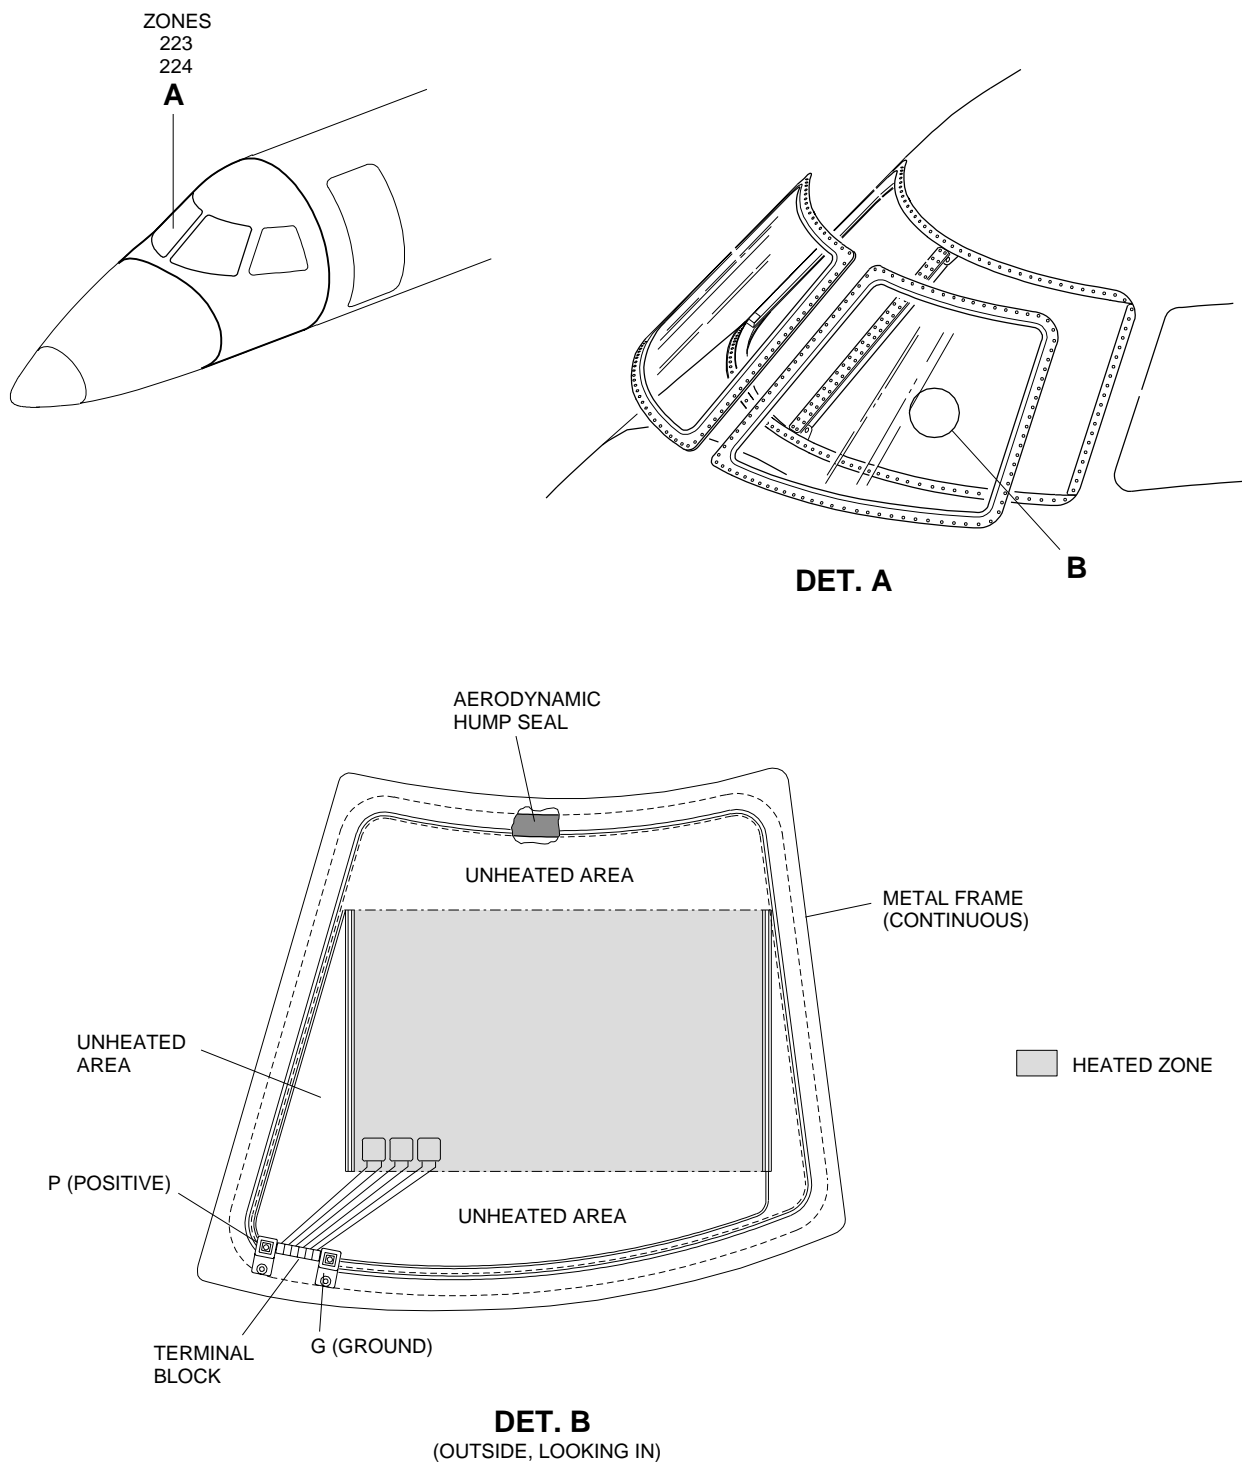
EFFECTIVITY: ALL  
Deicing Heated Zone  
Figure 603
