15049  
ORNL-TM-3027

DATE - June, 1970

SPRAY, MIST, BUBBLES, AND FOAM IN THE  
MOLTEN SALT REACTOR EXPERIMENT

J. R. Engel, P. N. Haubenreich, and A. Houtzeel

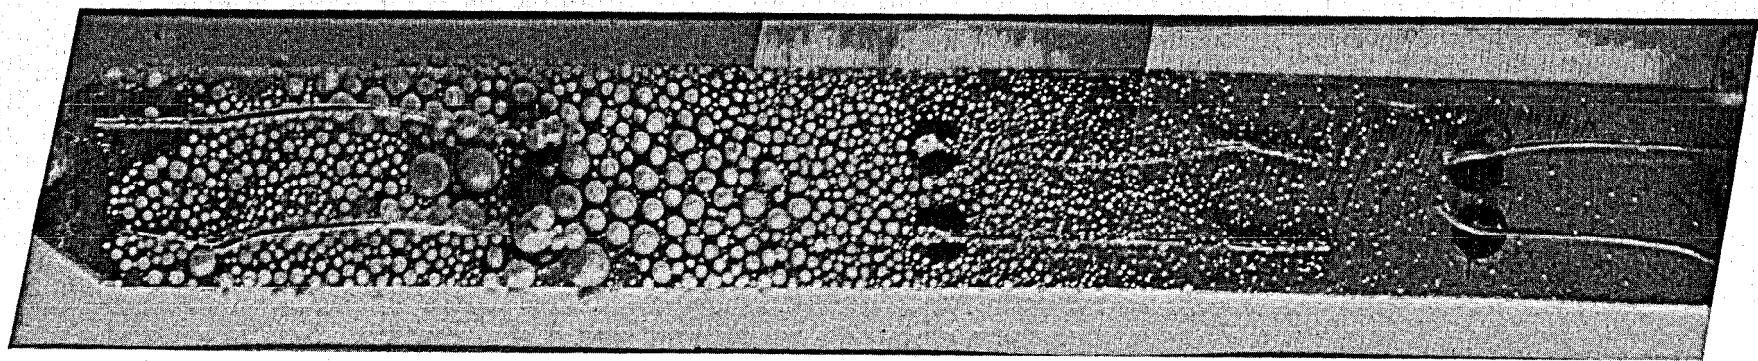
During operation of the fuel pump there is a mist, or suspension of molten-salt droplets, in the gas space of the pump bowl. There is much evidence for this, but none clearer than Fig. 4. This is a photograph of a 1/2-inch-wide strip of stainless steel that was exposed in the sampler cage for 12 hours. The 4-inch-long strip was positioned so that the lower end was at the salt pool surface (as indicated by the bubbler level elements). The upper end was near the penetration of the sampler tube into the top of the pump bowl. (See Fig. 1.) Although the size of the droplets and the amount of salt on the specimen in Fig. 4 are unusual (possibly because of the long exposure or the condition of the stainless steel surface), qualitatively similar deposition was observed on numerous other sample capsules and a set of graphite specimens<sup>3</sup> exposed in the gas space.

Fig. 4. Photograph of Salt Droplets on a Metal Strip Exposed in MSRE Pump Bowl  
Gas Space for 10 Hours

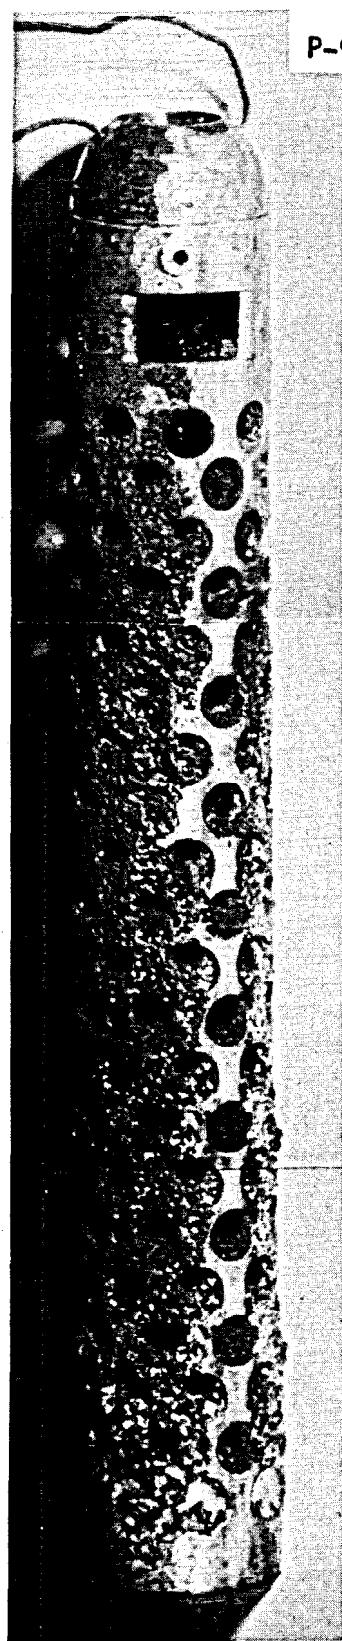
Fig. A-1. Nickel Cage from Second Beryllium Exposure in  $^{233}\text{U}$  Fuel Salt

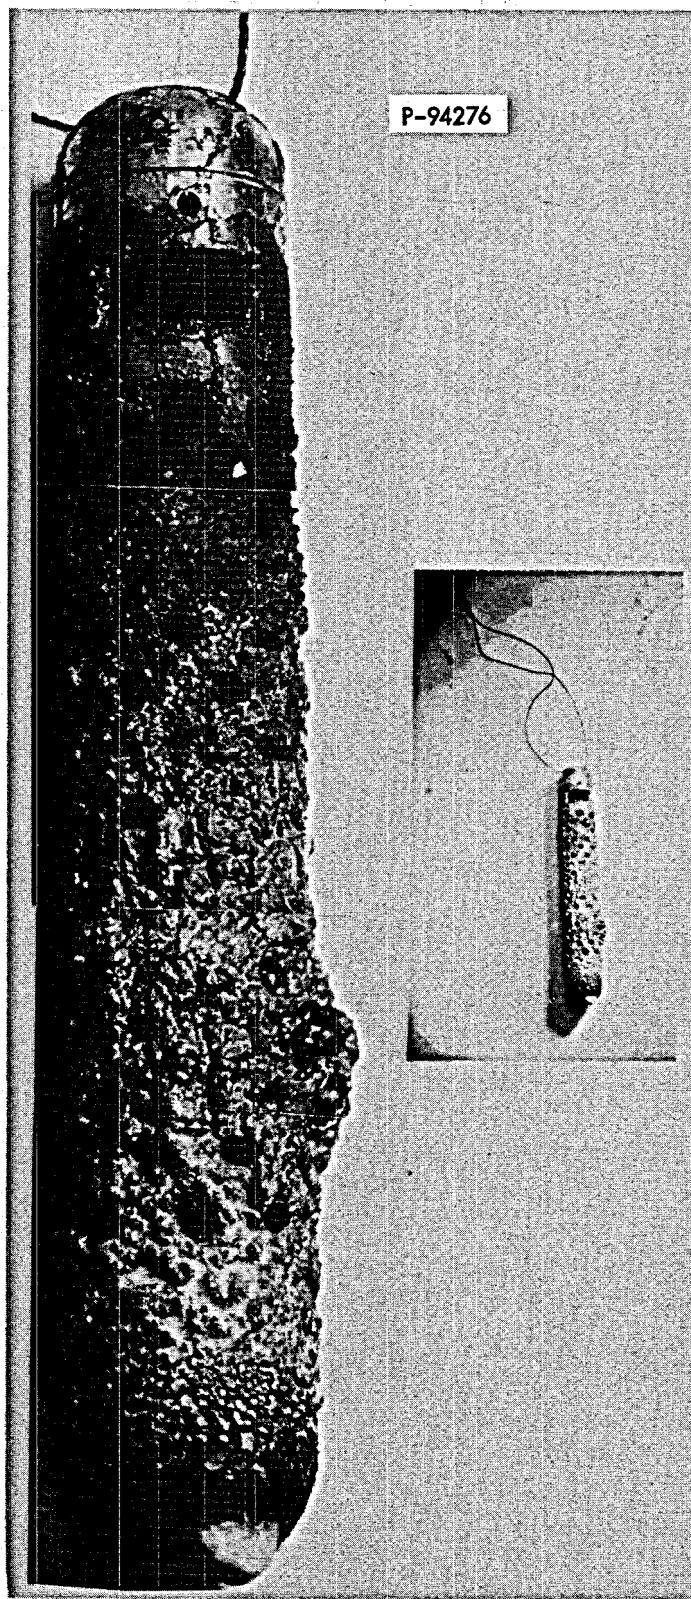
Fig. A-2. Nickel Cage from Fourth Beryllium Exposure in  $^{233}\text{U}$  Fuel Salt

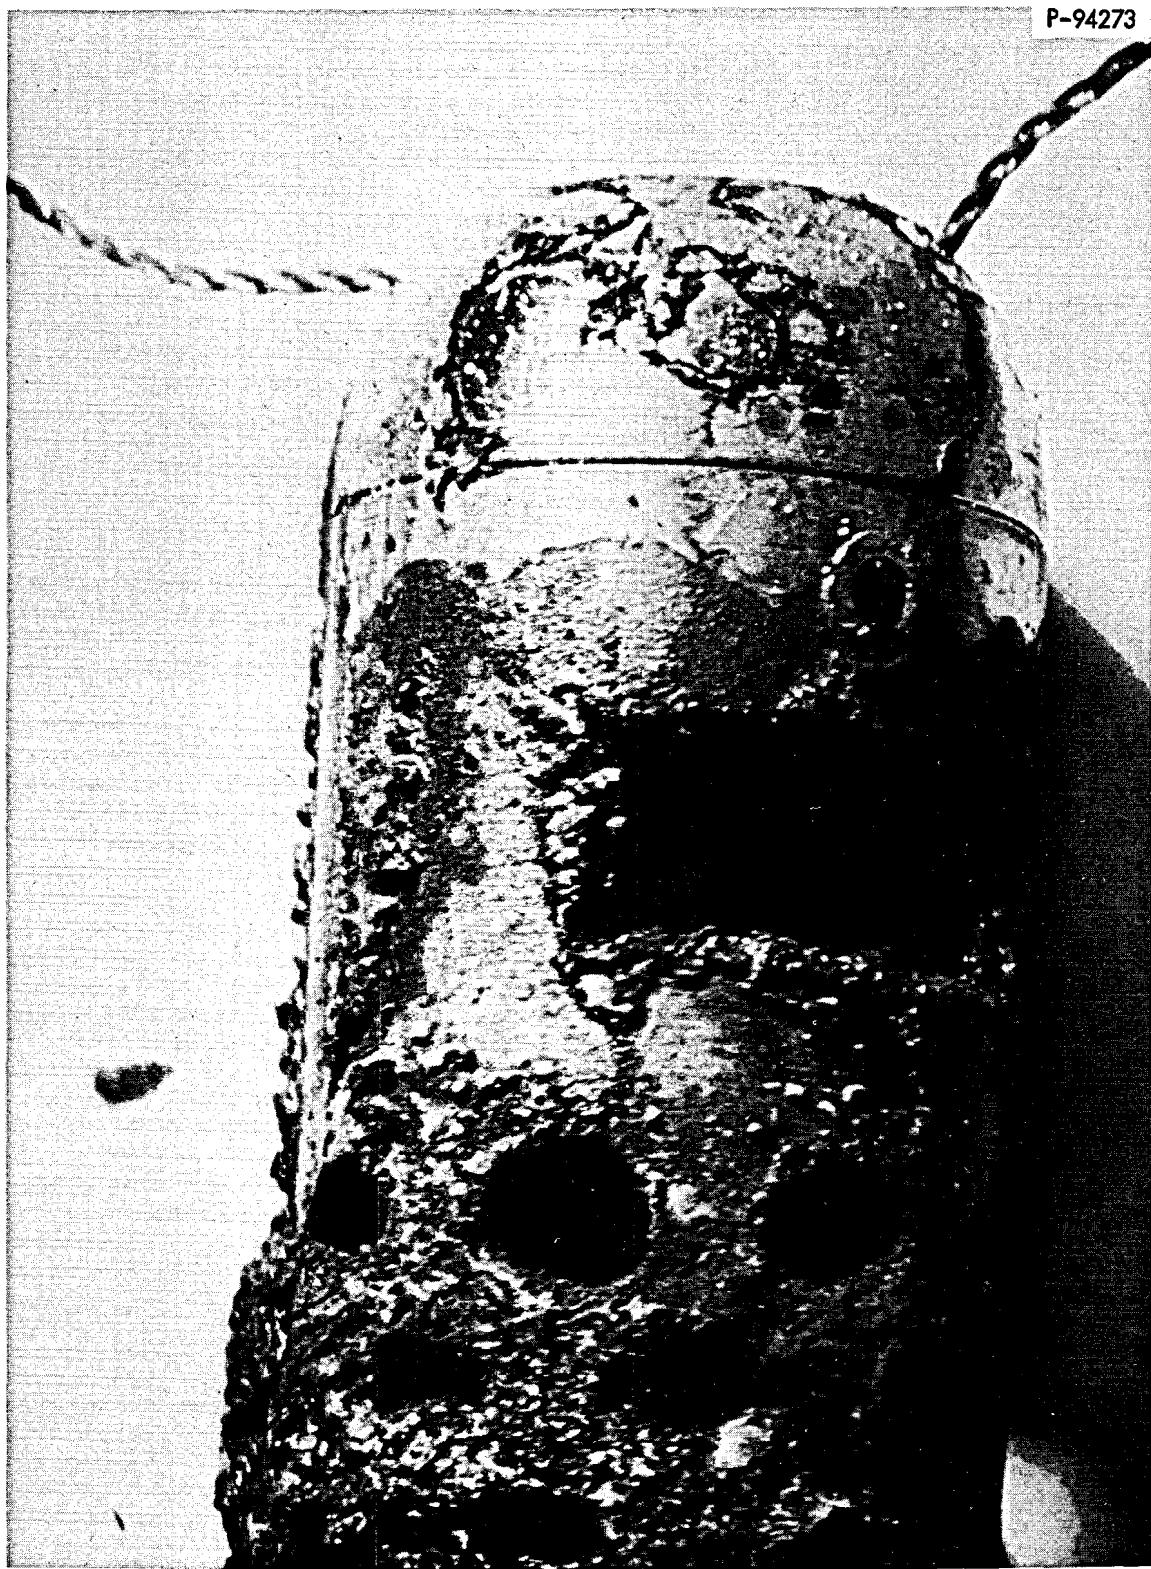
Fig. A-5. Top of Nickel Cage from Fourth Beryllium Exposure in  $^{233}\text{U}$  Fuel Salt

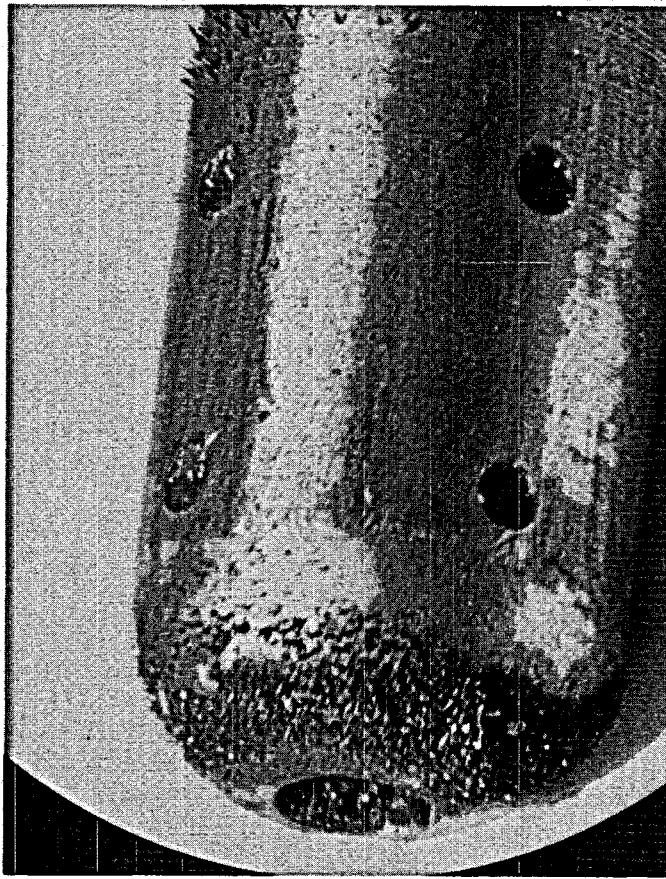
Fig. A-6. Metallic Particles on Copper Capsule Used to Expose a Magnet in  
 $^{233}\text{U}$  Fuel Salt

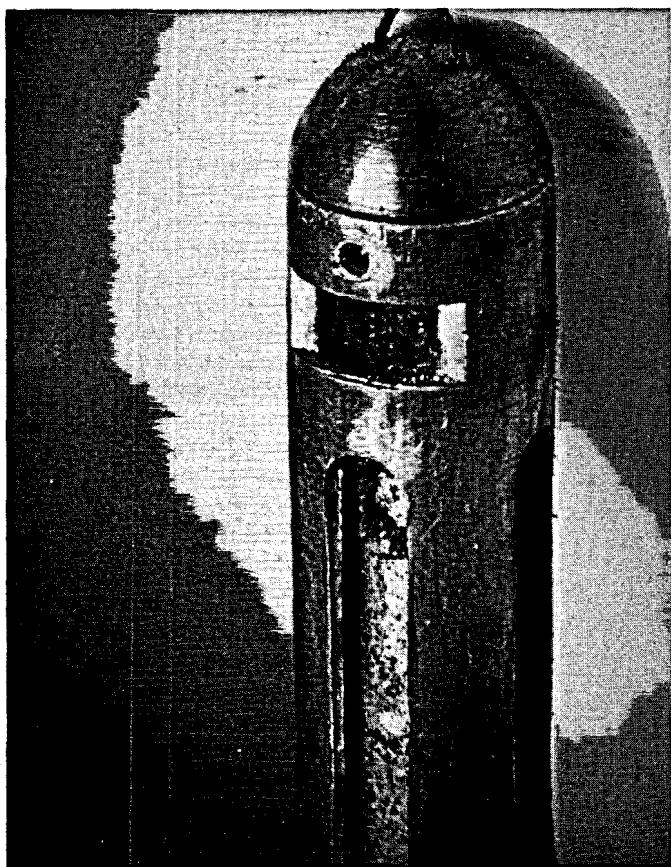
Fig. A-7. Upper End of Magnet Capsule

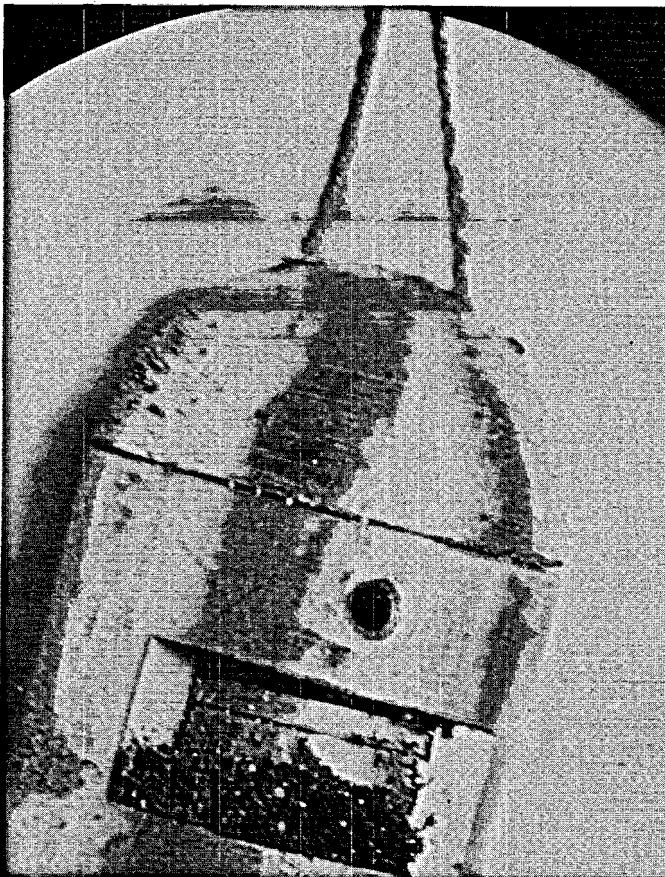
Fig. A-8. Upper End of Magnet Capsule Showing Collected Material

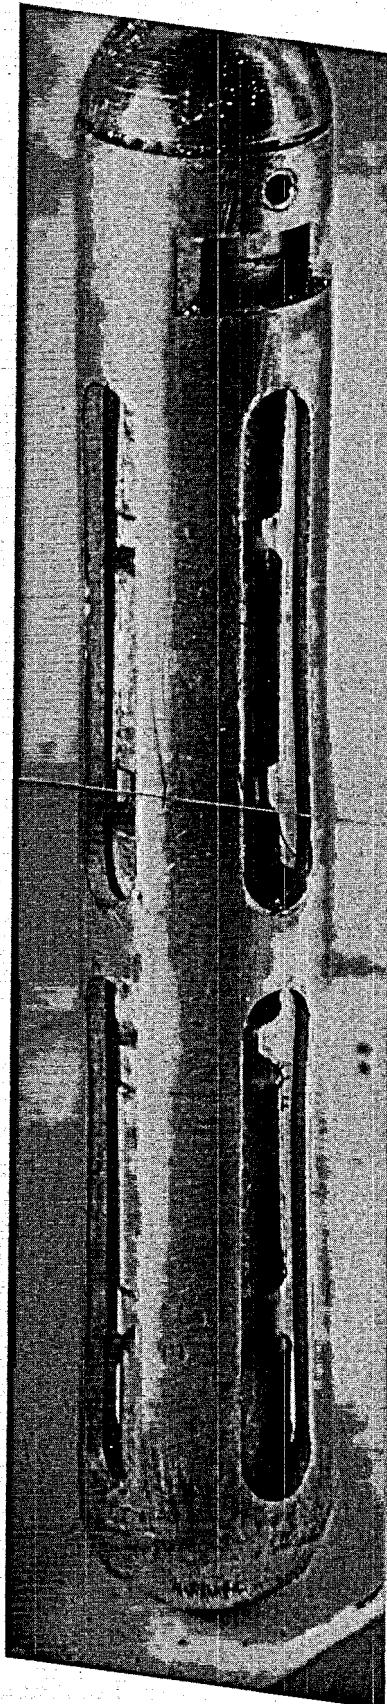
Fig. A-10. Capsule Containing Several Short Magnets

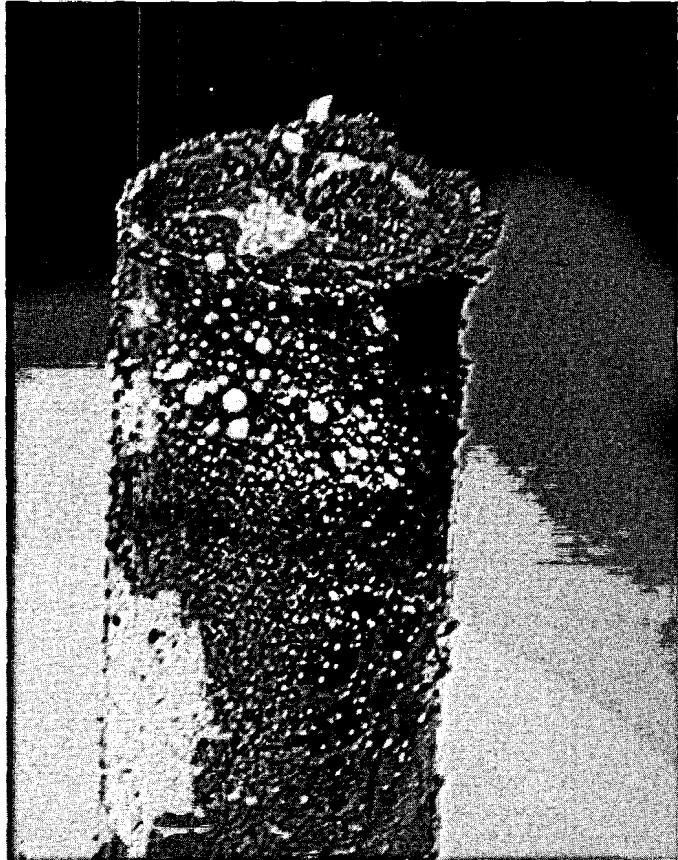
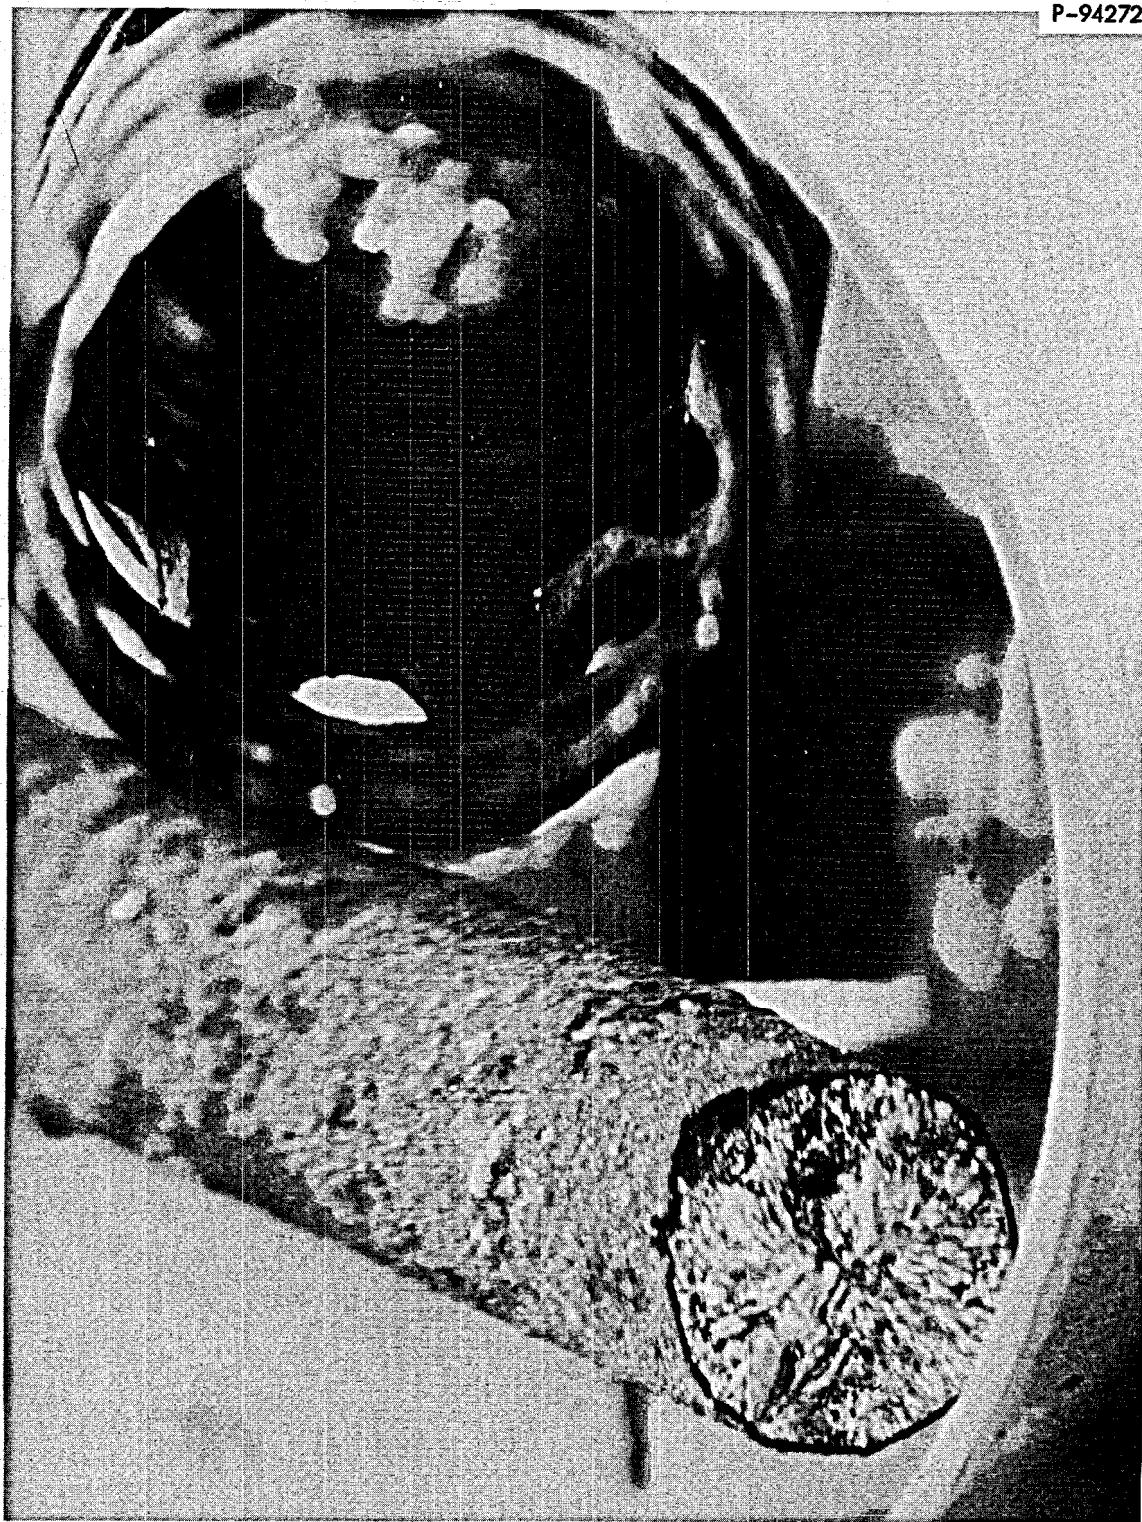
and A-12 show a chromium rod after about 6 hours' exposure to the salt. There was little attack on the Cr but both kinds of deposit, salt and crud, appeared. In this case, however, the salt appeared to be non-wetting. The fractured surface in Fig. A-12 (broken as part of the post-exposure examination) shows a black deposit on the lateral surfaces.

Fig. A-11. Chromium Rod Exposed to  $^{233}\text{U}$  Fuel Salt

Fig. A-12. Cross Section of Chromium Rod Showing Surface Deposit
