## MAIN WHEEL TIRE - INSPECTION/CHECK

## 2. MLG WHEEL TIRE - INSPECTION

- (1) This task gives the procedure to do an inspection on the tires of the Main Landing Gear (MLG). This inspection is a visual examination for wear, damage and general condition.
- (2) The procedure is the same for the tires of the left and the right MLG.
- (3) The [AMM TASK 32-49-04-200-801-A/600](#) gives the procedure to do an inspection on the tires of the NLG.
- (4) When replace a tire, before you disassemble the wheel assembly, make a mark with chalk on the damaged area (protrusion, blister, tear, etc).

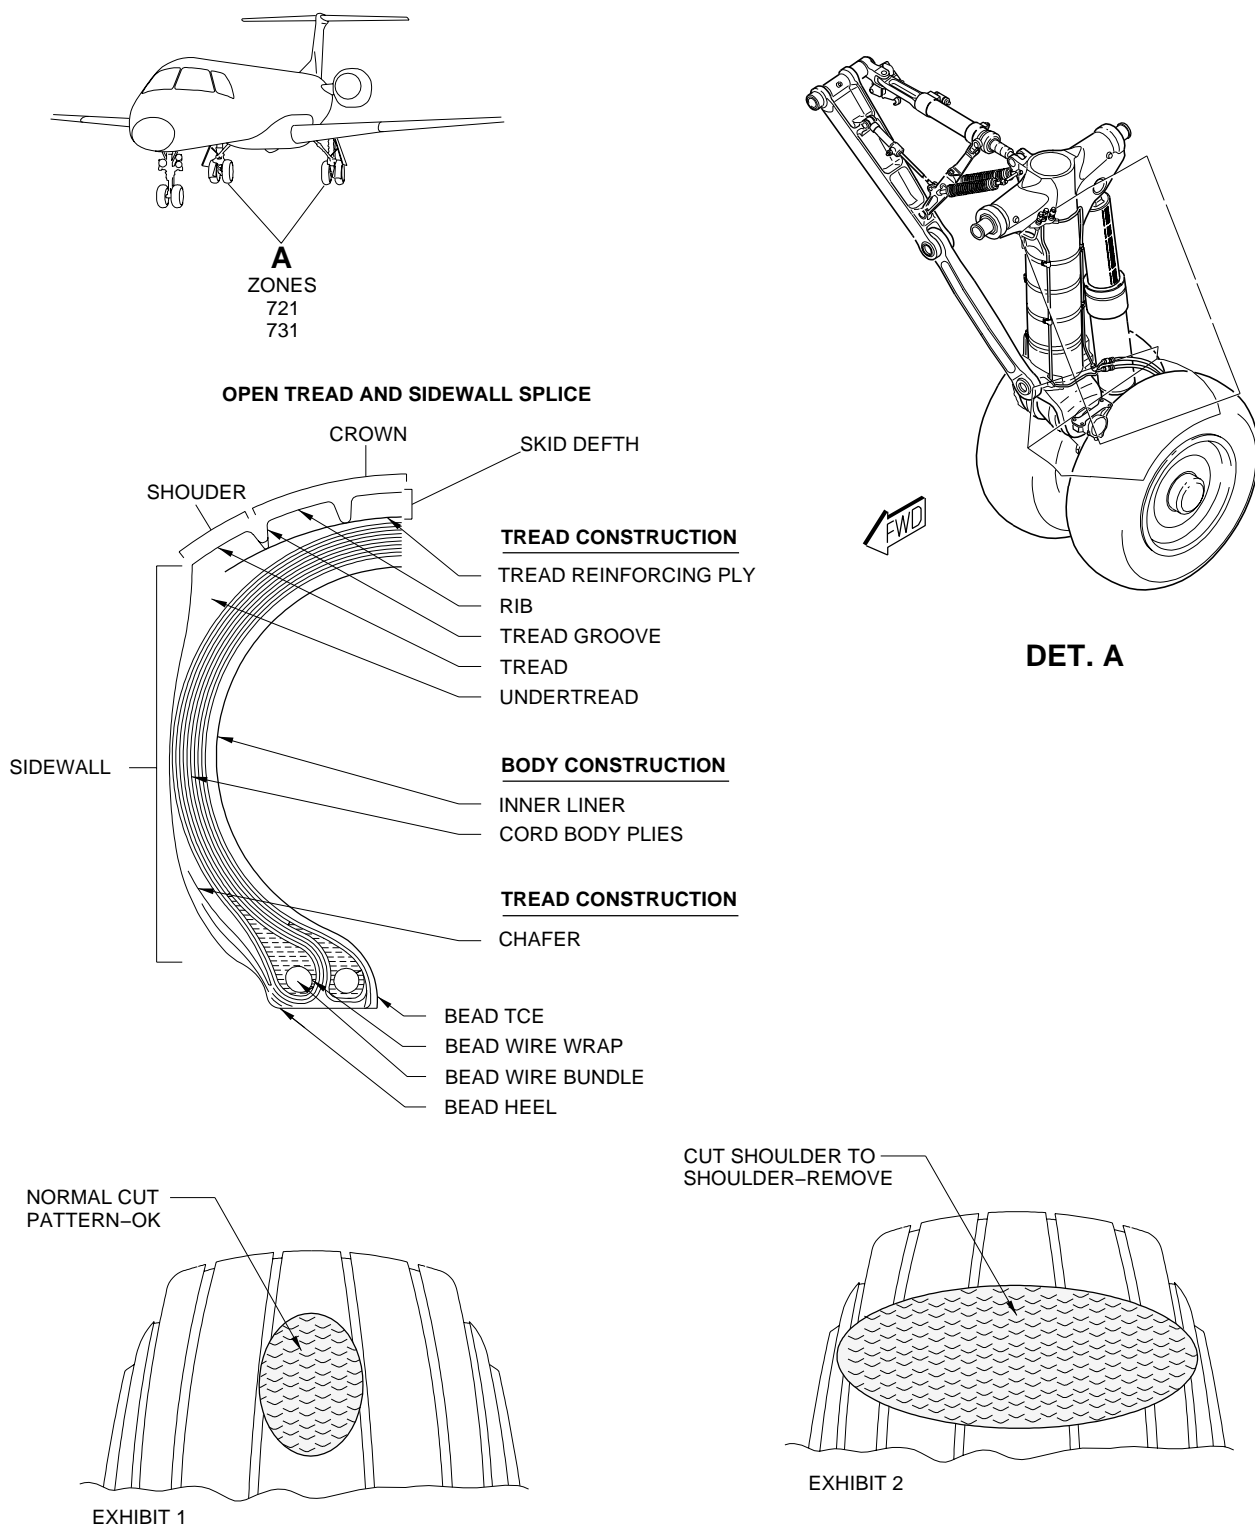
Figure 601

MLG Wheel Tire - Inspection

a When chevron cuts appear on a tire they can be used to indicate a properly inflated or under inflated tire. A properly inflated tire will have the chevron cuts on the center quarter of the tire tread area (exhibit 1 of the [Figure 601](#)) due to its round profile. A tire that is under inflated will have chevron cuts completely across the tread (exhibit 2 of the [Figure 601](#)) due to its flatter profile.

- (6) Examine the tires (2) of the MLG (Zone 721 and Zone 731). Replace the wheel (1) if you find, on a tire (2), one or more of the conditions below (AMM TASK 32-49-01-000-801-A/400 and AMM TASK 32-49-01-400-801-A/400). Refer to [Figure 601](#), Sheet 1.
