### **Apparent Impact Insulation Class (AIIC)**

**Report Date:** 2024-04-15 **Test Date:** 2024-04-04

**DLAA Test No** 1.1.1 **Source Room:** 2nd Floor Great Room

Test Site apartments Receiver Room: 1st Floor Great Room/Kitchen

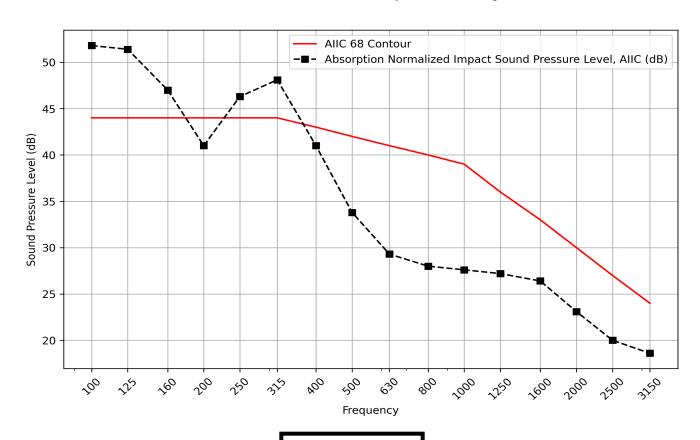
AIIC: 68

The Apparent Impact Insulation Class (AIIC) of 68 was calculated. The AIIC rating is based on Absorption Normalized Impact Sound Pressure Level (ANISPL), and includes the effects of noise flanking. The AIIC reference contour is shown on the next page, and has been fit to the Absorption Normalized Impact Sound Pressure Level values, in accordance with the procedure of ASTC Test Procedure ASTM E336-16 The results stated in this report represent only the specific construction and acoustical conditions present at the time of the test. Measurements performed in accordance with this test method on nominally identical constructions and acoustical conditions may produce different results.
