## **Apparent Sound Transmission Class (ASTC)**

**Report Date:** 2024-04-15 00:00:00 **Test Date:** 2024-04-04 00:00:00

**DLAA Test No** 1.1.1 **Source Room:** 2nd Floor Great Room

**Test Site** Gentry apts **Receiver Room:** 1st Floor Great Room/Kitchen

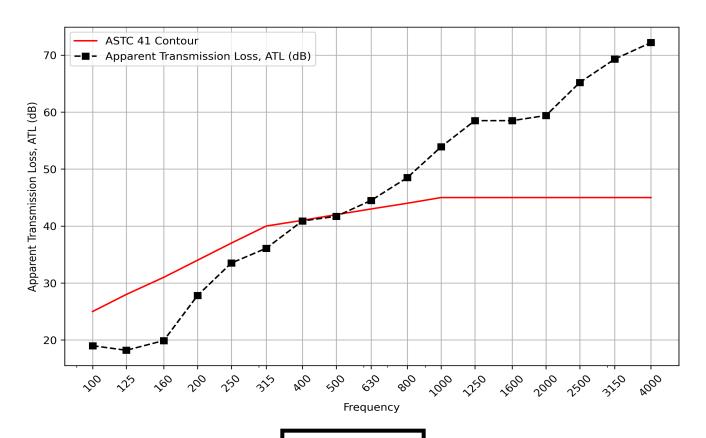
ASTC: 41

The Apparent Sound Transmission Class (ASTC) of 41 was calculated. The ASTC rating is based on Apparent Transmission Loss (ATL), and includes the effects of noise flanking. The ASTC reference contour is shown on the next page, and has been fit to the Apparent Transmission Loss values, in accordance with the procedure of ASTC Test Procedure ASTM E336-16
