# ***PM8841 Power Management IC***

## ***Device Revision Guide***

***80-NA554-4 Rev. H***

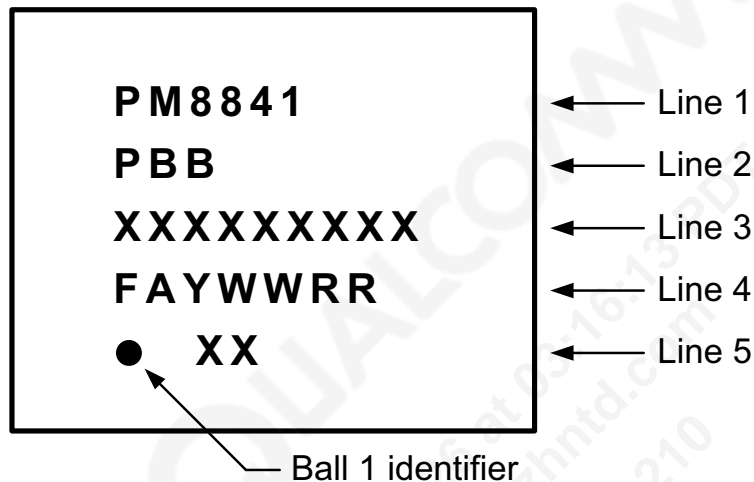
Figure 1 PM8841 device marking (top view – not to scale)

Line	Marking	Description
1	PM8841	Qualcomm product name
2	PBB	P = product configuration code <ul style="list-style-type: none"> <li>See <a href="#">Table 3</a> for assigned values.</li> </ul> BB = feature code <ul style="list-style-type: none"> <li>See <a href="#">Table 3</a> for assigned values.</li> </ul>
3	XXXXXXXXXX	XXXXXXXXXX = traceability information
4	FAYWWRR	F = supply source code <ul style="list-style-type: none"> <li>F = A for Global Foundries, Fab3, Singapore</li> </ul> A = assembly site code <ul style="list-style-type: none"> <li>A = A for StatsChipPac, SCS, Singapore</li> <li>A = B for Amkor, ATC, China</li> </ul> Y = single-digit year WW = work week (based on calendar year) RR = product revision <ul style="list-style-type: none"> <li>See <a href="#">Table 3</a> for assigned values.</li> </ul>
5	• XX	• = dot identifying pin 1 XX = traceability information

The PM8841 device can be identified by markings on its top surface and by the contents of an identification register; these identification techniques are described in [Section 2.1](#) and [Section 2.3](#). Further details about each sample type are presented in [Section 2.3](#) and [Chapter 3](#).
