EMC3080 Firmware Download

1. Module Introduction

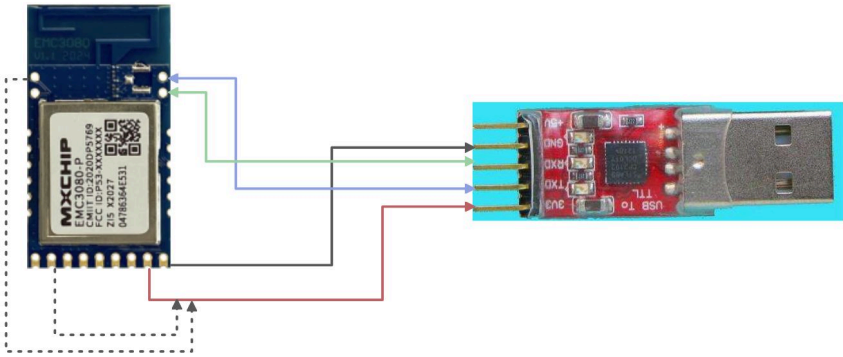
2.2 Wiring Diagram

1. Connect the wires according to the above diagram, and the dotted line shows the pins that need to be raised.
2. After the wiring is completed, disconnect the VCC first and then power it on again to trigger the module to enter the burning mode.

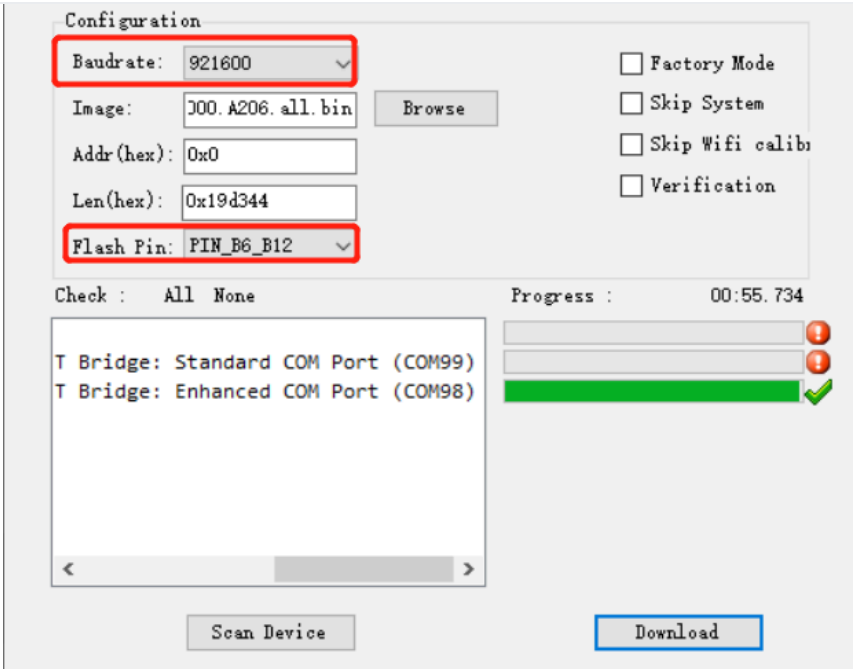
2.3 Software Configuration

- Select RTL8710C in Chip Select.
- Baudrate is 921600bps.
- Choose PIN_B6_B12 in Flash_Pin.
- Select the corresponding all. bin firmware through Browse.
- Click download to write firmware file.

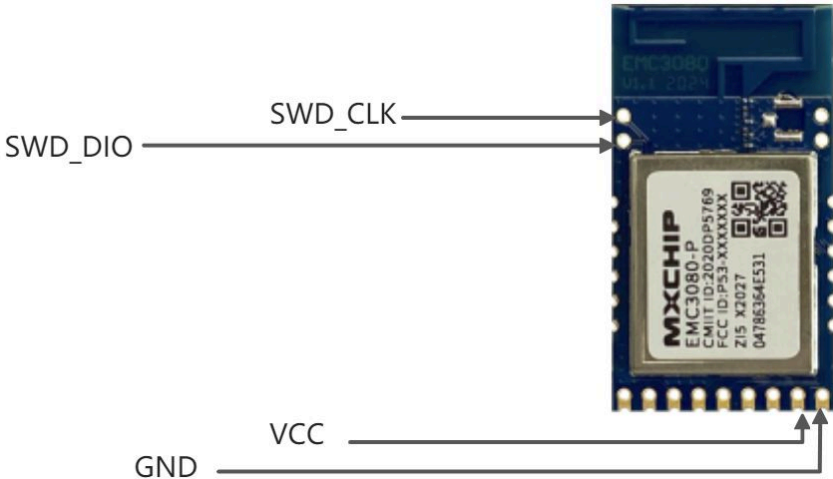
3.2.2 Wiring Diagram

Use the JLink four wire connection method to connect the module and the JLink burner.

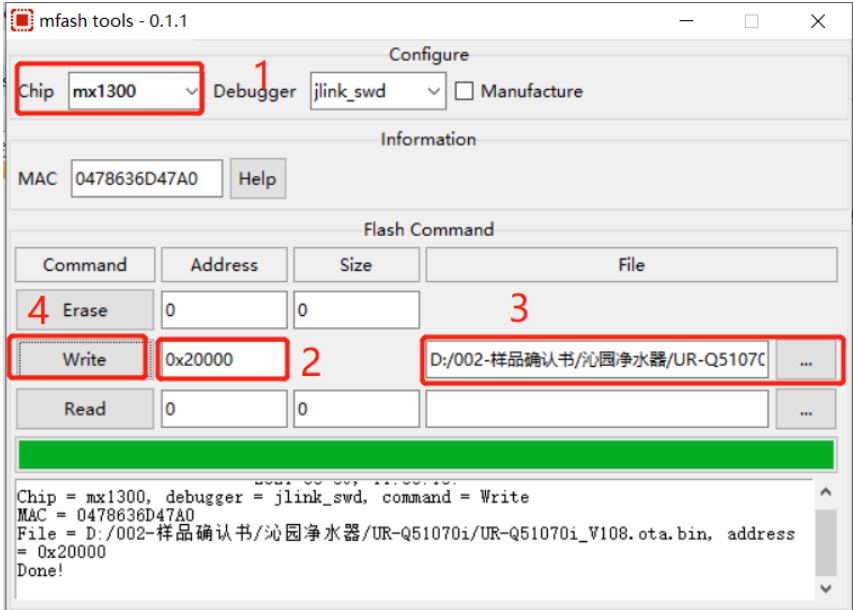
2) Download ota.bin

Due to the KV partition being before the APP partition, it is possible to avoid erasing information such as triples by directly writing to the ota. bin file.
