Apparent Impact Insulation Class (AIIC)

DLAA Test No 1.1.1 **Source Room:** 2nd Floor Great Room

Test Site Gentry apts **Receiver Room:** 1st Floor Great Room/Kitchen

Client Gentry Builders Test Assembly: Floor-ceiling

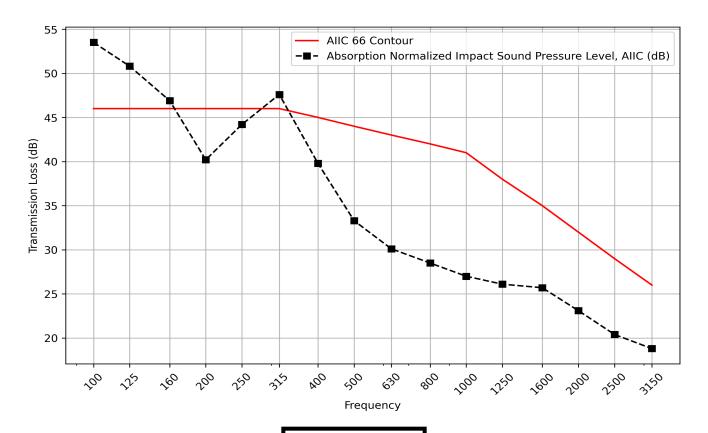
AIIC: 66

The Apparent Impact Insulation Class (AIIC) of 66 was calculated. The AIIC rating is based on Absorption Normalized Impact Sound Pressure Level (ANISPL), and includes the effects of noise flanking. The AIIC reference contour is shown on the next page, and has been fit to the Absorption Normalized Impact Sound Pressure Level values, in accordance with the procedure of ASTC Test Procedure ASTM E336-16 The results stated in this report represent only the specific construction and acoustical conditions present at the time of the test. Measurements performed in accordance with this test method on nominally identical constructions and acoustical conditions may produce different results.
