### **Apparent Impact Insulation Class (AIIC)**

**Report Date:** 2024-04-15 00:00:00 **Test Date:** 2024-04-04 00:00:00

**DLAA Test No** 1.2.1 **Source Room:** 2nd Floor Kitchen

**Test Site** Gentry apts **Receiver Room:** 1st Floor Great Room/Kitchen

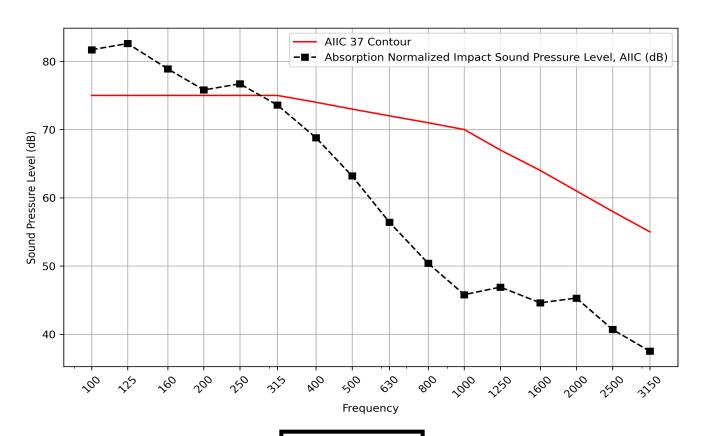
AIIC: 37

The Apparent Impact Insulation Class (AIIC) of 37 was calculated. The AIIC rating is based on Absorption Normalized Impact Sound Pressure Level (ANISPL), and includes the effects of noise flanking. The AIIC reference contour is shown on the next page, and has been fit to the Absorption Normalized Impact Sound Pressure Level values, in accordance with the procedure of ASTC Test Procedure ASTM E336-16 The results stated in this report represent only the specific construction and acoustical conditions present at the time of the test. Measurements performed in accordance with this test method on nominally identical constructions and acoustical conditions may produce different results.
