OpAmp Version Revisited

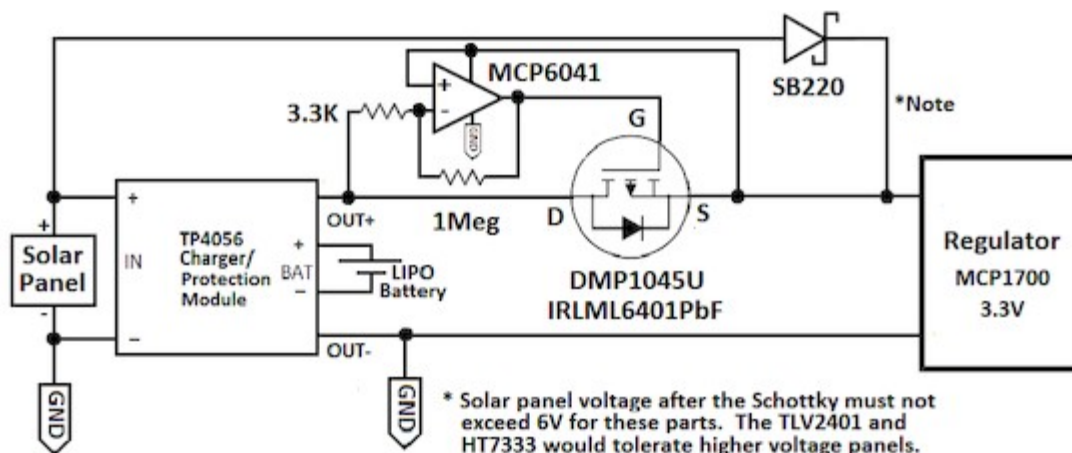
Solar Charger with Load Sharing Op Amp Version - with Feedback

One solution is to add some negative feedback into the circuit by adding two resistors. This solved the problem in the physical test circuit using the opamp with +0.8mV input offset voltage, and in simulation it works for +/-3mV input offset voltage.
