Apparent Impact Insulation Class (AIIC)

DLAA Test No 1.2.1 **Source Room:** 2nd Floor Kitchen

Test Site Gentry apts **Receiver Room:** 1st Floor Great Room/Kitchen

Client Gentry Builders Test Assembly: Floor-ceiling

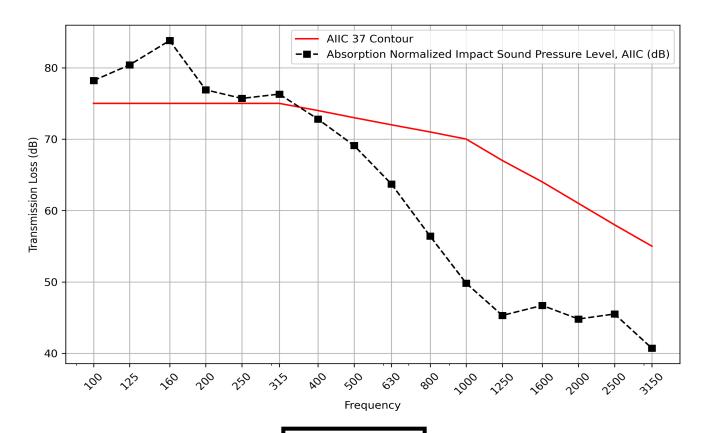
AIIC: 37

The Apparent Impact Insulation Class (AIIC) of 37 was calculated. The AIIC rating is based on Absorption Normalized Impact Sound Pressure Level (ANISPL), and includes the effects of noise flanking. The AIIC reference contour is shown on the next page, and has been fit to the Absorption Normalized Impact Sound Pressure Level values, in accordance with the procedure of ASTC Test Procedure ASTM E336-16 The results stated in this report represent only the specific construction and acoustical conditions present at the time of the test. Measurements performed in accordance with this test method on nominally identical constructions and acoustical conditions may produce different results.
