Apparent Impact Insulation Class (AIIC)

Report Date: 2024-04-15 **Test Date:** 2024-04-04

DLAA Test No 1.1.1 **Source Room:** 2nd Floor Great Room

Test Site Gentry apts **Receiver Room:** 1st Floor Great Room/Kitchen

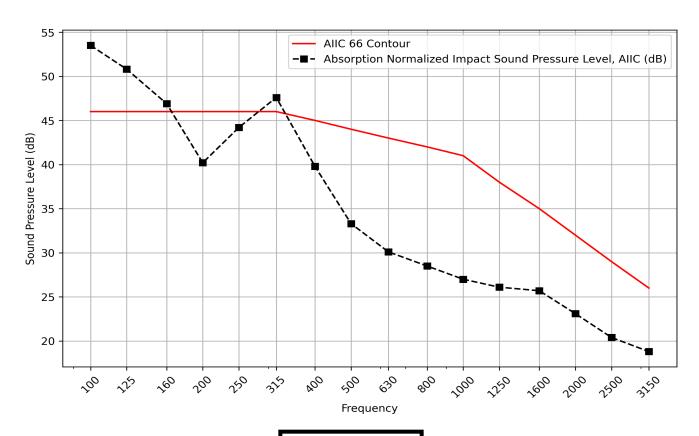
AIIC: 66

The Apparent Impact Insulation Class (AIIC) of 66 was calculated. The AIIC rating is based on Absorption Normalized Impact Sound Pressure Level (ANISPL), and includes the effects of noise flanking. The AIIC reference contour is shown on the next page, and has been fit to the Absorption Normalized Impact Sound Pressure Level values, in accordance with the procedure of ASTC Test Procedure ASTM E336-16 The results stated in this report represent only the specific construction and acoustical conditions present at the time of the test. Measurements performed in accordance with this test method on nominally identical constructions and acoustical conditions may produce different results.
