# A tailor-made checker for specific DV challenges

Kisa Shen (author & presenter)

SNUG Taiwan

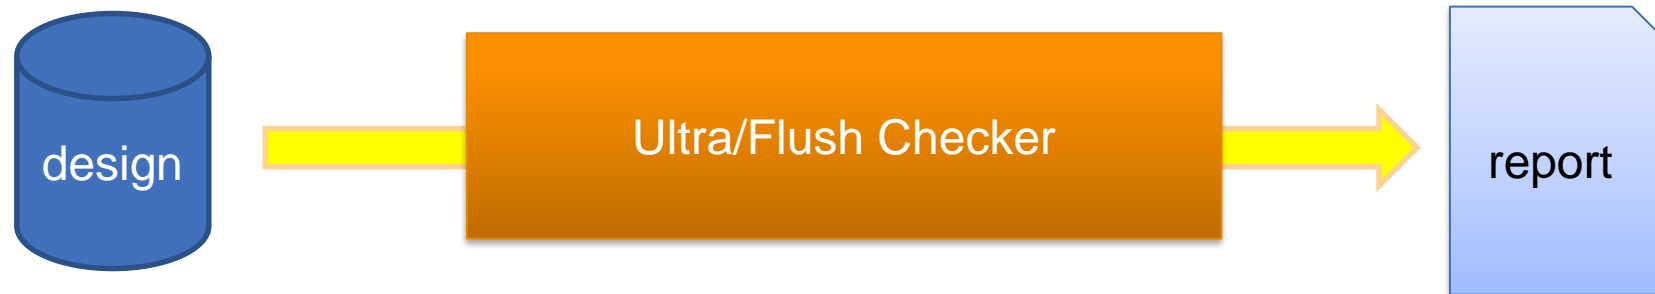
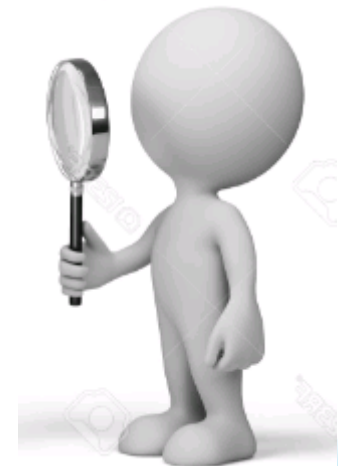
- Static Connectivity Check
- Treat Ultra as golden
- Verification goals
  - Ultra and Flush must connect to the same destination
  - Ultra and Flush must be pairs
  - Tied constant scenarios must be reviewed
