Apparent Impact Insulation Class (AIIC)

DLAA Test No 1.1.1 **Source Room:** 2nd Floor Great Room

Test Site Gentry apts **Receiver Room:** 1st Floor Great Room/Kitchen

Client Gentry Builders Test Assembly: Floor-ceiling

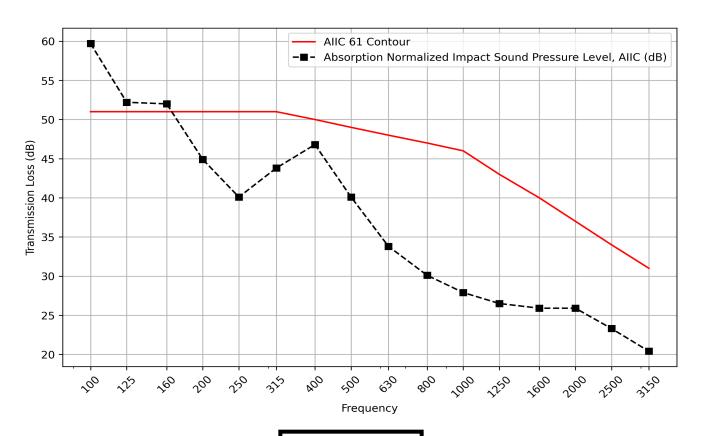
AIIC: 61

The Apparent Impact Insulation Class (AIIC) of 61 was calculated. The AIIC rating is based on Absorption Normalized Impact Sound Pressure Level (ANISPL), and includes the effects of noise flanking. The AIIC reference contour is shown on the next page, and has been fit to the Absorption Normalized Impact Sound Pressure Level values, in accordance with the procedure of ASTC Test Procedure ASTM E336-16 The results stated in this report represent only the specific construction and acoustical conditions present at the time of the test. Measurements performed in accordance with this test method on nominally identical constructions and acoustical conditions may produce different results.
