Test Site: Ka'ulu by Gentry
Client: Gentry Builders, LLC

Report Date: April 05, 2024 Source Room: 2nd Floor Bed 1, Volume: 1180 cu. ft. April 04, 2024 Receiver Room: 1st Floor Bed 1, Volume: 1410 cu. ft. DLAA Test No: 1.4.1 Test Assembly: Floor-ceiling, Area: 130 sq. ft.

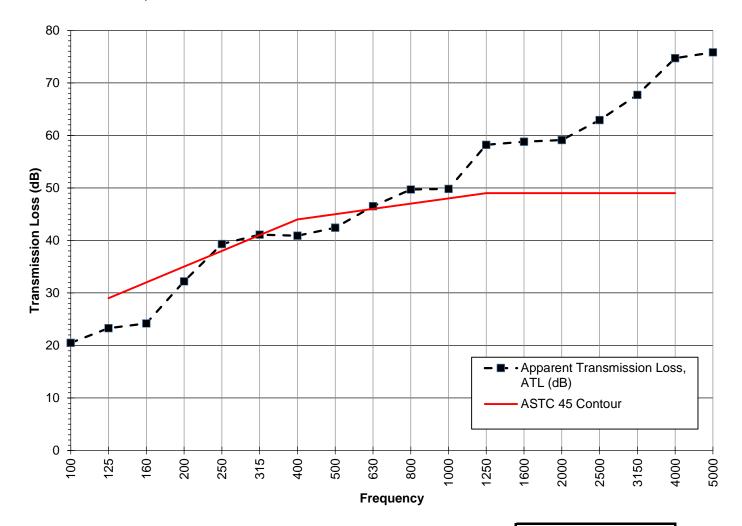
**ASTC: 45**

An Apparent Sound Transmission Class (ASTC) of 45, and a Noise Isolation Class (NIC) of 43 was calculated. The NIC rating is based on Noise Reduction (NR), and includes the effects of noise flanking. The NIC reference contour is shown on the next page, and has been "fit" to the Apparent Transmission Loss values, in accordance with the procedure of ASTM E413-16.
