11th Generation Intel® Core™ Processor

Specification Update

Supporting 11th Generation Intel® Core™ Processor, Intel® Pentium® Processor, and Intel® Celeron® Processor for UP3, UP3 IOT, UP4, H35, H81, UP3-Refresh, and H35-Refresh Processor Line Platforms, formerly known as Tiger Lake

Revision 029

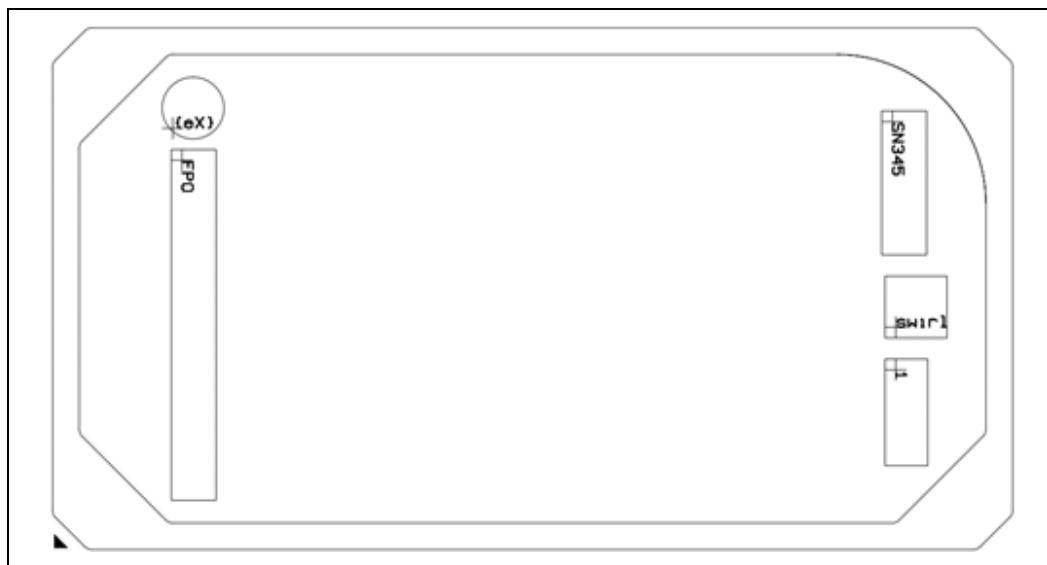
Pin Count: 1449

Package Size: 45.5 mm x 25 mm

Production (SSPEC):

- FPO: FPOxxxxx
- {eX}
- SWIR1: Intel® logo

Note: "1" is used to extract the unit visual ID (2D ID).

Figure 2-1. Processor Based on UP3/H35/UP3-Refresh/H35-Refresh Processor Line Multi-Chip Package BGA Top-Side Markings	9
Figure 2-2. Processor Based on UP4 Processor Line Multi-Chip Package BGA Top-Side Markings	10
Figure 2-3. Processor Based on H81 Processor Line Multi-Chip Package BGA Top-Side Markings	11
