Influence of metallic contamination on surface charge distribution of a 200kV cone-type insulator

DU Qiangdong¹, LIU Haoyu¹, WU Zhicheng¹, ZHU Zhihao¹, ZHAO Junping¹, CUI Boyuan², HE Jie², CHEN Yun²
 (1. State Key Laboratory of Electric Insulation and Power Equipment, Xi'an Jiaotong University, 710049 Xi'an, China;
 2. China Electric Power Research Institute, 100085, Beijing, China)

Abstract – In the operation of HVDC GIL (Gas-insulated Transmission Line), cone-type insulator can separate SF₆ chambers, support the HV conductor and play the role of electric insulation. However, with long-term applied HVDC voltage, charges are prone to accumulate on the insulator surface, which can lead to the decrease of flashover voltage and threaten the stability of power system. Besides, the existence of metallic particles inside the GIL chamber, especially those attached along the insulator surface, can result in a more serious charge accumulation. Therefore, it is necessary to measure the surface charge distribution of clean and metal particle contaminated cone-type insulator in order to analyze its insulation properties under HVDC voltage. In this paper, a 3D 4-axis manipulating system is bu

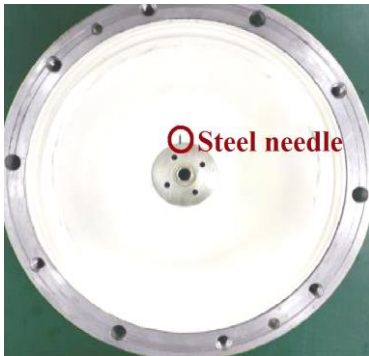
Fig. 4 200kV cone-type insulator with metallic contamination

The cone-type insulator is deliberately cleaned before each test with anti-electrostatic dust paper dipped in anhydrous ethanol. Its surface is scanned before voltage application to ensure the non-existence of charge. In this paper the influence of metallic particle is studied with the model shown in Fig. 4. A steel needle with diameter of 0.56mm and length of 15mm is fixed near to the HV bus to simulate metallic contamination.

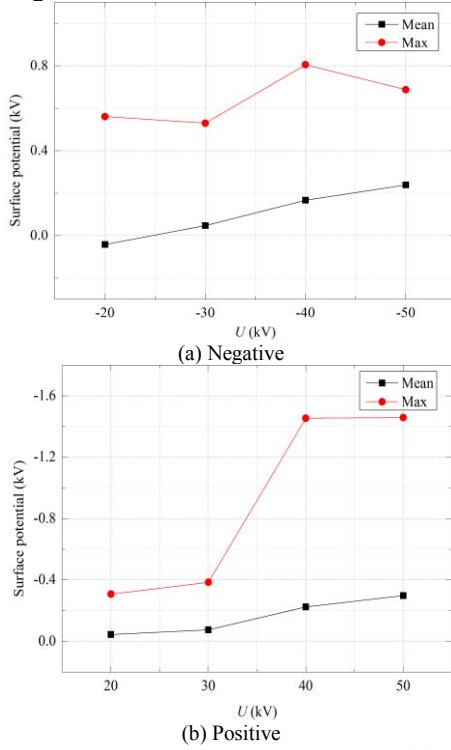
Fig. 6 Average and maximum surface potential with different voltage application

Fig. 6 shows average and maximum surface potential with various HVDC voltage applications. The average potential increases evenly with HVDC voltage amplitude while the maximum potential shows randomness to a certain extent.

Negative charge is more prone to accumulate on the insulator surface with its maximum density more significant than that of positive charge.
