# SERVICE INSTRUCTION REFRIGERATION

## POSITION OF THE INDENTATION FOR THE REPLACEMENT OF THE TEMPERATURE SENSOR (KIT B) Rev. 06

Publication no. **599 37 42-07** Service 11.2009 ITZ/AA

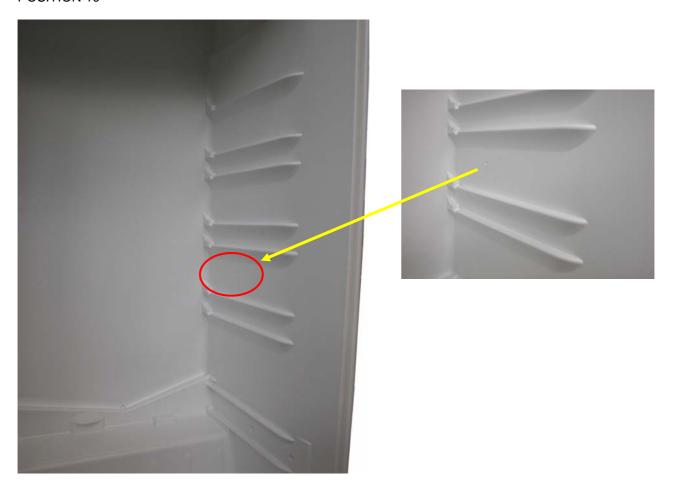
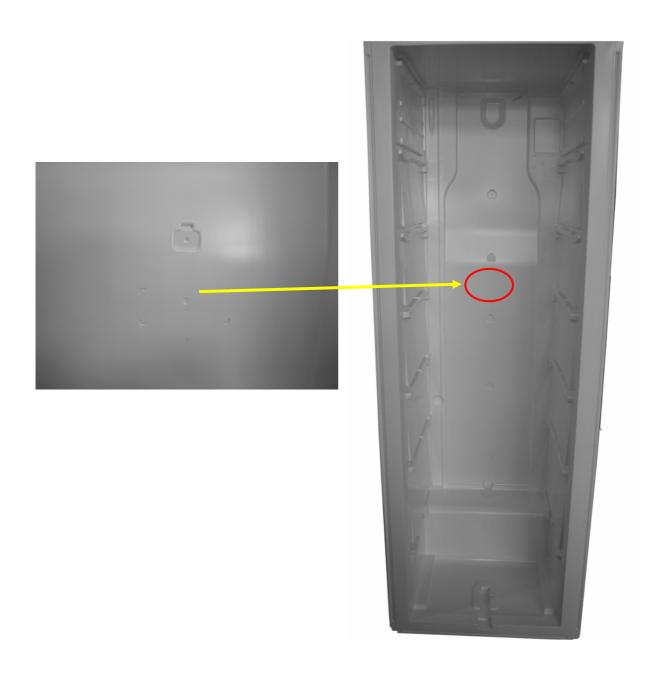
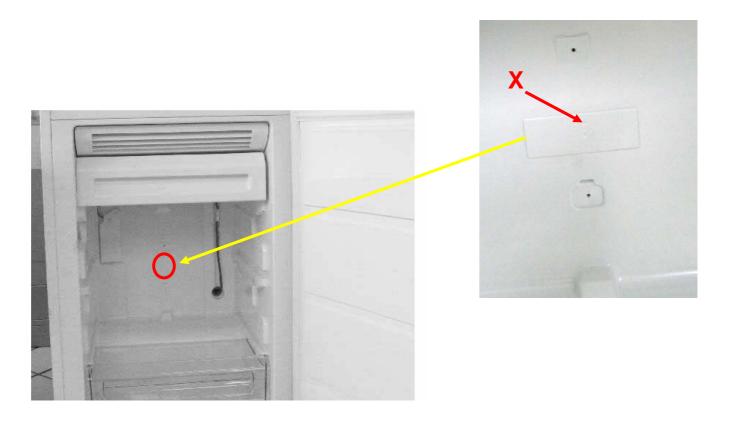
Otherwise, if it indicates KIT NOT AVAILABLE, do not drill the compartment, because the sensor is foamed in the compartment side panel and therefore the KIT B cannot be used, due to the interference between the sensor cover and the freezer drawer.

If the Service Bulletin 599374122 indicates the use of the KIT B part no. 50286483008, drill the compartment in the point corresponding to the indentation  ${\bf X}$  shown in figure.
