MH370 Burst Frequency Offset Analysis and Implications on Descent Rate at End-of-Flight

Ian D. Holland Defence Science and Technology Group, Edinburgh, Australia

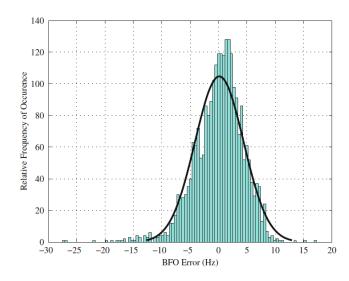
Based on 20 previous flights of 9M-MRO in the week leading up to the accident flight (see [2] for further details), a histogram was produced for the difference between the predicted BFO (based on known details of the plane and the satellite's position and velocity) and the measured BFO (based on Inmarsat ground station logs). This difference (i.e. predicted minus measured) is referred to as the BFO error. The histogram of the BFO error is shown in Fig. 2, along with a Gaussian distribution fit line. It can be seen that the distribution is somewhat Gaussian. The standard deviation of the BFO error was found in [2] to be 4.3 Hz. Whilst it is reasonable to apply bounds on the possible BFO error based on ± 3 standard deviations as was done for the approximate analysis described in [7], for the purpose of the descent analysis presented later in Sec. VI, it is assumed the BFO error is strictly bounded on the larger interval [-28, +18] Hz, which corresponds to the bounds of all 2501 observed valid³ in-flight BFO error values available from the preceding 20 flights of 9M-MRO.

Fig. 2. Histogram of BFO errors for 20 flights of 9M-MRO prior to MH370 (reproduced from Fig. 5.5 of [2]). The mean and standard deviation for the distribution are 0.18 Hz and 4.3 Hz, respectively [2].

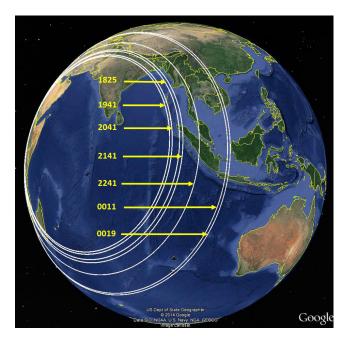
Fig. 3. BTO rings during the MH370 flight [3]. Note that the latitude of the arrows shown for each ring is arbitrary.

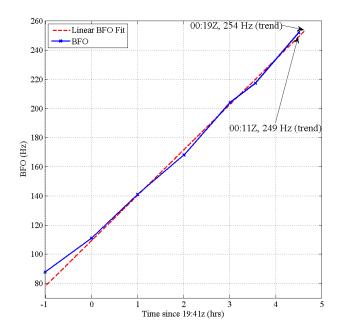
The measured BFOs from 19:41Z to 00:11Z are shown in Fig. 5 together with a line-of-best-fit. This line is extended forward to the time of the 00:19Z log-on resulting in an expected BFO of roughly 254 Hz⁷. With reference to the track angle curves presented in Fig. 4, the 00:11Z BFO error value for the southern-most track is roughly 6 Hz, meaning the measured BFO of 252 Hz was 6 Hz lower than the lowest value it could have been (assuming roughly level flight at

Fig. 5. Measured BFOs during the MH370 flight with trend-line extrapolated back to 18:40Z and forward to 00:19Z.

approximately 450 kts). If we assume the same error value at 00:19Z, and use the extrapolated BFO, assuming a south track with level flight and similar ground speed, the expected BFO value is 260 Hz.

The BFOs logged for messages from the plane received at the Perth GES at 00:19:29Z and 00:19:37Z 8 March 2014 were much lower than the expected value of 260 Hz. In the absence of any other factors affecting the BFOs at these times, this suggests a large uncompensated negative vertical velocity component in the BFOs. In determining how to interpret this data, it is important therefore to carefully consider any known other factors that could effect these BFOs. One potential factor is an SDU oscillator startup transient. This section analyses the range of expected effect on the BFO caused by a period of power outage followed by a restart of the SDU, as was a possibility between 00:11Z and 00:19Z on 8 March 2014 (see [3] for further details).

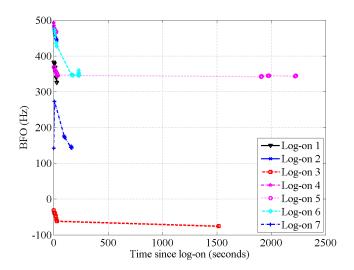
as part of a standard log-on sequence. The BFOs over those minutes displayed somewhat unusual behavior in that (barring the first BFO) the BFO appeared to be exhibiting a transient settling behavior. This is shown in Fig. 6. It was noted in [1] that the spike in BFO observed at this time⁸ was not fully understood and whilst originally attributed to a possible aircraft maneuver it could also be related to actual frequency changes occurring during the logon sequence. A subsequent study [8] by the SATCOM sub-group of the MH370 Flight Path Reconstruction Group revealed this was most likely due to power-on frequency drift and subsequent stabilization of the oven-controlled crystal oscillator (OCXO) in the SDU. In [8], a number of different SDUs were tested to investigate the effects of power outages on the BFO during SDU power on, triggering a SATCOM logon such as that which occurred for MH370 at 18:25:27Z. It was found that whilst the frequency settling behavior was different for each individual SDU, any given SDU displayed repeatable behavior for a fixed outage duration, and similar settling characteristics for outages of different duration.

Based on sequences of Inmarsat BFO logs for 9M-MRO concerning four log-ons after periods of SATCOM outage in the week leading up to the accident flight, it was found (in [8]) that the SDU in 9M-MRO resulted in a BFO that was initially too high at the time of log-on, followed by a simple decay over the next few minutes to a steady-state value. Regarding the log-on event at 18:25:27Z for MH370, it was noted that there was a non-zero bit error rate (BER) associated with the log-on request at that time. The associated received signal level and carrier-to-noise density ratio (C/N_0) were also unusually low. As such, the first BFO was deemed untrustworthy. Note that this is not the only time such a behavior was observed for the SDU in 9M-MRO. In the analysis of BFOs presented in [2], there was an outlier in the BFO (with an error of

Fig. 7. Measured BFOs for 7 log-ons of 9M-MRO.

on the tarmac for the whole time) that demonstrate the BFO appears to have fully settled to a steady-state value. Log-ons 1 to 5 only lasted for less than 1 minute after the log-on request message. The results for log-ons 6 and 7, which had log-on sequences lasting a few minutes suggest a settling behavior of approximately 3 minutes duration. For all observed log-on sequences, there seems to be a simple decay of BFO over a few minutes after SDU startup and log-on request (see also Fig. 8). It is therefore possible a similar decay was occurring during the SDU log-on sequence beginning at 00:19:29Z.
