Follow Up Changes:

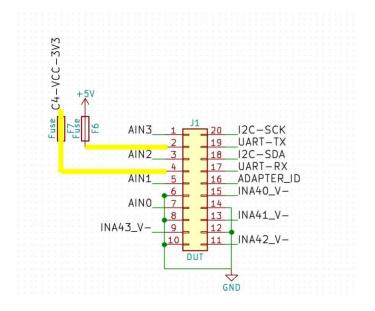
1) J17 needs to be flipped along its horizontal axis. For example, the pad for pin 1 should be where the pad for pin 2 is, and the pad for pin 2 should be where the pad for pin 1 is.

This means that J15 and J16 should switch places, and then be rewired.
