**COLORADO**  
Oil & Gas Conservation  
Commission  
Department of Natural Resources

# **ANALYSIS OF FLOWLINE- RELATED SPILLS**

**January 1, 2019 – December 30, 2019**

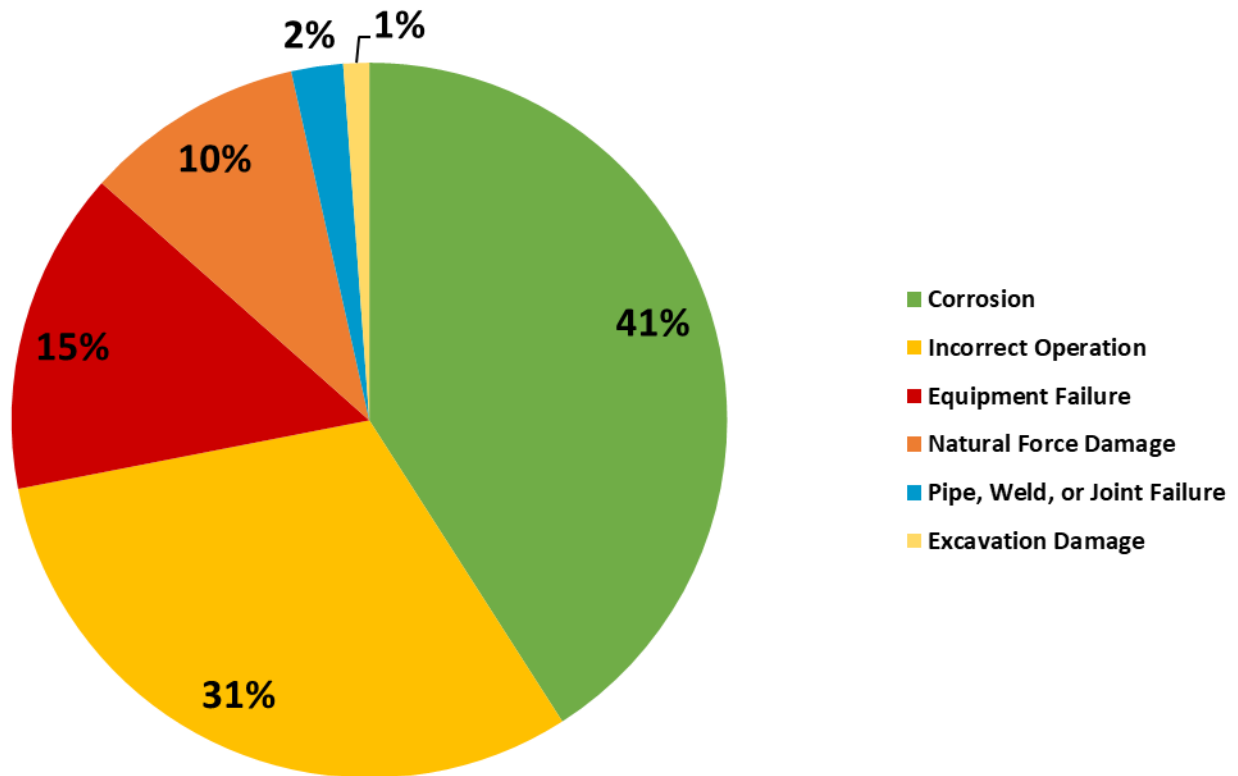
**Figure 1. Reported Causes of 2019 Flowline Releases**

### Reported Causes of Flowline Releases January 1, 2019 - December 21, 2019

Corrosion, incorrect operation, and equipment failure represent 86% of the root causes of flowline related spills. This analysis will focus on those four root causes.

Approximately 41% of the spills were caused by corrosion. Of the 70 spills reported with corrosion as a root cause, 39 were due to internal corrosion, while 17 were due to external corrosion, and 14 were unknown.

Incorrect operation accounts for 31% of the spills. These spills were split between the following: valve misalignment (22), improper installation (16), inadequate procedures (13), and overpressure (2).

Equipment failures were also significant for 2019, making up 15% of all flowline-related spills. TEP Rocky Mountain had the highest number of equipment failures (4/25). Three of four of these failures were due gasket failures and likely due to age of these wear items.
