AL FLASHER 24 V VIBRATION TEST REPORT

Part Name	AL FLASHER 24 V	Application	COMMERCIAL APPLICATION
Customer Part No.	FGG00700	Customer	ASHOK LEYLAND
UCAL Part No.	RDEPL/AL/16	Report No	R&D/AL/24VF/VAL/26/004

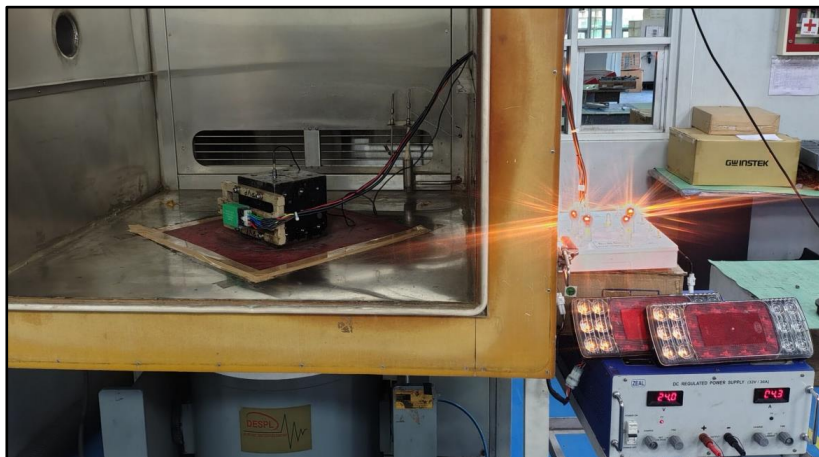
The performance of the Flasher assembly is acceptable after test. The samples are met the requirements.
