DTC	B1299	REAR LH SEAT ECU COMMUNICATION STOP
-----	-------	-------------------------------------

CIRCUIT DESCRIPTION

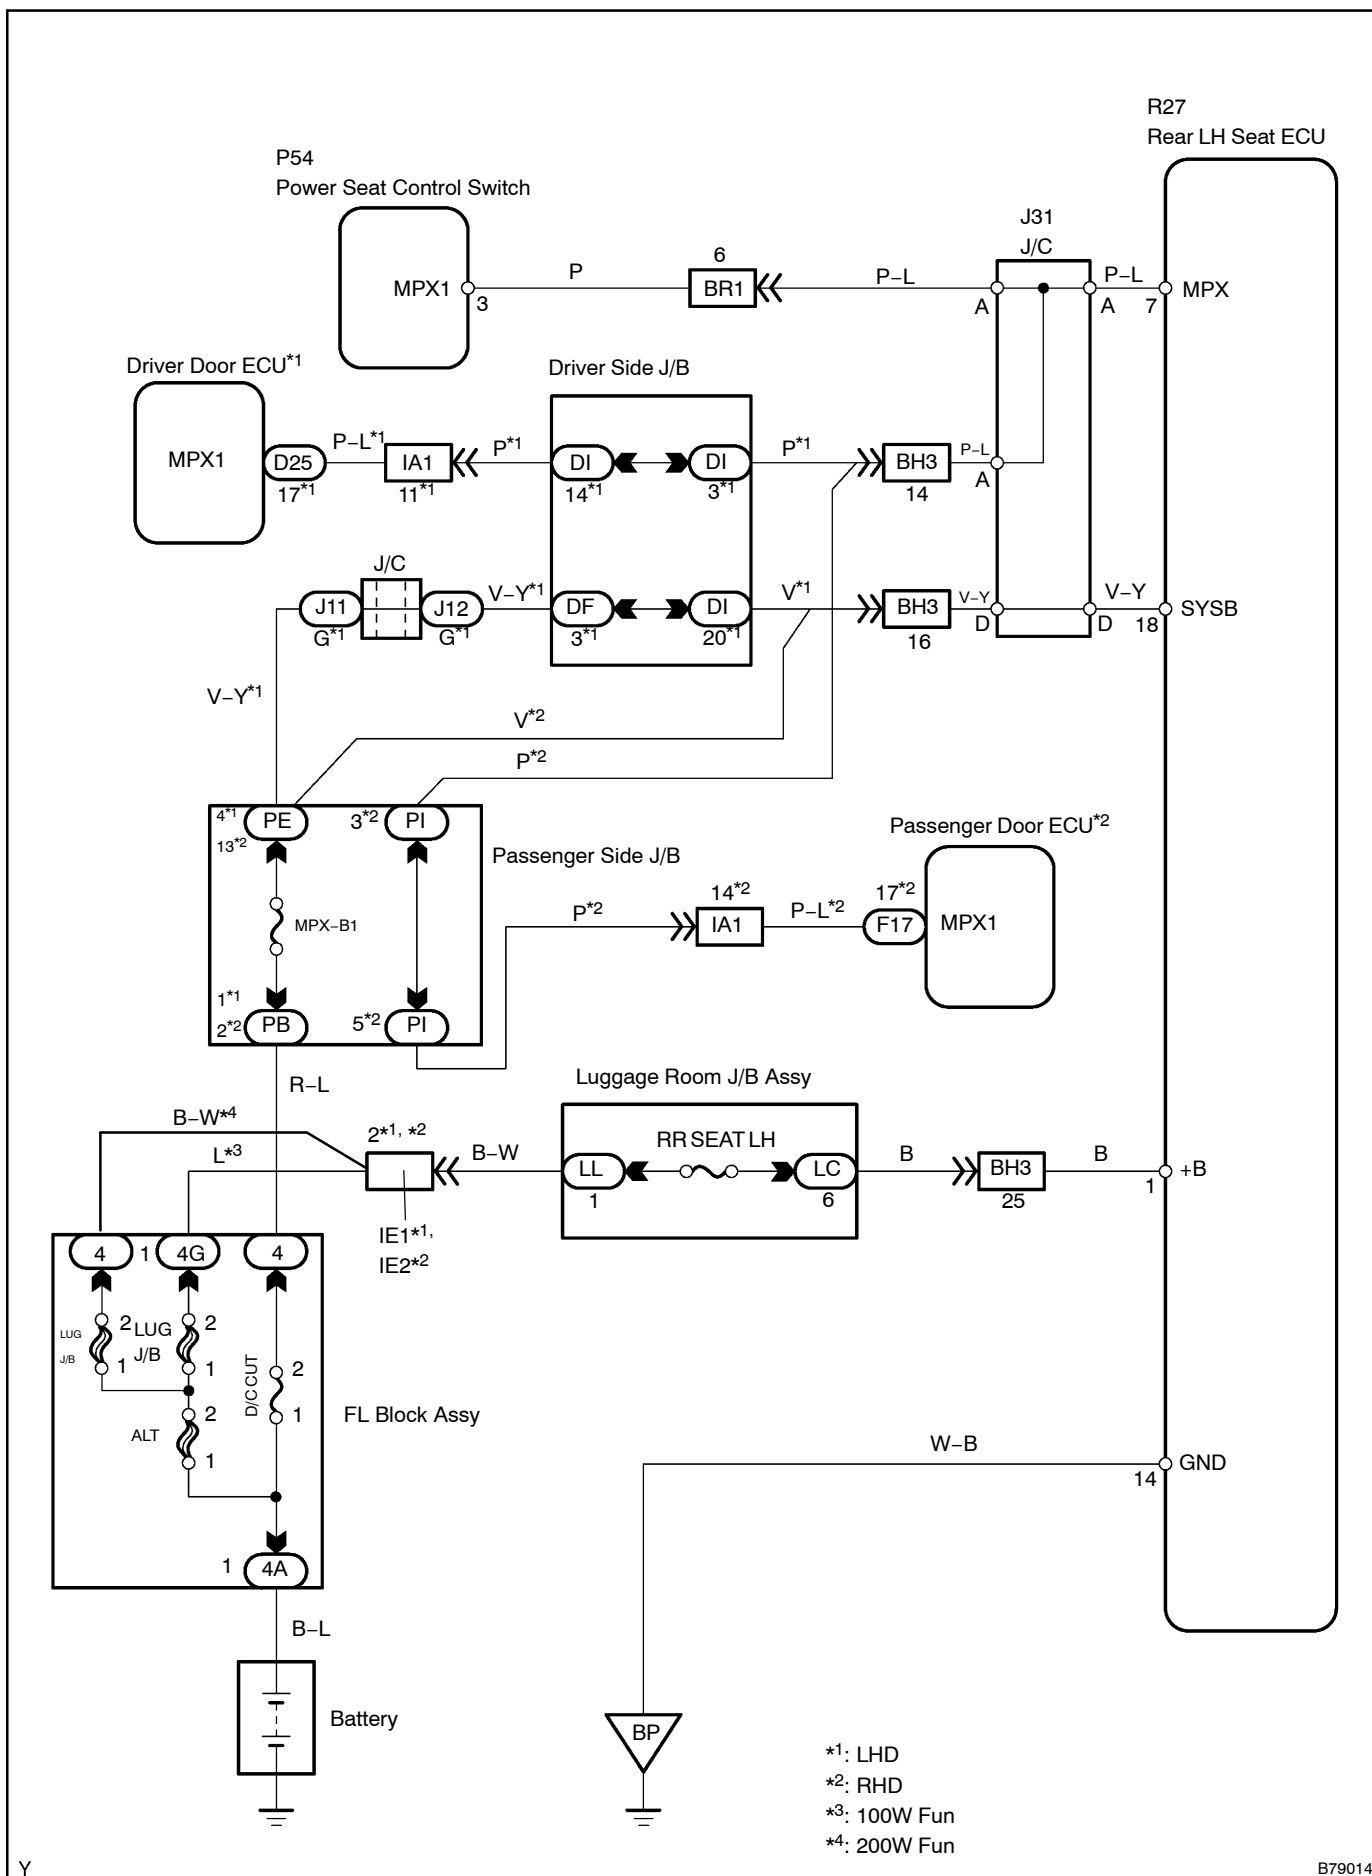
WIRING DIAGRAM

The wiring diagram is shown on the next page.

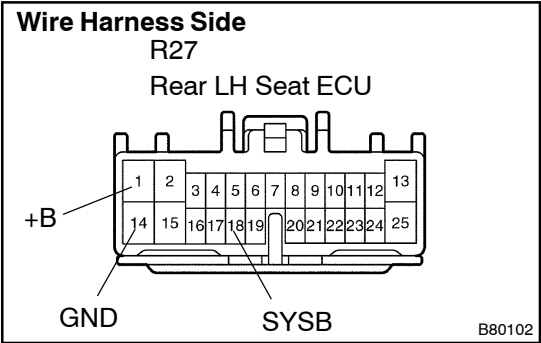
2 CHECK WIRE HARNESS (REAR LH SEAT ECU – BODY GROUND)

- (a) Disconnect the R27 ECU connector.
 - (b) Measure the resistance of the wire harness side connector.
- Standard:

Tester Connection	Specified Condition
R27-18 (SYSB) – Body ground	10 to 14 V
R27-1 (+B) – Body ground	10 to 14 V
R27-14 (GND) – Body ground	Below 1 Ω

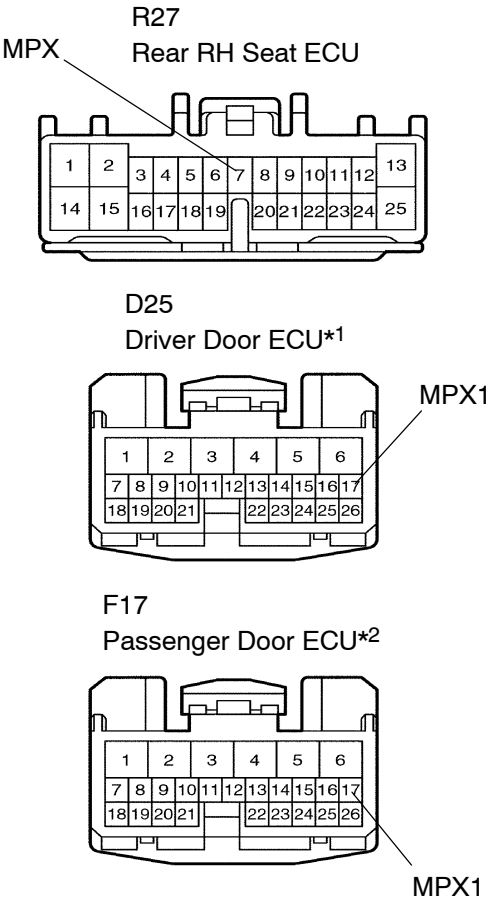
B80104

Wire Harness Side

*1: LHD
*2: RHD

- (a) Disconnect the R27 ECU connector.
- (b) Disconnect the D25*¹ or F17*² ECU connector.
- (c) Measure the resistance between the wire harness side connectors.

Tester Connection	Specified Condition
R27-7 (MPX) - D25-17 (MPX1)	Below 1 Ω

Tester Connection	Specified Condition
R27-7 (MPX) - F171-7 (MPX1)	Below 1 Ω
