TECHNICAL BULLETIN

Ref: TB 062

Section
Model: MYHTIC 22 AL	☛ 1
Information: Bug causing impossibility to restart the instrument.	☛ 2
Action: Do not set "DELAY ms" parameter lower than 100 millisecond.	☛ 3
Send by ORPHE SA to: All distributors	
Contacts: Contact ORPHEE SA for further information.	
Information feedback asked by ORPHEE SA To inform ORPHEE SA of the incidents relating to this document.

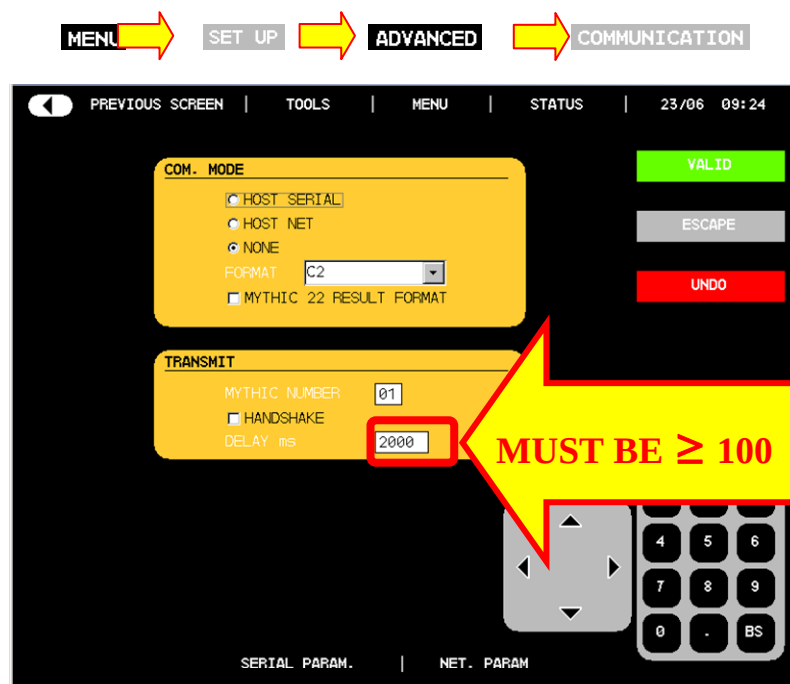
Orpheediscovered a bug which causes an impossibility to restart the instrument. Actually, when the “**DELAY ms**” parameter from “**COMMUNICATION**” screen is set with a lower value than 100, it is impossible to restart the instrument after shutdown.

In order to avoid this unpleasant scenario, it is strongly recommended to inform all distributors to always set this parameter with a value **higher or equal to 100**. The bug will be corrected with a future software release.
