# HD-64 User Manual

**Author:** Vittorio Pascucci (Side Projects Lab)

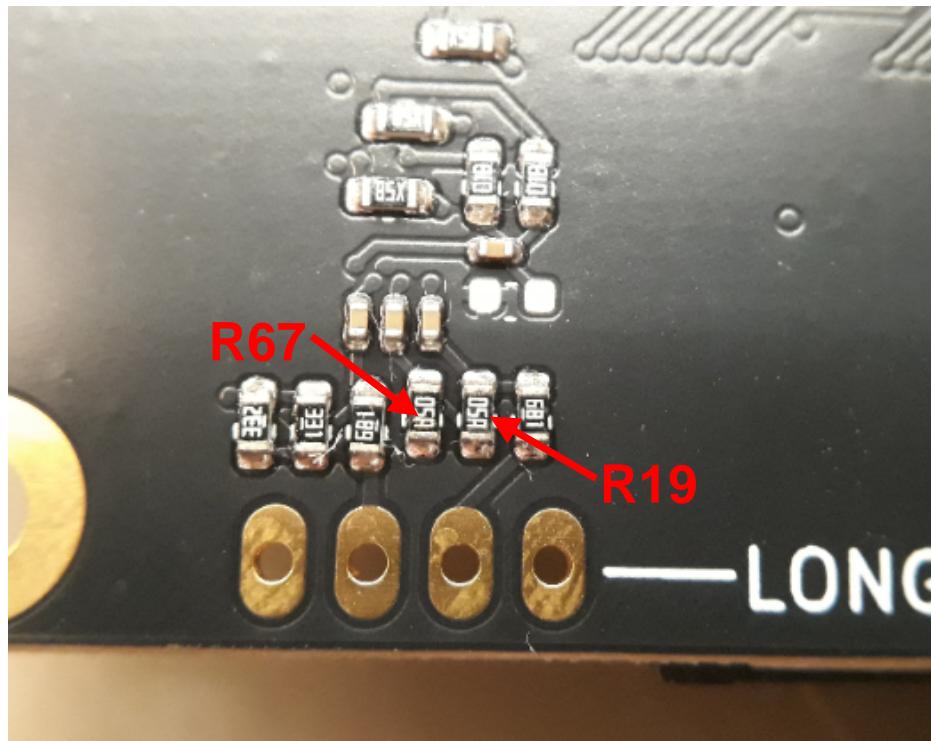
Figure 17. HD-64 Chroma Amplitude Hardware Bug

Due to a component mixup while ordering the first production batch of board version 0.2, resistors R19 and R67 have wrong values, which causes the chroma amplitude to be out of spec.

In the affected boards, both resistors have a value of 110 Ohm (the markings are "05A"), instead of 220 Ohm and 100 Ohm respectively.

Even with this issue it is likely that there will be no noticeable problem on CRTs and LCDs due to the ability of most screens to compensate for inaccuracies of the chroma amplitude. Should the color look "off" there are two recommended ways to fix the issue:

**What to do:** Replace R19 and R67 with 220 Ohm and 100 Ohm respectively (0603 size) or, Add a 680 Ohm 0603 resistor on top of R67 (so without removing the current resistors) so that the parallel of the original 100 Ohm resistor and the added 680 Ohm becomes 87 Ohm, which brings the chroma amplitude back to the correct value.

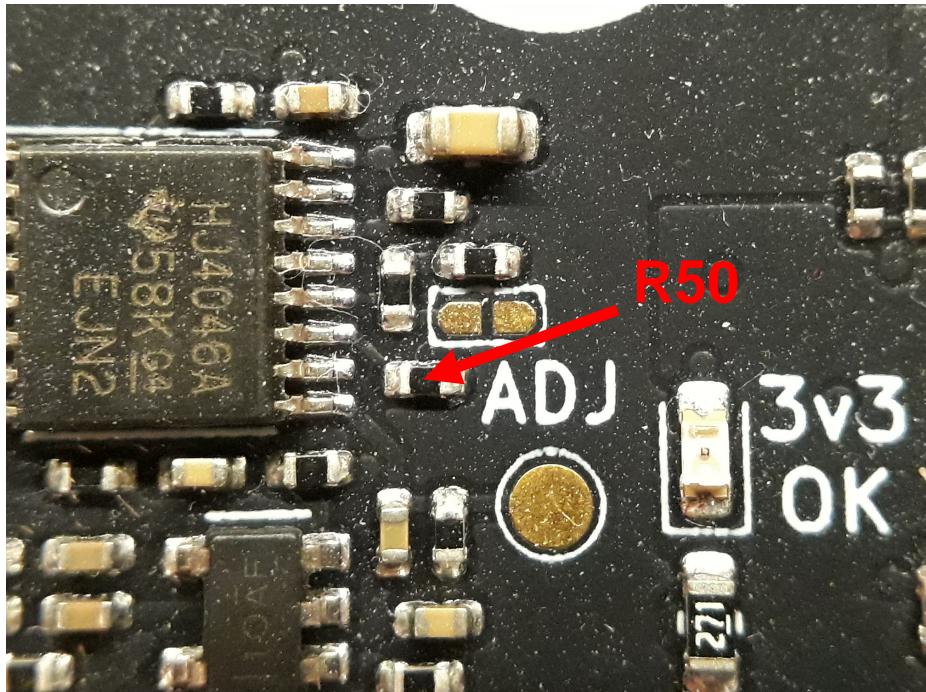
Figure 18. HD-64 PLL Bias Hardware Bug

Boards of production batch 1 and 2 are affected, though this bug is unlikely to have any real world ripercussions.

Resistor R50 has the wrong value (22kOhm), causing the PLL bias to be lower than originally intended (1.5V instead of 2.1V), though well within the allowed range (1V to 3V).

This imperfection means that the "Adj jumper" (Item 5 in [Figure 4](#)) will not be effective against a possible decrease of the PLL center frequency due to component aging. Should the PLL bias voltage spontaneously drift towards or below 1V over time, closing the "Adj jumper" will further lower the bias, causing the PLL to operate even more out of spec.

**What to do:** If the voltage on the test point nearby the "Adj Jumper" falls below 1v (with the Adj jumper open), R50 shall be replaced with a 33kOhm, 0402 resistor.
