DTC	B1213	TILT AND TELESCOPIC ECU COMMUNICATION STOP
-----	-------	--

CIRCUIT DESCRIPTION

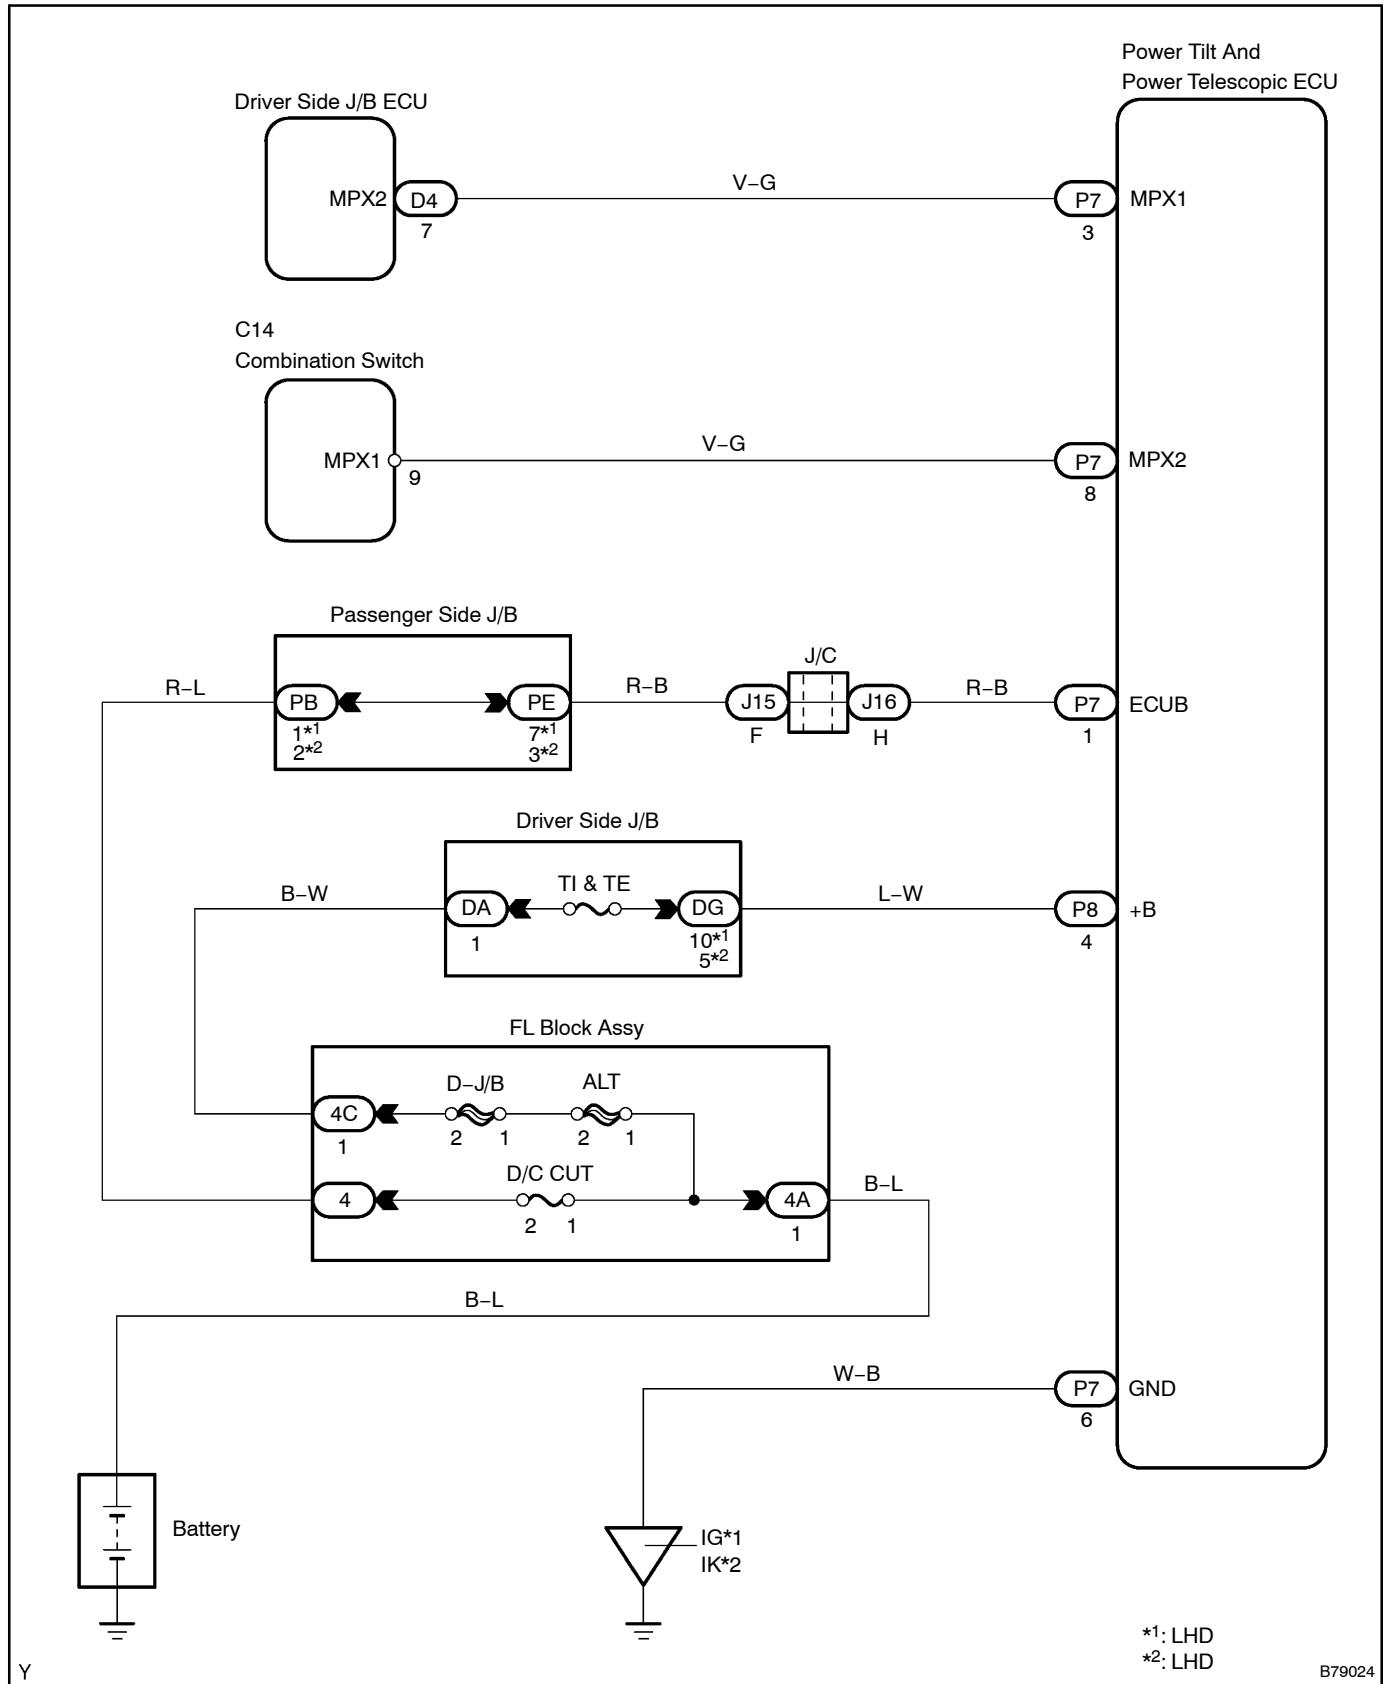
## WIRING DIAGRAM

This DTC is detected when communication between the tilt and telescopic ECU and gateway ECU stops for more than 10 seconds.

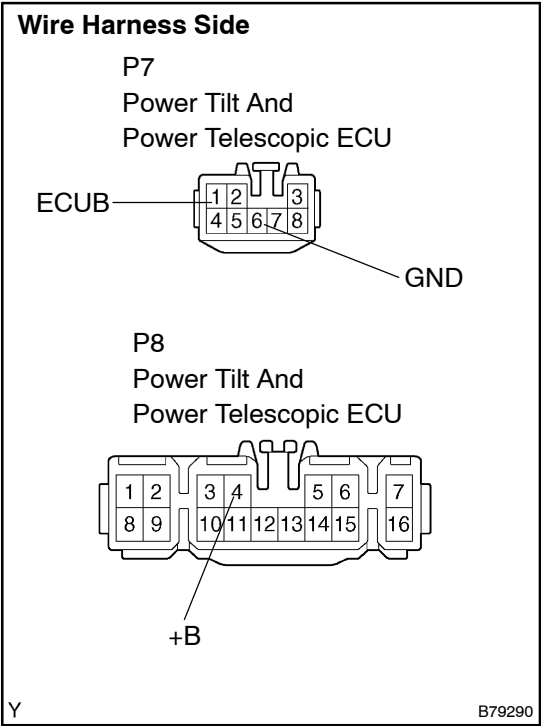
2 CHECK WIRE HARNESS (POWER TILT AND POWER TELESCOPIC ECU – BODY GROUND)

- (a) Disconnect the P7 and P8 ECU connectors.
- (b) Measure the resistance and voltage between the wire harness side connector and body ground.

Standard:

Tester Connection	Specified Condition
P7-1 (ECUB) – Body ground	10 to 14 V
P8-4 (+B) – Body ground	10 to 14 V
P7-6 (GND) – Body ground	Below 1 Ω
